**REPORT INTO THE  
FATAL INCIDENT  
OFF INISHOWEN HEAD,  
CO. DONEGAL  
ON  
28th JUNE 2014**

**REPORT NO. MCIB/238  
(No.6 OF 2015)**

Report MCIB/238 published by The Marine Casualty Investigation Board.  
Printed 8th June 2015.

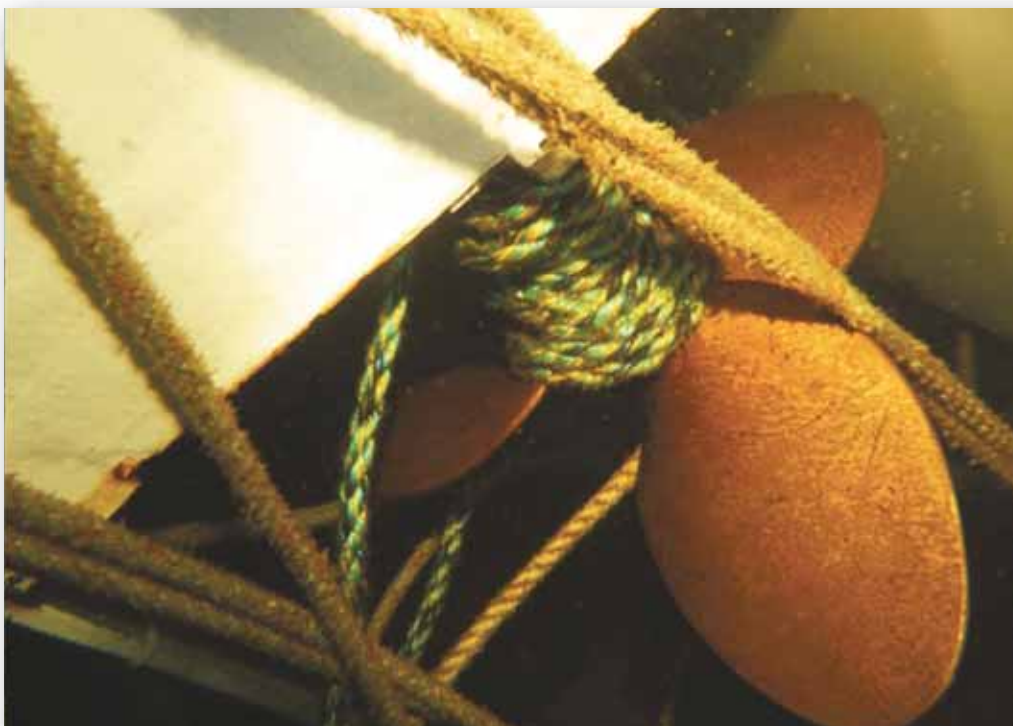
- 3.8 The photographs show that the vessel had a rope wrapped around the propeller.
- 3.9 The divers reported that a line from the propeller led directly to a lobster pot that was trapped between two rocks (see Appendix 7.4 Photographs No.1 & 2).

- 3.11.11 The gearbox linkage was found engaged in the ahead position.
- 3.11.12 Information received indicated that there were two bilge pumps aboard.
- 3.11.13 A coloured 3 strand polypropylene rope was entangled around the propeller. One end led up the port side of the transom to the deck area. The other end had been cut. The direction of the rope indicated that the engine was going ahead at the time.

Photograph No. 1 - Underwater image showing rope wrapped around the propeller

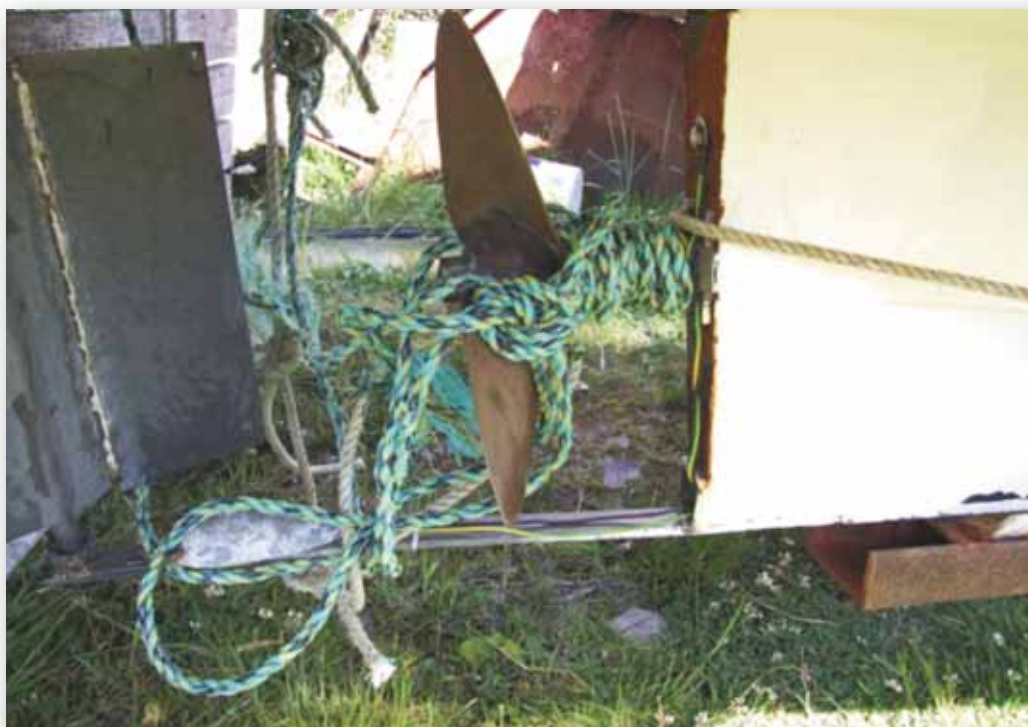
- 4.6 Reviewing the video footage of the vessel before it was raised, shows that there were a few ropes around the wreck. The most important was the 3 strand multi-coloured rope which was wrapped around the propeller. One end led downwards to the lobster pot that was trapped. The other end led up the port side of the transom and onto the deck.

Photograph No. 2 - View of rope wrapped around propeller as seen at time of inspection

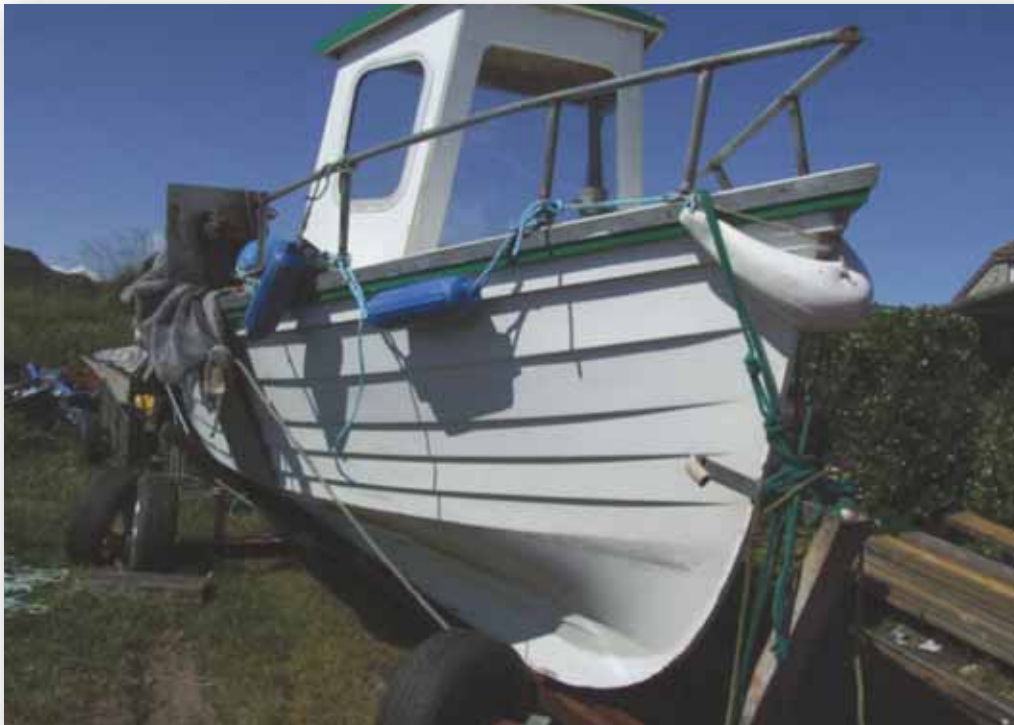
- 3.11.3 The vessel had been fitted out in 2013 for use as a fishing vessel. It is understood that it was intended to have the vessel inspected under the Code of Practice for Compliance for Design, Construction, Equipment and Operation of Small Fishing Vessels of less than 15 m. The vessel was in service for less than 6 months and had been used approximately 4 times for potting. It was described as a "work in progress" (see Appendix 7.4 Photographs No.3).

Photograph No. 3 - View of vessel from starboard side forward

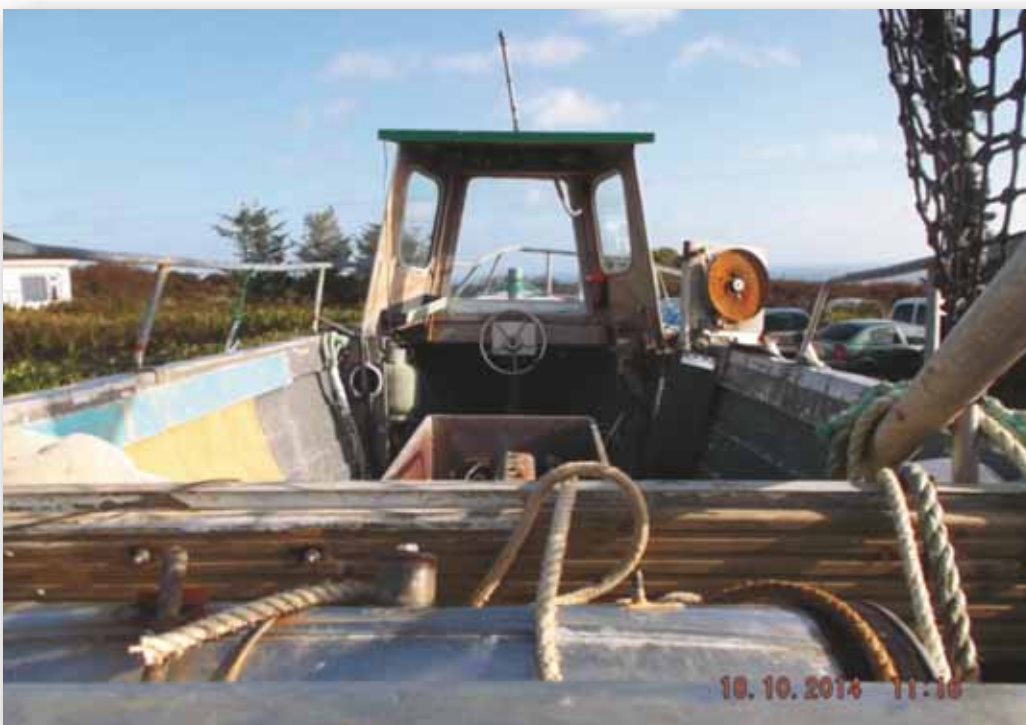
- 3.11.4 The vessel had a small forward open wheelhouse or cuddy. There was a new marine VHF transceiver in this area, fitted for Digital Selective Calling (DSC) operations (manufacturer's name not visible). There was a bracket for the EPIRB, which was empty. The only other instruments were an instrument panel and ignition switch for the engine (see Appendix 7.4 Photographs No.4).

Photograph No. 4 - View of inside of vessel from top of transom

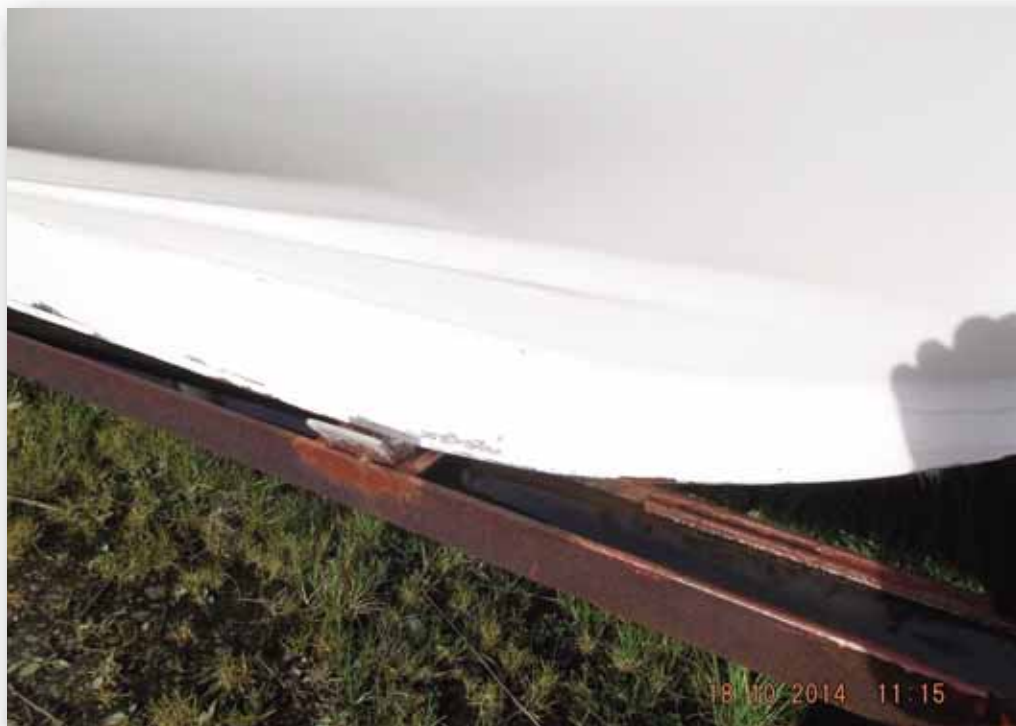
- 3.11.16 The line outlining the separation of the keel extension was clearly visible at the time of inspection. It formed a small crack, visible to the naked eye, mainly towards the fore end. When the photograph was blown up on screen the full extent of the separation was realised (see Appendix 7.4 Photographs No.5).

Photograph No. 5 - Shows cracking along keel line
