**REPORT OF THE INVESTIGATION
INTO
THE SINKING OF
“FV NAPIER”
ON
30th JANUARY 2014**

**REPORT NO. MCIB/236
(No.4 OF 2015)**

Report MCIB/236 published by The Marine Casualty Investigation Board.
Printed 25th February 2015.

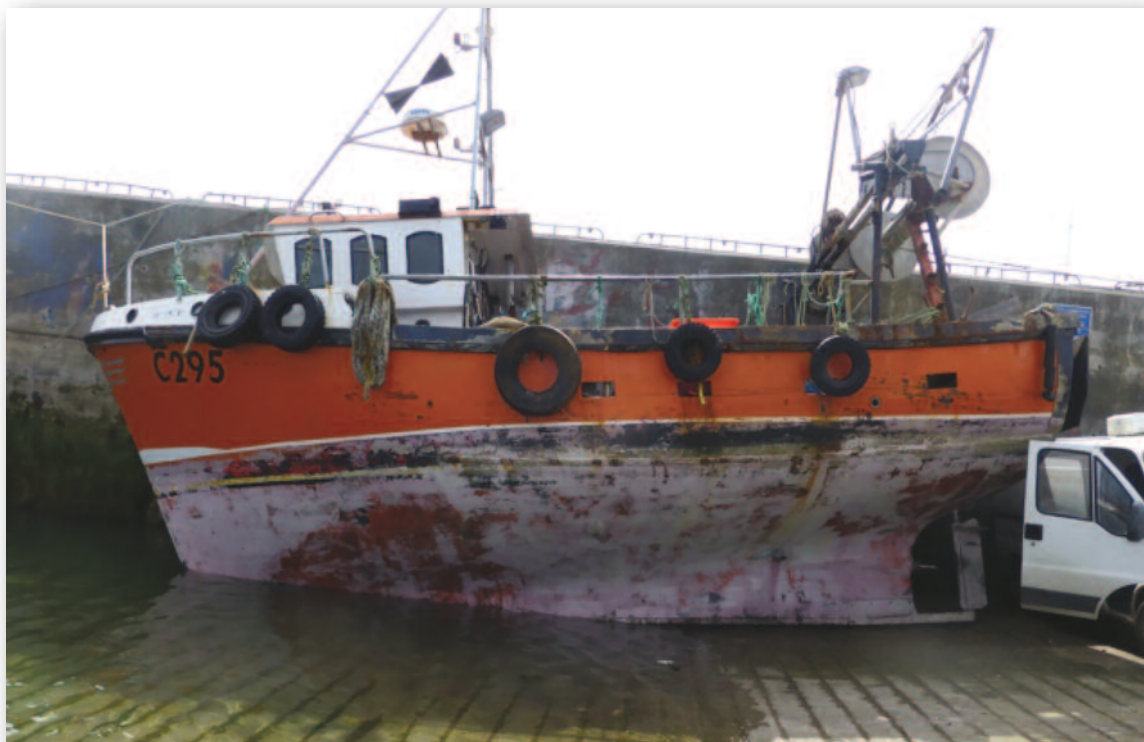
Photograph No. 1 - "FV Napier"

History: Built 1985 in Scotland. Purchased about 8 years ago in Downpatrick, Northern Ireland by current Skipper. In use since then working out of Kilmore Quay, Wexford (90% potting, 10% scallops) (see Appendix 7.1 Photographs 1 & 2 of vessel taken at Kilmore Quay during survey in 2013).

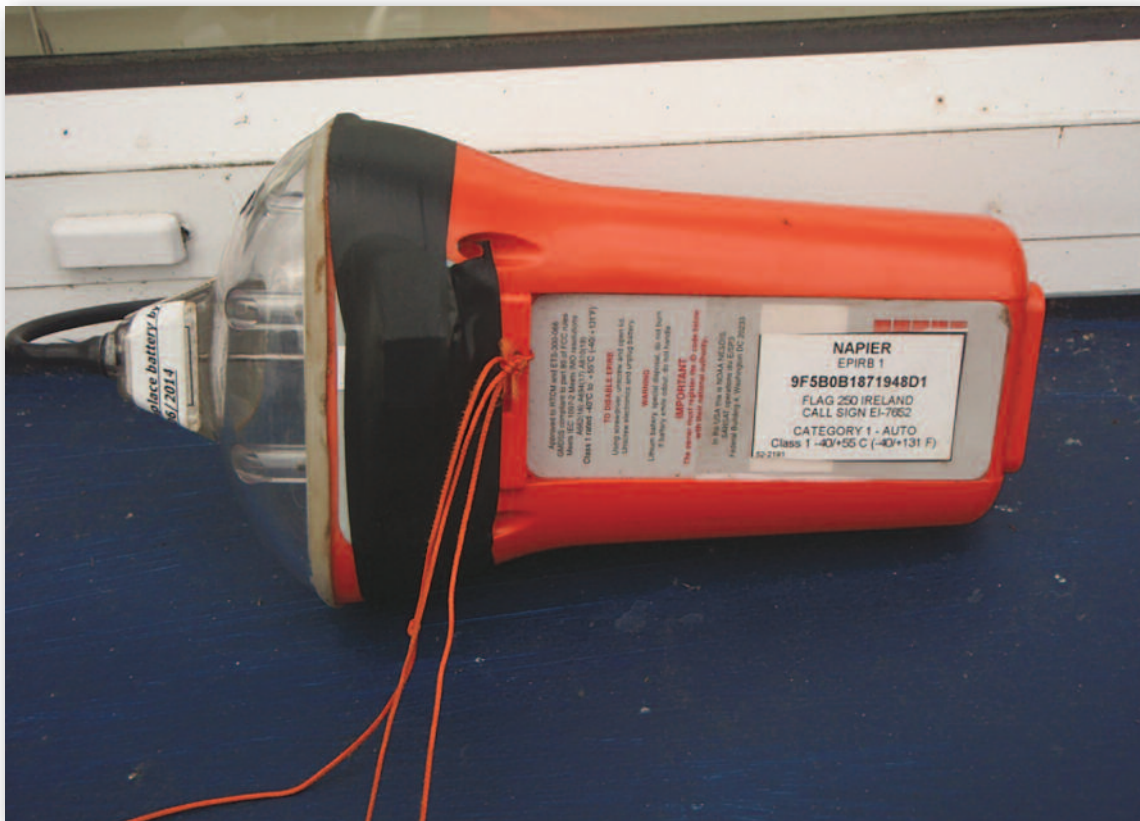
Photograph No. 3 - EPIRB

EPIRB Details: Make McMurdo No. 52.2191.
Napier EPIRB 1 9F5Bo@B1871948D1 Flag 250 Ireland.
Call sign E1-7652 Cat 1 Auto Class 1.
Battery replacement due 06/2014 (see Appendix 7.1 Photograph 3 of EPIRB taken by MCIB 22/08/2014).
