**REPORT OF INVESTIGATION
INTO A FATAL INCIDENT
INVOLVING THE CAPSIZED
DRASCOMBE LUGGER,
“ZILLAH”
OFF SCHULL, CO. CORK
ON
13th AUGUST 2014**

**REPORT NO. MCIB/240
(No.5 OF 2015)**

Report MCIB/240 published by The Marine Casualty Investigation Board.
Printed 25th May 2015.

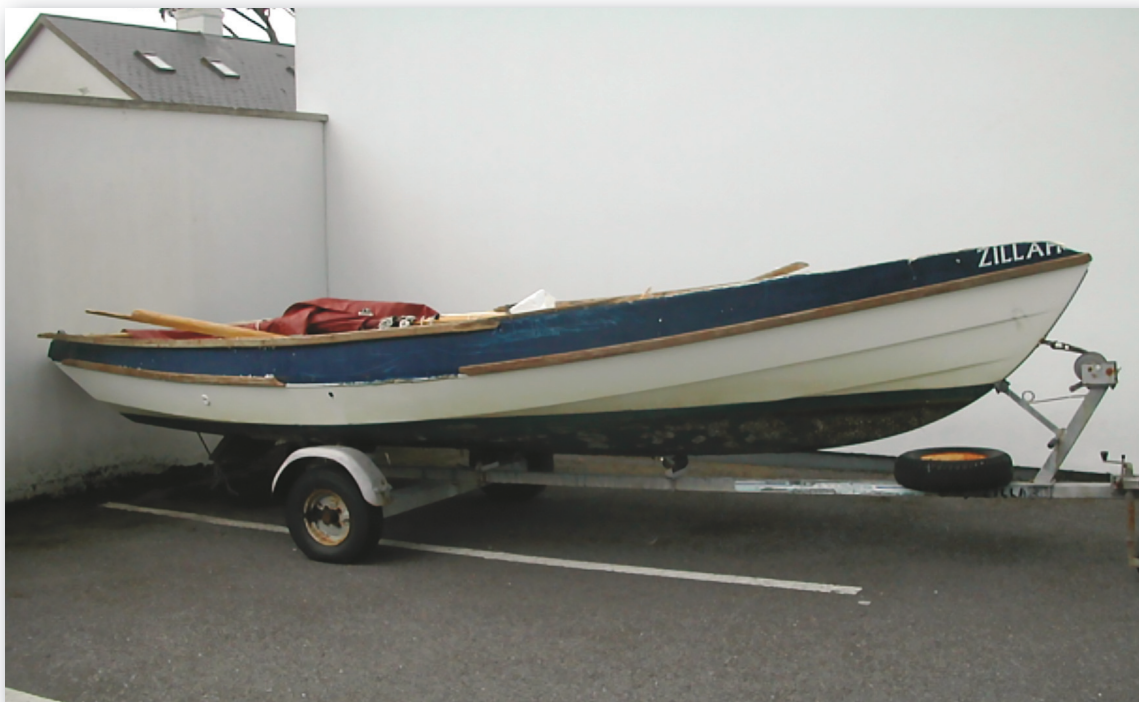
Photograph 1 - "Zillah" ashore following recovery

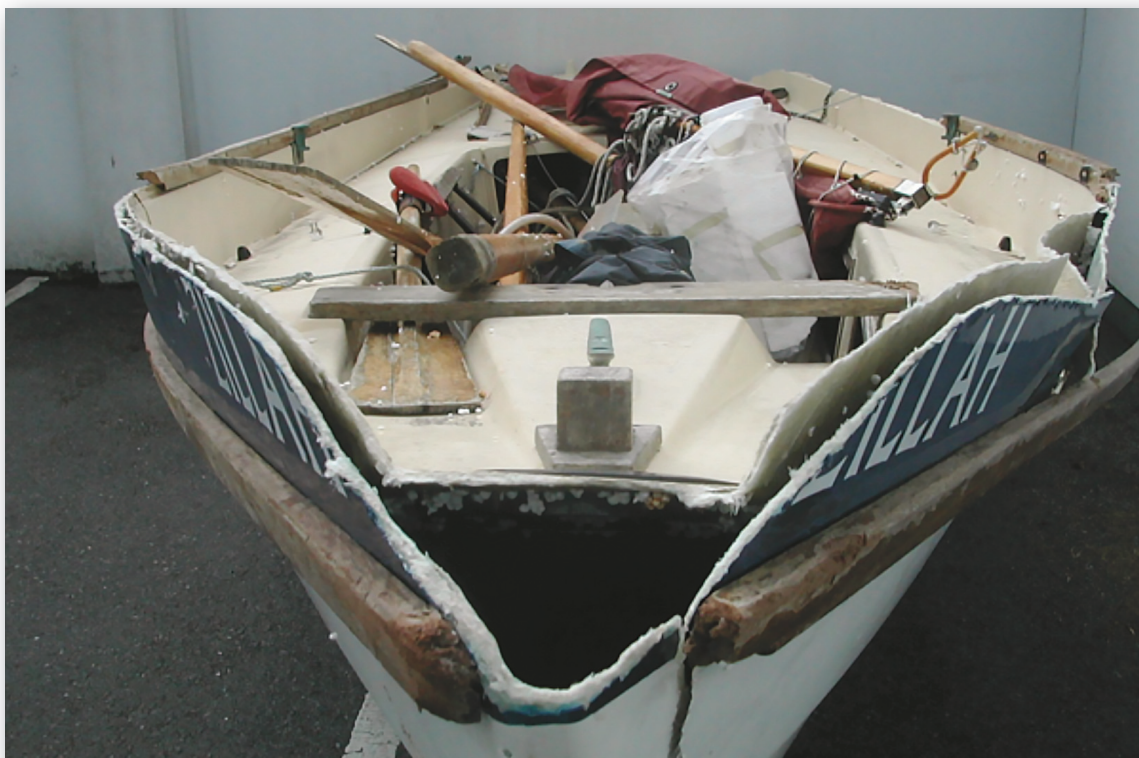
- 4.2 The vessel turned “turtle” very quickly and the centre plate fell back into its casing, possibly becoming detached from its pivot and being suspended below the upturned hull from the retrieval line. There was no mechanism for retaining the centre plate in the extended position.

Photograph 2 - Damage suffered by "Zillah" following floundering

- 6.1 It is recommended that the manufacturers of the Drascombe Lugger investigate the feasibility of installing a system whereby the centreplate can be retained in the deployed position such that it will remain extended in the event of a capsize. It should be possible to retrofit this mechanism to existing vessels.
- 6.2 It is recommended that the Drascombe Association highlight the possibility of capsizing these vessels under certain conditions.
- 6.3 It is recommended that the Drascombe Association instigate a campaign to raise awareness amongst its members of the wisdom of upgrading their vessels inbuilt buoyancy to comply with Category C of the RCD.
- 6.4 Owners and operators of recreational craft should be aware of and follow the Department of Transport, Tourism and Sport's Code of Practice for the Safe Operation of Recreational Craft.
