**REPORT INTO THE FATAL  
INCIDENT  
INVOLVING  
“MFV DEAN LEANNE”  
ON  
12th JUNE 2013**

**REPORT NO. MCIB/231  
(No.1 OF 2015)**

Report MCIB/231 published by The Marine Casualty Investigation Board.  
Printed 21st January 2015.

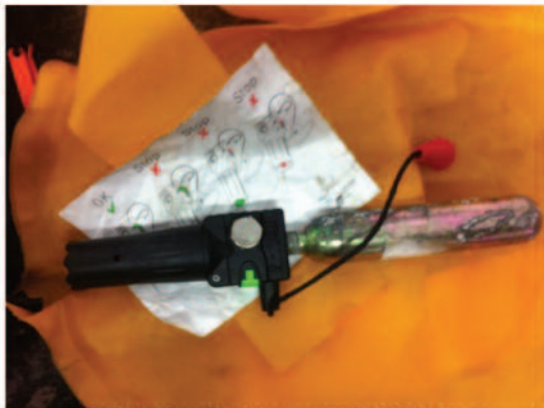
Fig. 1 United Molders Auto Head - Manual Clip in place

The PFD was presented in an open but deflated condition. The evidence showed the Gas Cylinder had been discharged and the Operating Cartridge had been activated. The presence of the Manual Clip (Green) in its correct location confirms the PFD inflated automatically and that the manual override was not applied.( See Fig. 1)

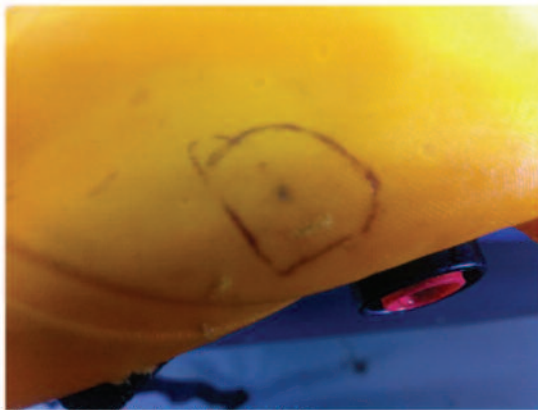
Fig. 2 - Small Holes Visible Jacket 1

The PFD inflated correctly but immediately showed signs of losing pressure and deflating. On further, inspection I discovered two small holes in the bottom section, right hand side of the bladder. The holes were conducive to being pierced by a sharp object, such as a wire spike or similar small sharp pointed object. (See Fig. 2.)

It would appear that this PFD did inflate correctly but would have deflated quite rapidly given the 2 holes found in the Bladder. It is hard to estimate how long it would take before this PFD would become ineffective as it would vary with body weight and sea conditions, however, my estimate would be between 15 - 30 min. There was no evidence to show that this PFD had ever been through a service procedure and this finding is supported by the fact the Gas Cylinder was heavily corroded and the Operating Cartridge was 4 years and 1 month out of date.

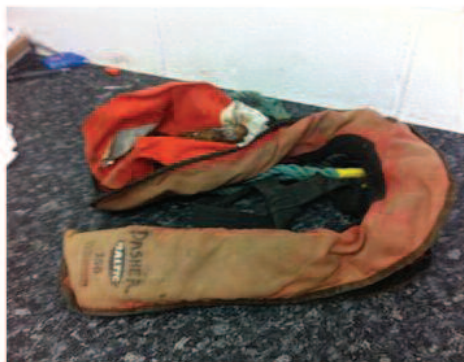
Fig. 3. Cover showing worn condition

The PFD was presented in partially opened but showed no signs of inflation. It appeared badly worn with the cover in poor condition. The Gas Cylinder showed severe corrosion with rust scale present. (See Fig. 3 & 4 )

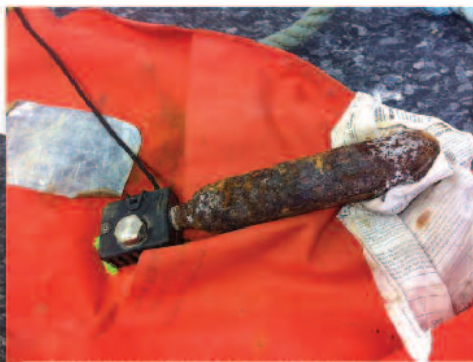
Fig. 4 Cylinder showing heavy corrosion

There was no evidence to show that this PFD had ever been through a service procedure and this finding is supported by the fact the Gas Cylinder was heavily corroded.

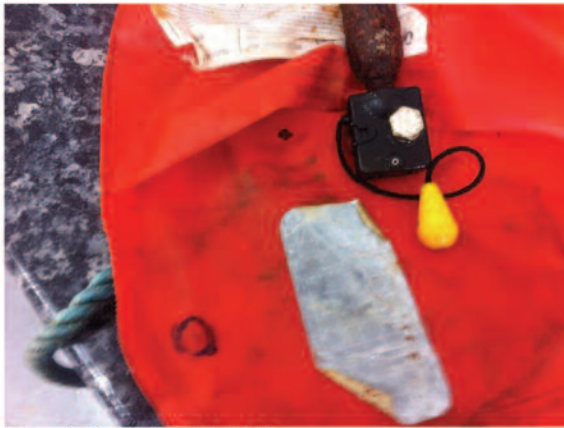
Figure 5 - Small Hole in Jacket 2

The PFD inflated correctly but immediately showed signs of losing pressure and deflation. On inspection I discovered a small hole on lower, right hand side of the Bladder. The hole was conducive to being pierced by a sharp object, such as a wire spike or similar small sharp pointed object. (Fig. 5 )

It would appear that this PFD was never activated. It was a manually activation PFD and if the Toggle Cord had been pulled, it would have inflated correctly but would have rapidly deflated due to the hole found in the Bladder. It is hard to estimate how long it would take before this PFD would become ineffective as it would vary with body weight and sea conditions, however, my estimate would be between 15 - 30 min.

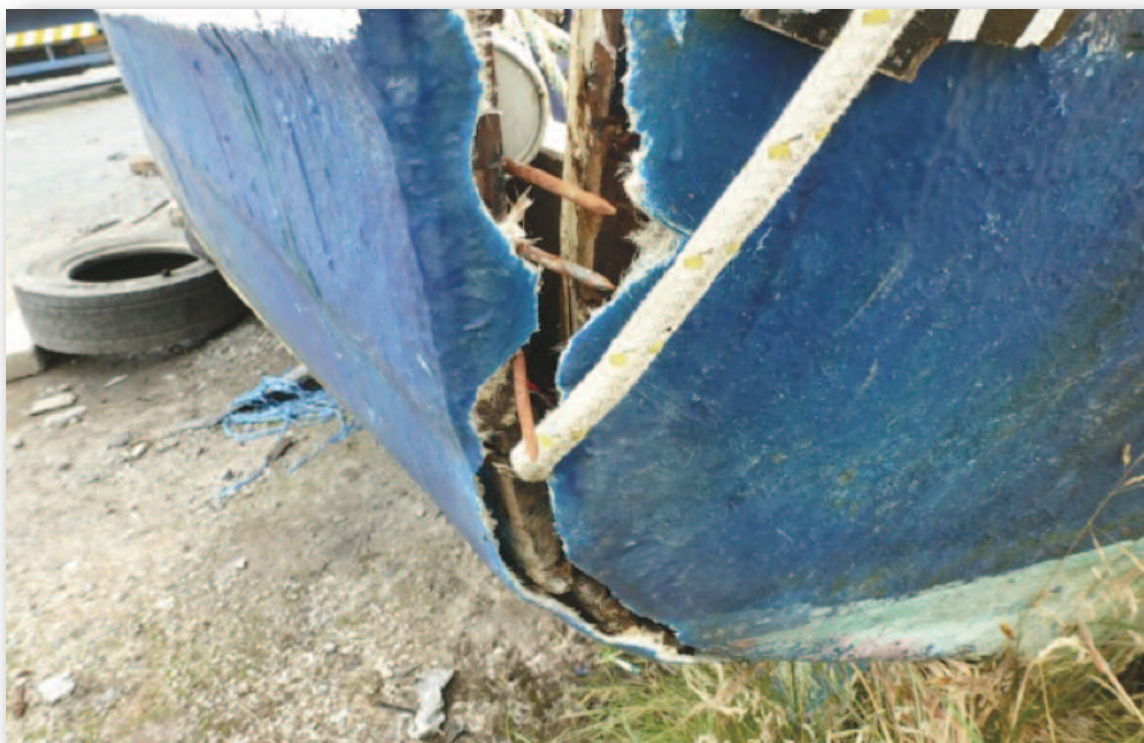
- 3.2.2 On inspection of the craft on the 16th June 2013 (the day of salvage) it was noted that there was extensive damage to the stem of the vessel and to the transom of the vessel, with delamination of fibreglass sheathing starboard side amidships. The outboard engine was broken off from the transom bracket. The pot hauler was lying in the vessel, with the pot hauler driving engine missing. Four pots and an assortment of pot ropes and anchors were lying in the vessel.

Photograph No. 2 - Damages to Transom

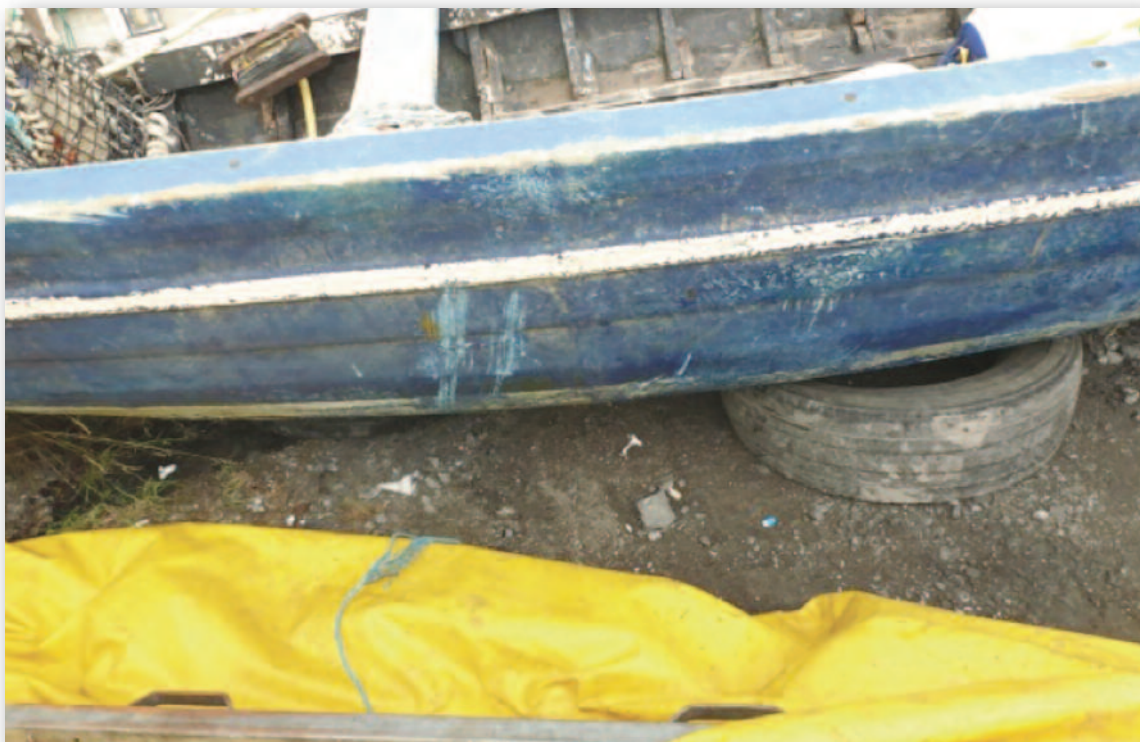
Photograph No. 3 - Damages Starboard Side

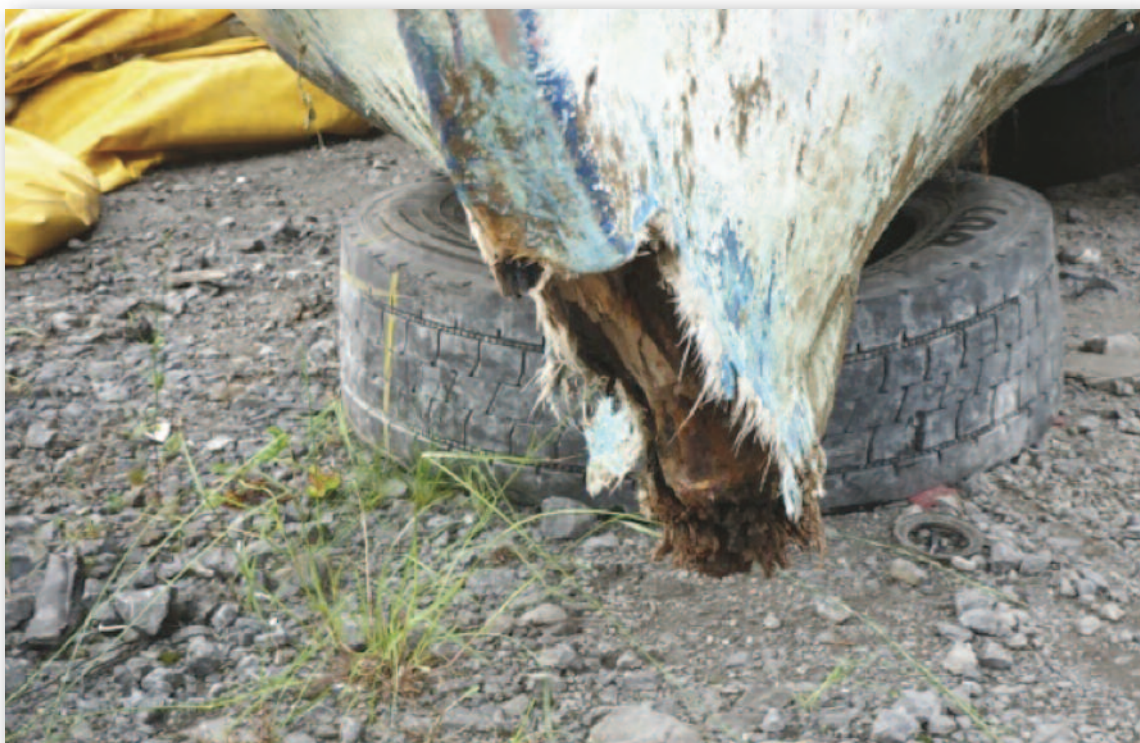
Photograph No. 4 - Damages to Stem

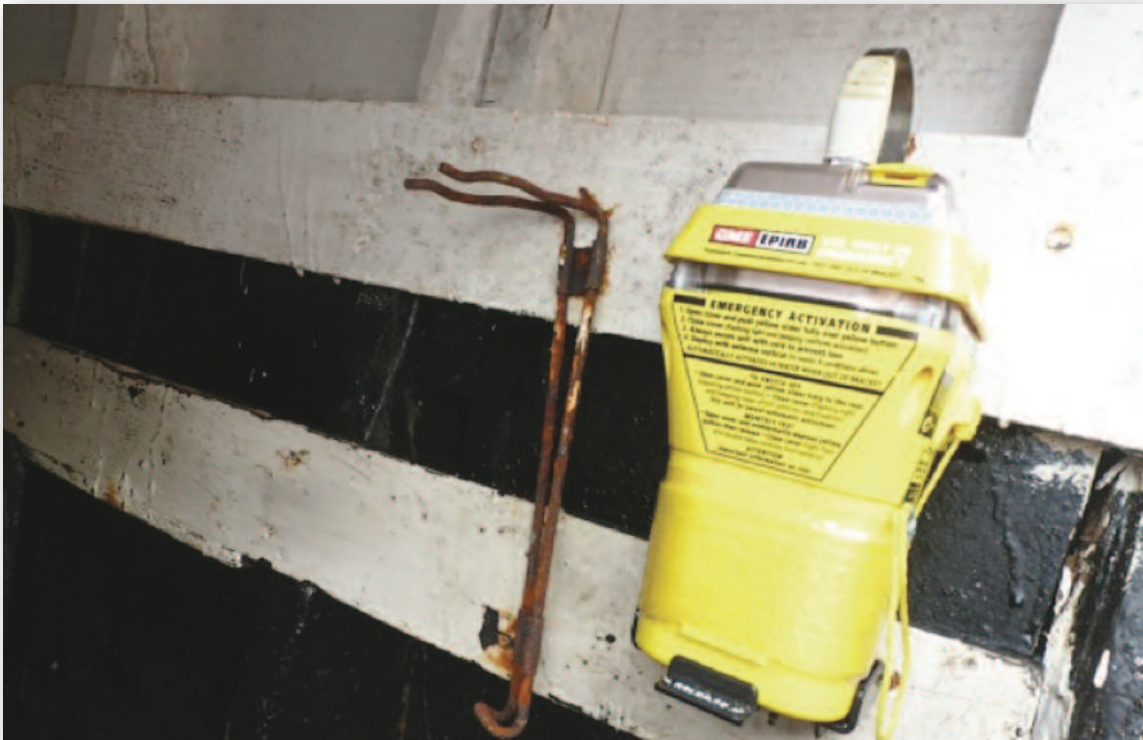
- 3.4.2 The vessel’s EPIRB was found on Saturday the 15th June 2013 on a beach in the vicinity of Tramore.
- 3.4.3 The stated normal stowage position of the EPIRB was in a bracket in a locker at the forward starboard side of the craft. (See Photograph No. 5 Appendix 7.5).

- 3.4.4 It is understood that the vessel did not fully sink and that the bow remained out of the water. If the EPIRB had remained in its bracket it would not have activated, as it needs to be semi-immersed to activate. The EPIRB was found after the incident on a beach. The EPIRB may have been removed from its bracket by hand or it may have remained in its location only subsequently becoming dislodged. It is considered most likely that the EPIRB was removed by hand from the bracket. In any event it did end up in the water but no signal was received by the Coast Guard.

Photograph No. 5 - EPIRB Fitted in Holding Bracket  
*Unlikely to come out of bracket without manual assistance from a person*

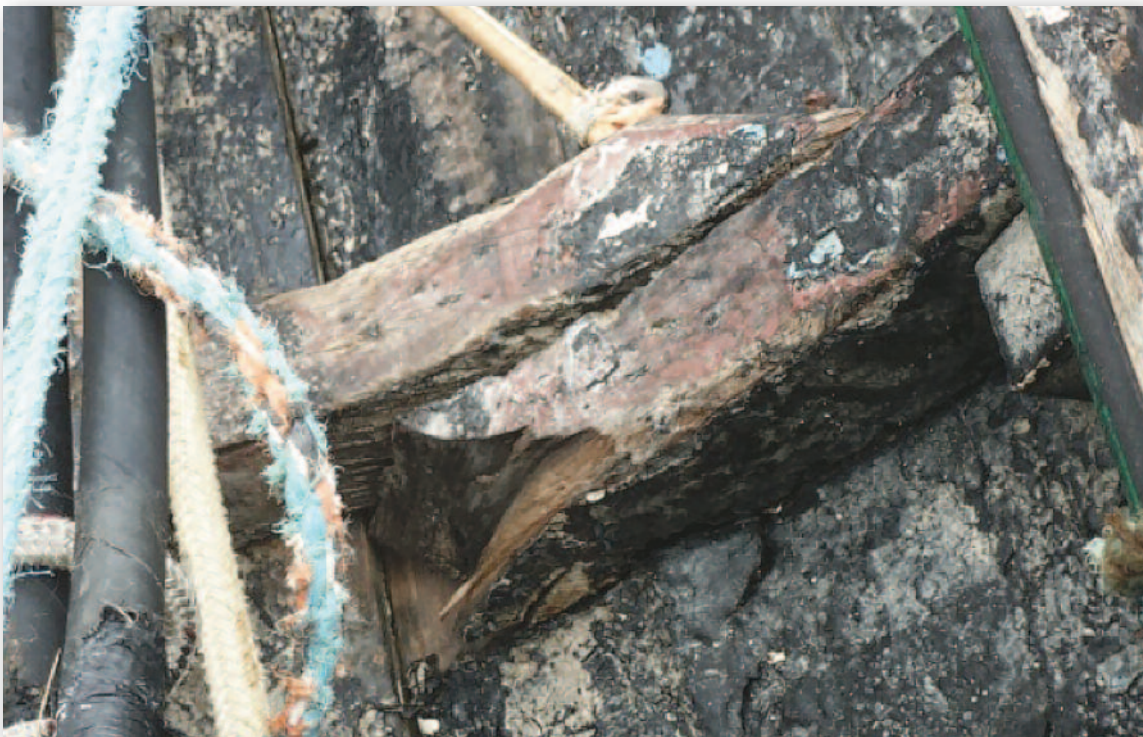
- 3.2.4 The MCIB Inspection of the vessel noted that the vessel had been fibre glassed externally. The external structure of the vessel was in a poor condition with evidence of extensive rot and decay, effectively giving a fibreglass shell with reduced structural integrity.

Photograph No. 6 - Typical Internal Timbers of Vessel

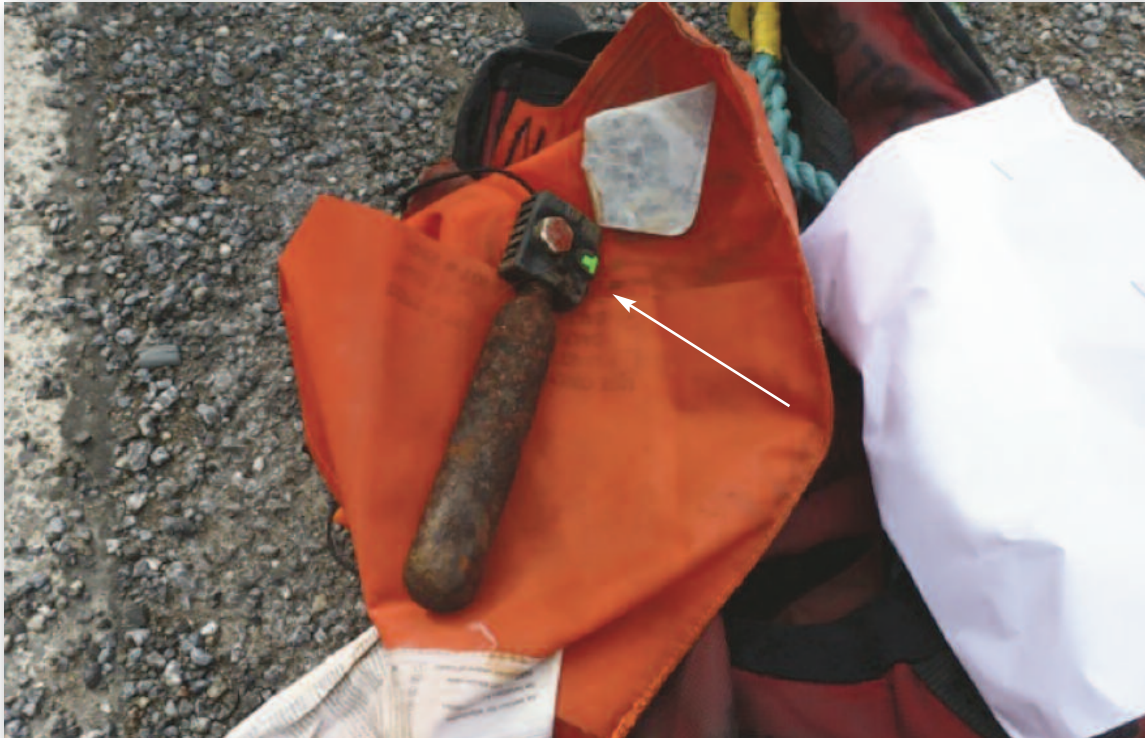
Photograph No. 11 - CO<sub>2</sub> Bottle in PFD Worn By Casualty No. 2  
*Note Tell-tale Indicates bottle Not Triggered.CO<sub>2</sub> bottle heavily corroded*

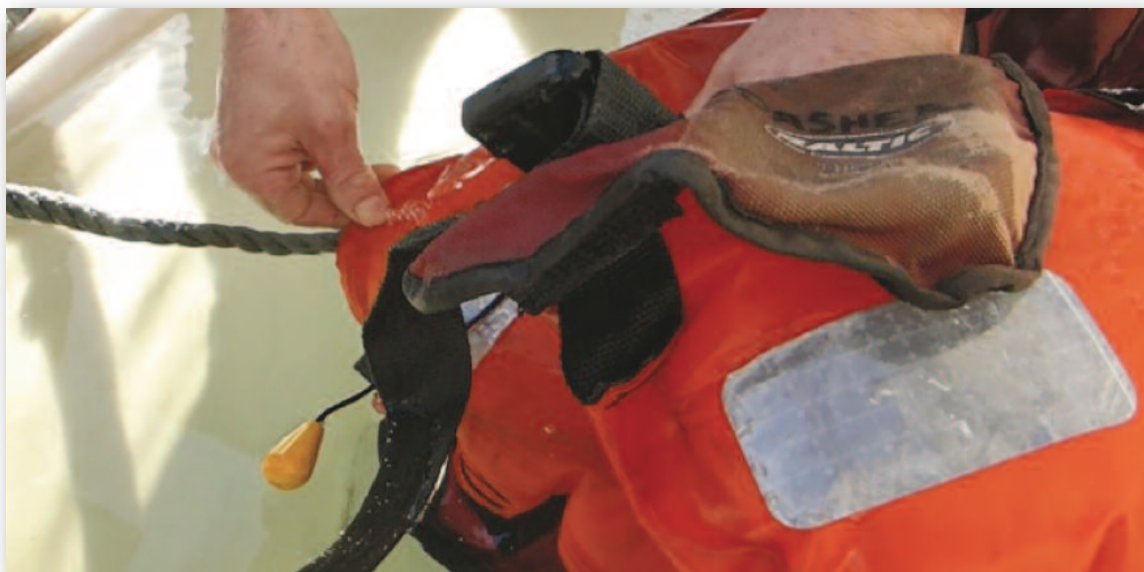
- 3.3.5 A test was carried out on the PFD with the corroded CO<sub>2</sub> bottle in place. When the operating chord was pulled the PFD inflated in the normal manner, but was found to leak at the left hand side of the bladder.

Photograph No. 13 - Leaking Bladder on PFD from Casualty No. 2

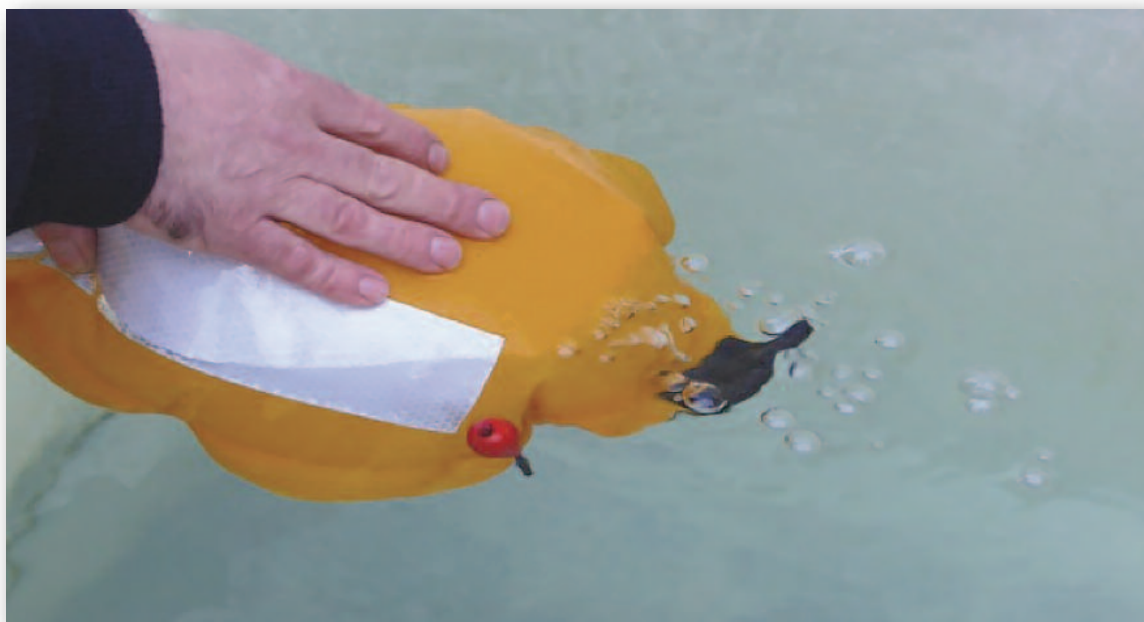
- 3.3.2 A subsequent test of the PFD was carried out at an approved facility by fitting a replacement CO<sub>2</sub> bottle and hydrostatic release. When the PFD was placed in a tub of water it was found to inflate but leak at the left hand side of the bladder.

Photograph No. 14 - Leaking Bladder on PFD from Casualty No. 3

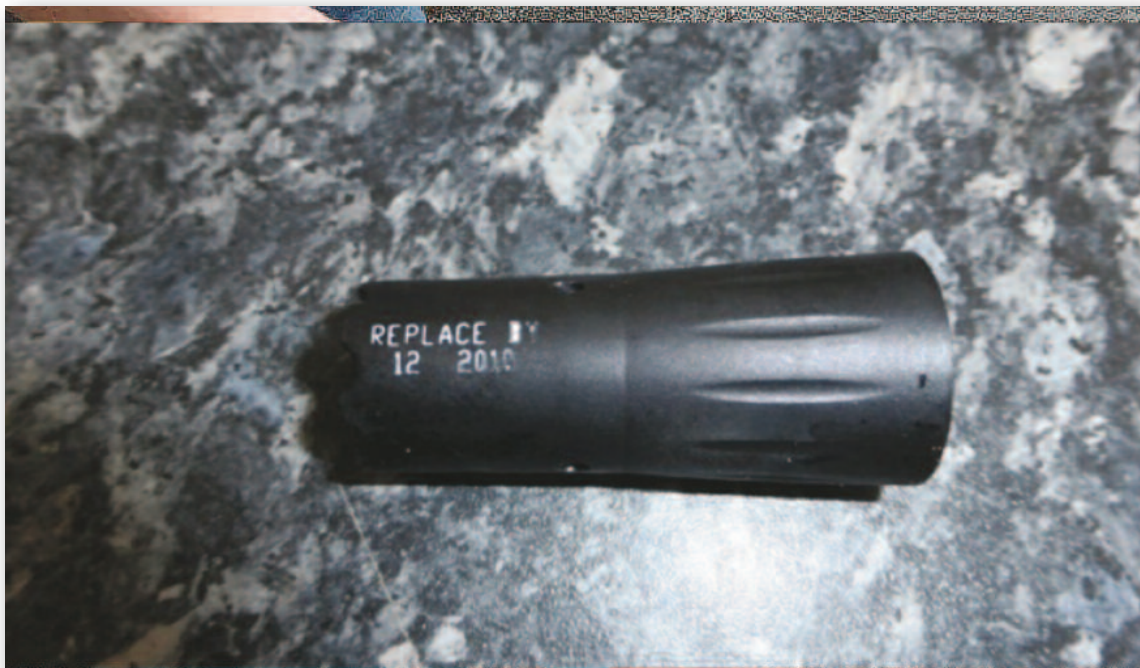
- 3.3 Personal Floatation Devices:**
- 3.3.1 The PFD on crew member No. 3, a Mullion Neptune 150 newton PFD was fitted with an automatic hydrostatic release mechanism and was found to have inflated. The rupture disc on the CO<sub>2</sub> bottle was found to have ruptured. However, the bladder on the PFD was found to be partially filled with water. The hydrostatic release on the PFD was found to be out of date, the expiry date being December 2010.

Photograph No. 15 - Hydrostatic Release on PFD From Casualty No. 3  
Date indicates that it should have been replaced

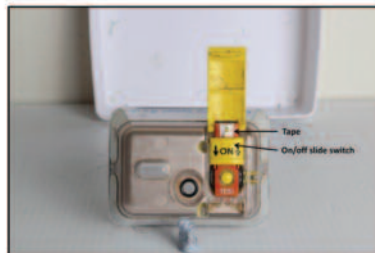
**Figure 1**

- On initial inspection, the on/off switch (Figure 1) was in the off position and its sealing tape was intact. As the tape was meant to tear when the switch was turned on, this indicated that the unit had not been switched on. However, the test button was latched

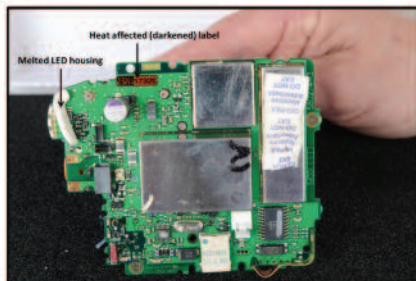
Figure 3

- There were signs of heat damage inside of the EPIRB, the LED housing had melted and the identification label had discoloured (Figure 3). Both batteries had full discharged.

- The unit did not operate when tested. It drew an excessive amount of current and produced a constant voltage output from the micro-processor (this voltage output should have oscillated).
- When the micro-processor was replaced with a new programmed unit, the EPIRB operated correctly.
- It was concluded that the micro-processor failed due to an internal fault and not as a result of the failure of another component or erroneous input.

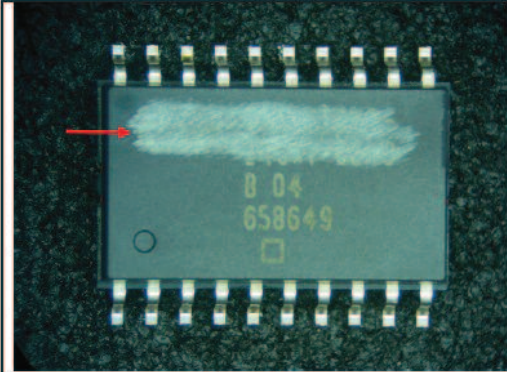
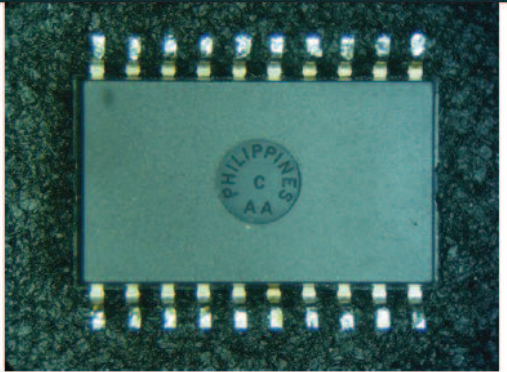
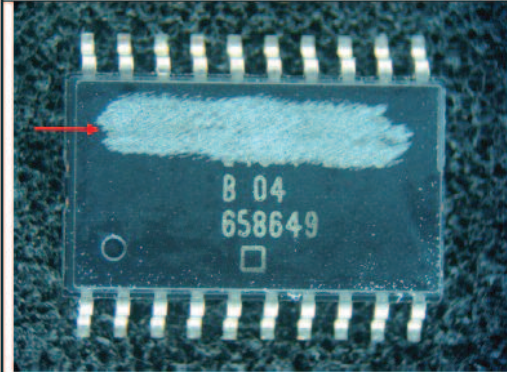
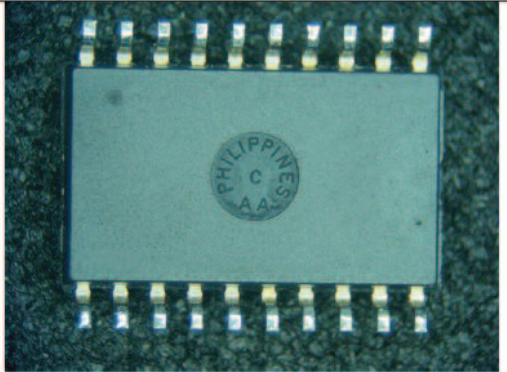
**Figure 1.** [Back to analysis](#)  
S/N #: 1  
GRAPHICS: Representative optical photos  
COMMENTS: External visual inspection showed top package scratches upon receipt showing that the top mark was intentionally removed.

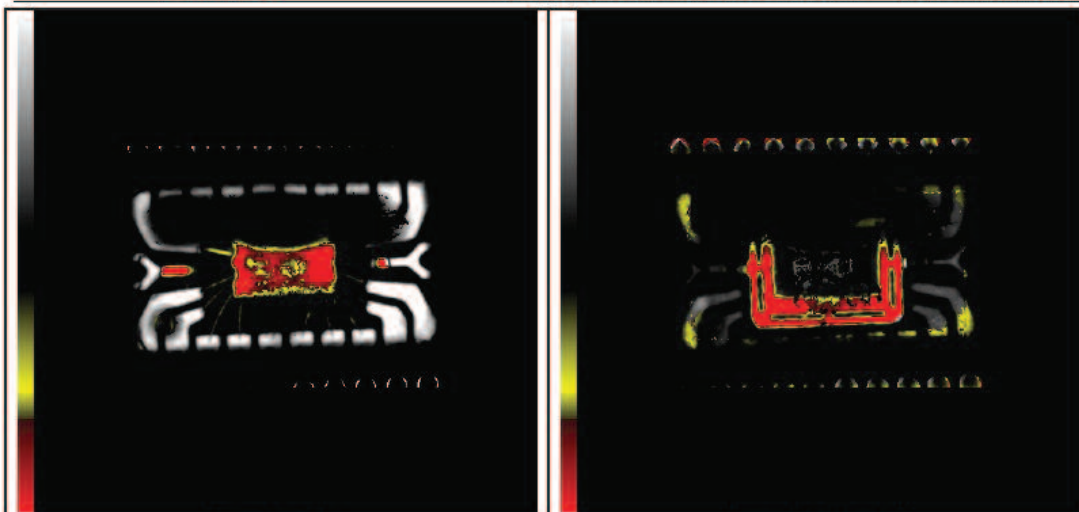
COMMENTS: Top die and paddle delamination was observed.

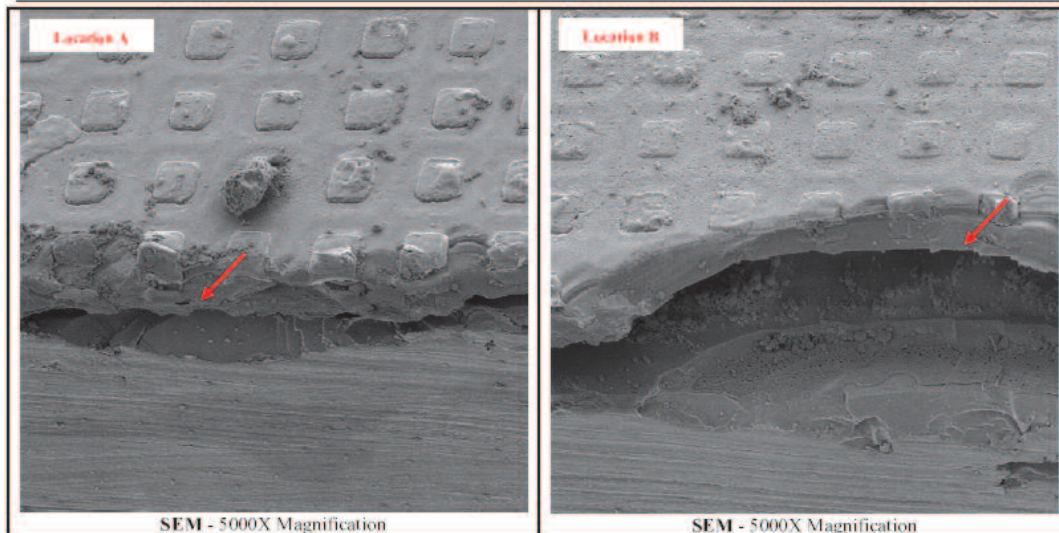
**Figure 5.** [Back to analysis](#)  
*S/N #: 1*  
*GRAPHICS:* Representative Bright Field, Nomarski and SEM photos  
*COMMENTS:* Die-level delamination was observed.
