**REPORT OF THE INVESTIGATION
INTO
THE GROUNDING
OF “MV ARSLAN II”
ON THE ARKLOW BANK
ON
14th JANUARY 2014**

**REPORT NO. MCIB/235
(No.6 OF 2014)**

Report MCIB/235 published by The Marine Casualty Investigation Board.
Printed 4th December 2014.

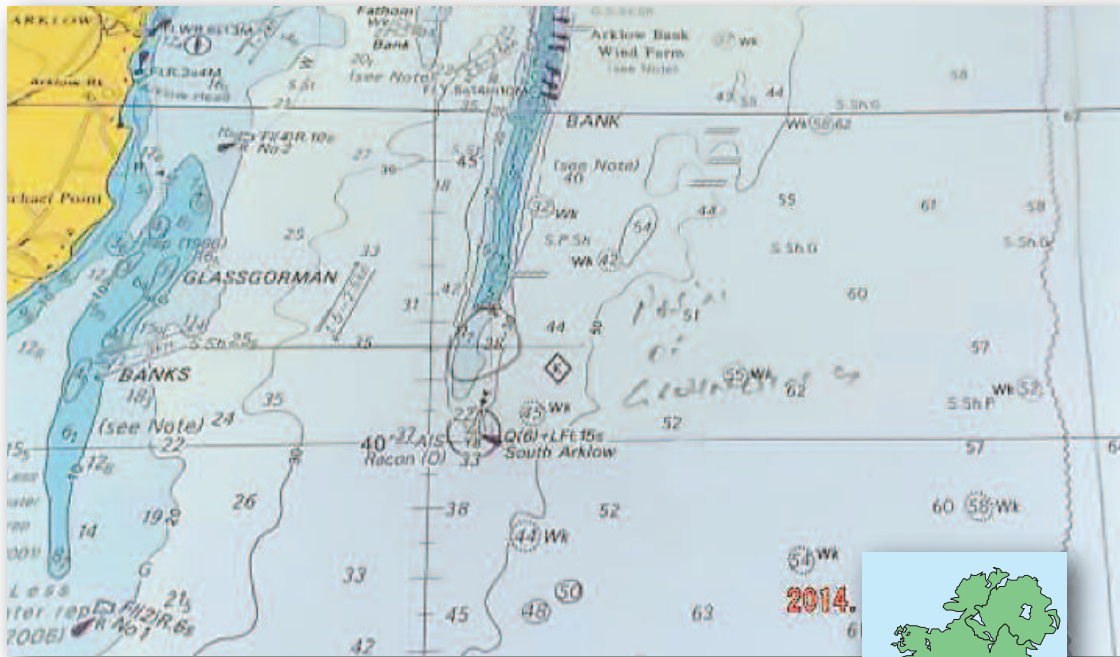
Position for grounding plotted on chart by MCIB Investigator,
Chart BA 1411

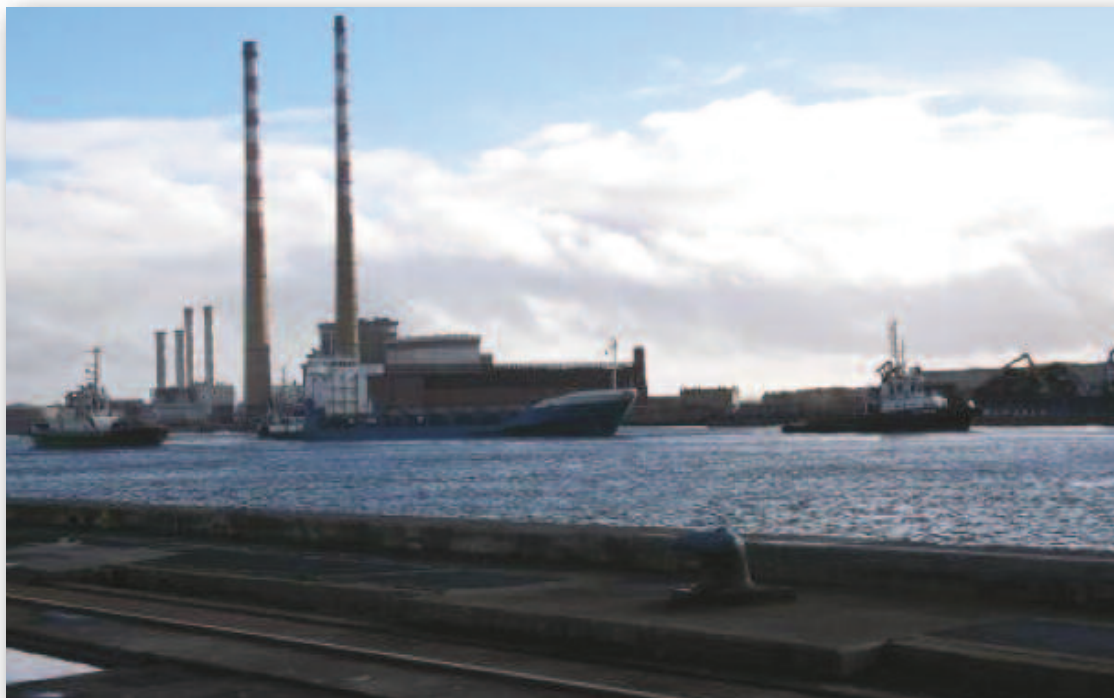
Photograph 1 - Vessel arriving at Dublin

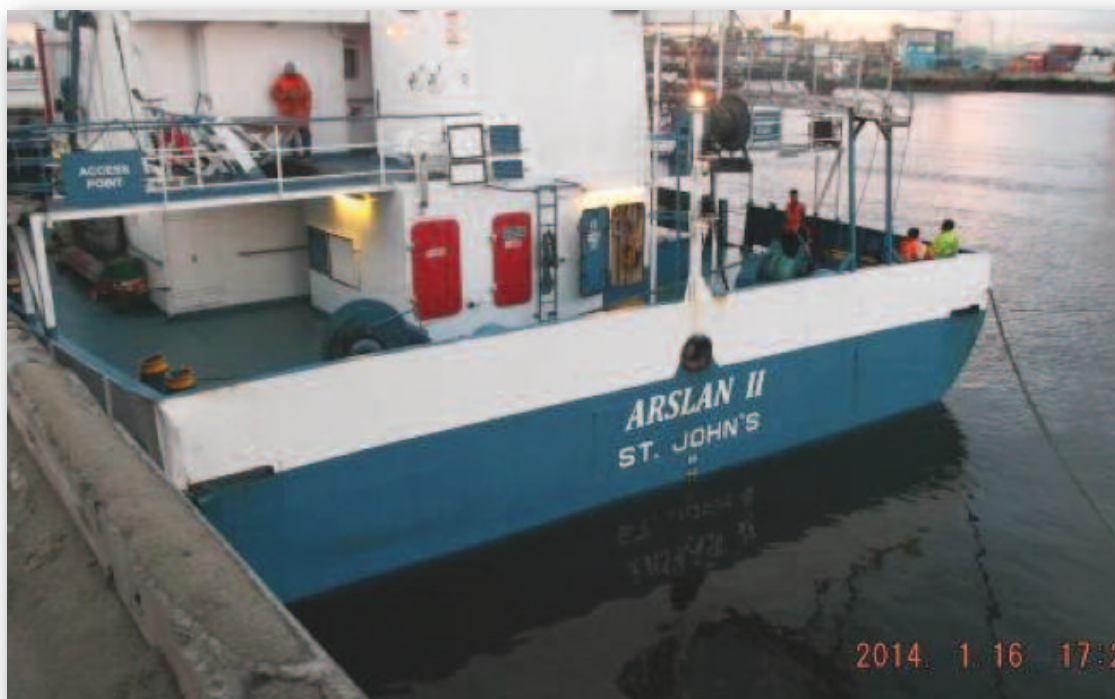
Photograph 2 - Vessel's stern with draft of 6.4 metres

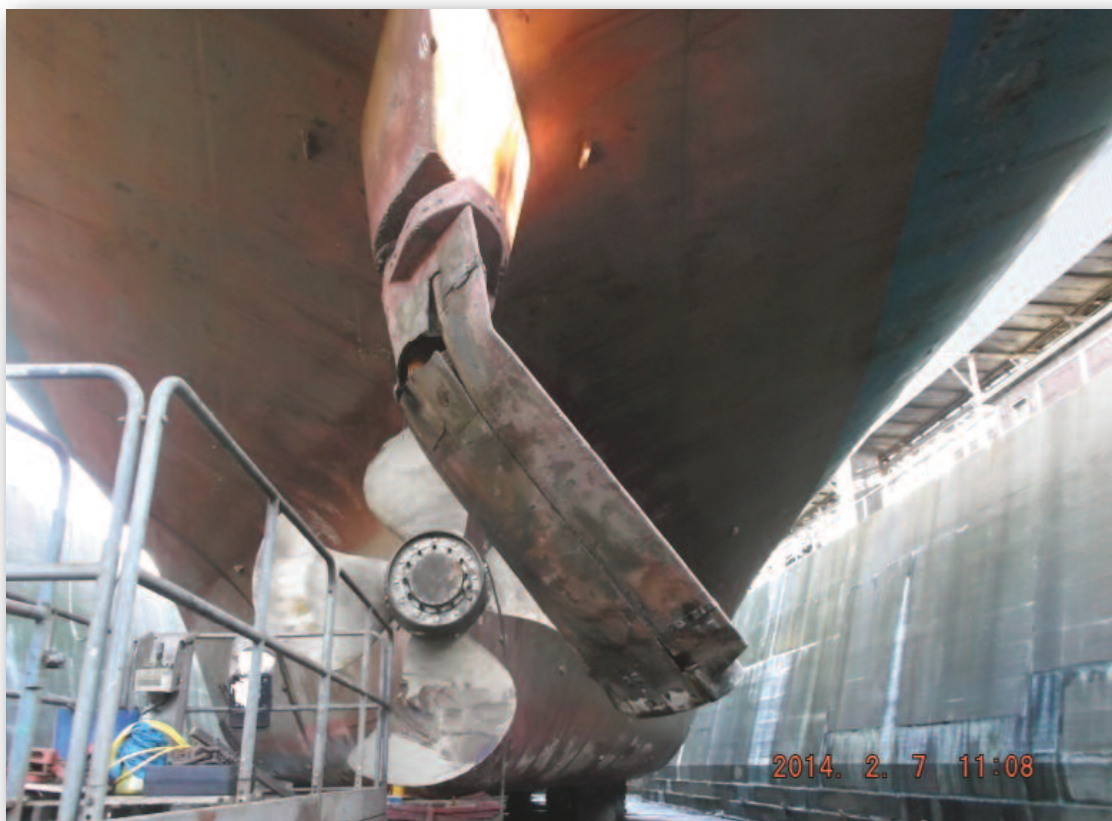
- 2.3.7 There was no pollution caused by the incident.
- 2.3.8 The vessel's rudder was damaged and it suffered structural damage to the bottom of the hull.

- 3.7 The vessel floated off the bank at approximately 18.30 hrs. It was found that the steering gear was damaged. The Master anchored the vessel close to the grounding position.

Photograph 3 - Damage to rudder

- 3.9 The vessel was towed into port on 16th January 2014 and brought to the South Bank Quay.
- 3.10 The vessel later entered dry dock in Dublin for repairs to its rudder (See Appendix 7.3 Photograph 3) and other repairs that might be deemed necessary. In the dry dock, it was noted that the starboard bilge keel for the vessel was missing. Paint coatings indicated that it was missing for a considerable period. The port bilge keel was damaged towards the aft end. The rudder was bent over to starboard and the plating was fractured on the port side. The bottom plating was set in, on both sides, at the turn of the bilge for almost the entire length of the vessel. There was damage to the port side sea chest gratings. There was a stress fracture in the shell plating, port side, at the turn of the bilge in way of frame 40.

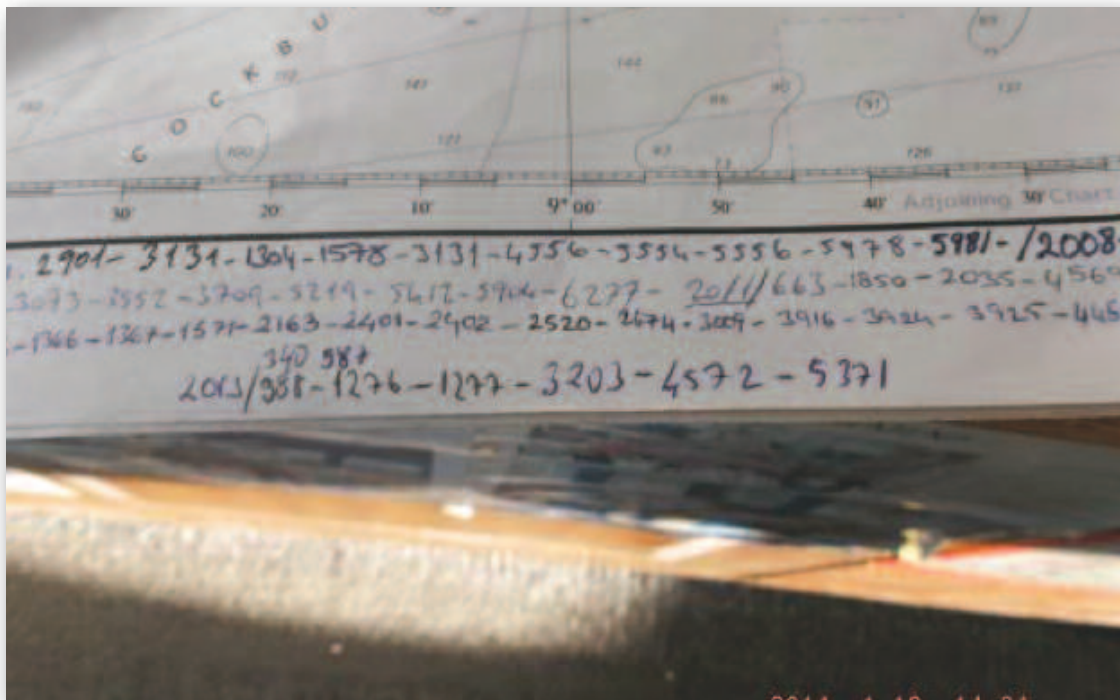
Chart Corrections

- 4.4.2 British Admiralty Chart, BA 1123, Western Approaches to Saint George's Channel and Bristol Channel was relied on, issued on 12th June 2006, last correction was 5371 of 2013 (Correction 4988 of 2012 was missing). (Please refer to Appendix 4 Figure 1). This was the chart in use at the time. It was found that the last recorded position before the grounding was made at 11.00 hrs CET. Positions
