**REPORT OF THE INVESTIGATION  
INTO  
THE INCIDENT INVOLVING  
“MV HHL NEW YORK”  
AT FENIT  
2nd NOVEMBER 2013**

**REPORT NO. MCIB/234  
(No.3 OF 2015)**

Report MCIB/234 published by The Marine Casualty Investigation Board.  
Printed 24th February 2015.

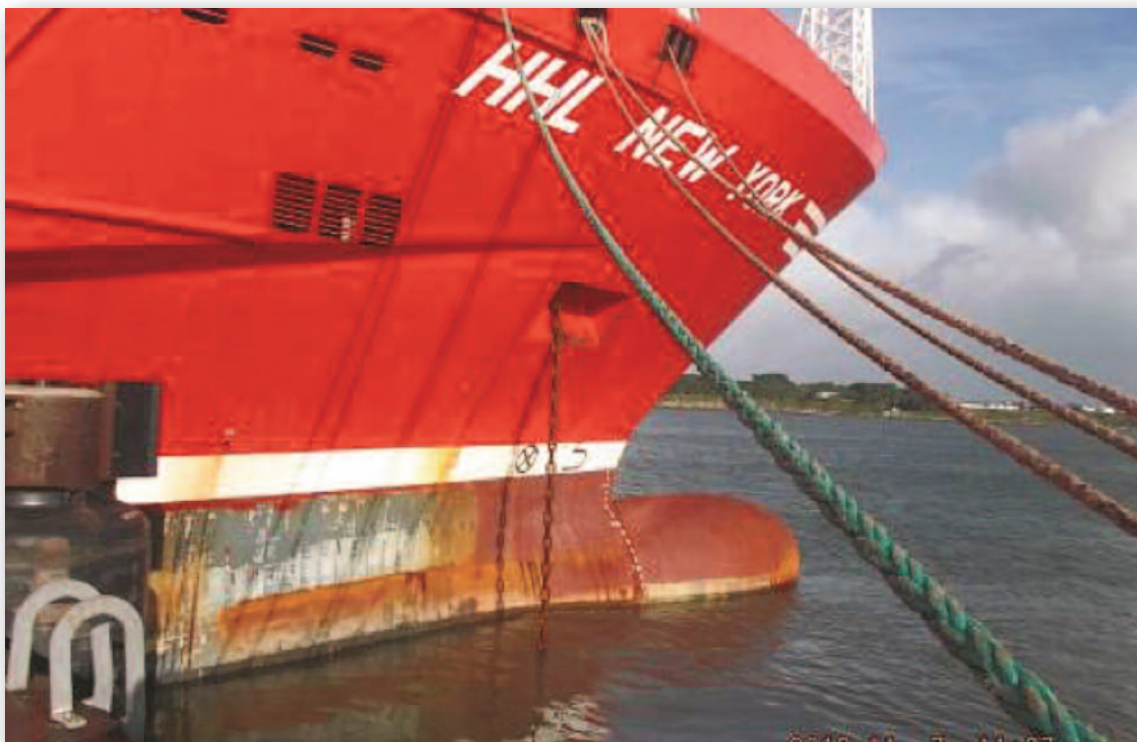
Photograph No. 1 - View from head of pier shows amount of overhang

3.2 It was reported that when berthing operations commenced, the vessel deployed timber fendering designed to keep the side of the vessel 1.3 m clear of the quayside. When in position for berthing, the bow overhung the head of the pier, from frame 168, (please refer to Photograph No. 1 and No. 2 in Appendix 7.5), which show the overhang of the bow and bow lines lead aft.

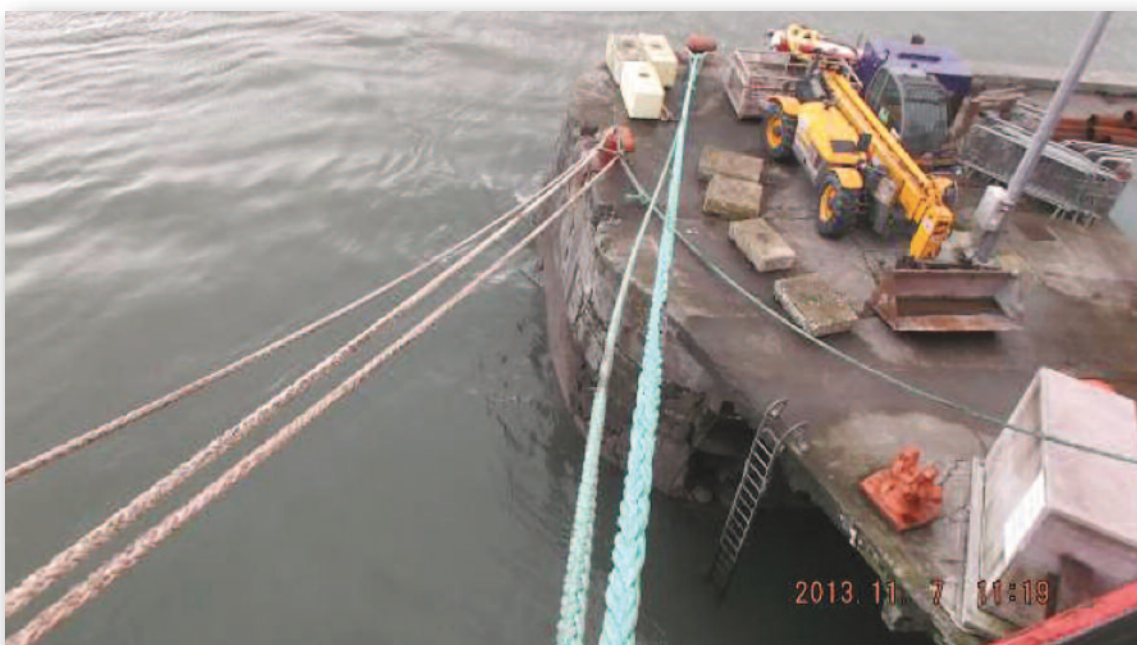
Photograph No. 2 - View of ship's lines from aft starboard side of forecastle, all lead aft

- 3.13 At the forecastle, it was noted that all mooring lines deployed by the vessel led aft, at this point additional lines had been deployed. Remnants of broken lines were found. The lines were in good visual condition. All ship's lines were standard 8 strand multi-plait rope of approximately 64 mm diameter. The forecastle has a "whaleback" or weather shield. This could restrict deployment of lines. Lines were deployed from both reels attached to the windlass and loose lines set around bollards on the forecastle.

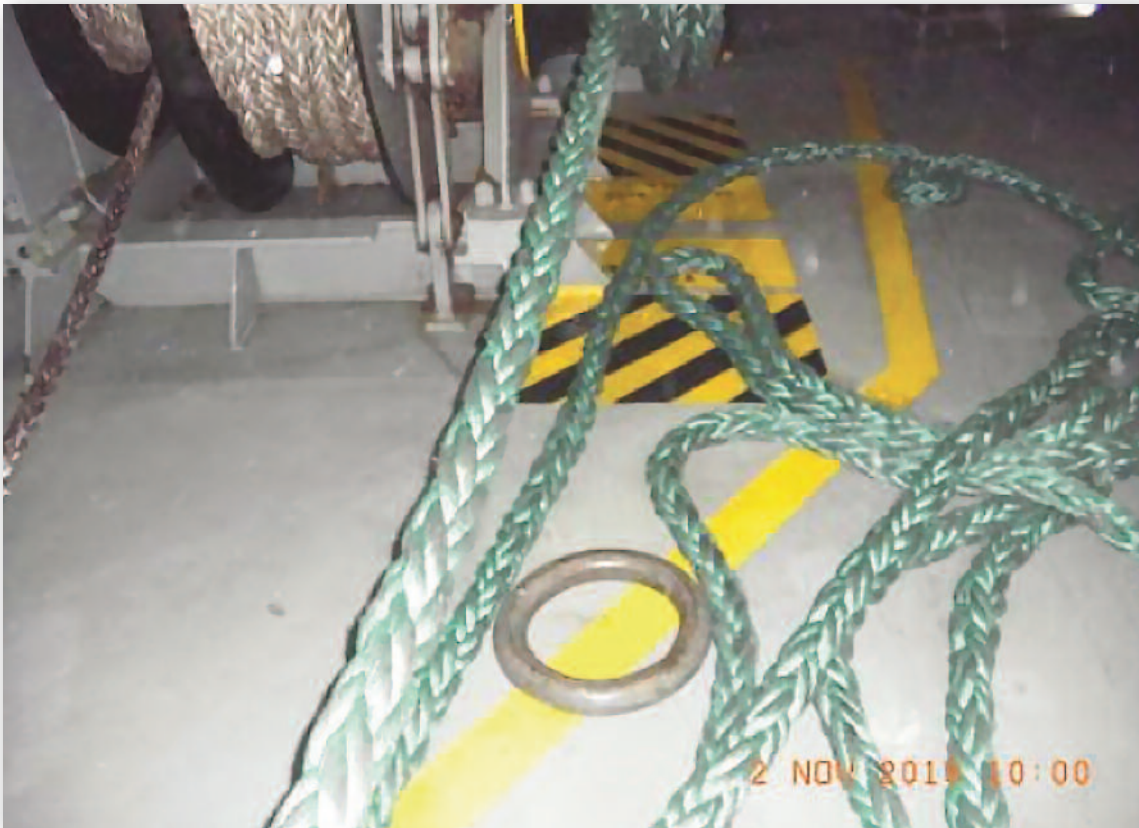
Photograph No. 3 - Location of ring as found by crew (ship photo)

3.8 On making rounds the crew found a large mooring ring lying on the poop deck on the starboard side of the accommodation. This was identified as the mooring ring to which the after backsprings had been made fast (please refer to Appendix 7.5 Photograph No. 3 and No. 4).

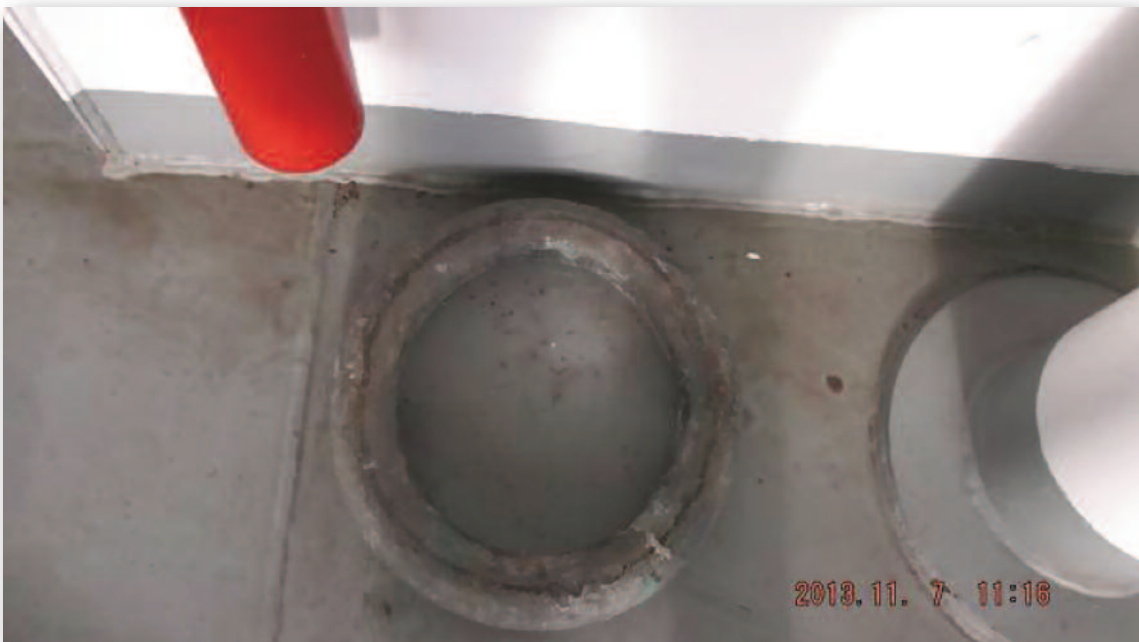
Photograph No. 4 - Mooring ring on deck, aft starboard side of accommodation area

- 3.12 The mooring ring that had failed was found on deck. The ring was of galvanised steel, with a wall thickness of 55 mm and an outer rim diameter of 355 mm. The ring was intact. There were no markings to indicate safe work limits or to identify the manufacturer.

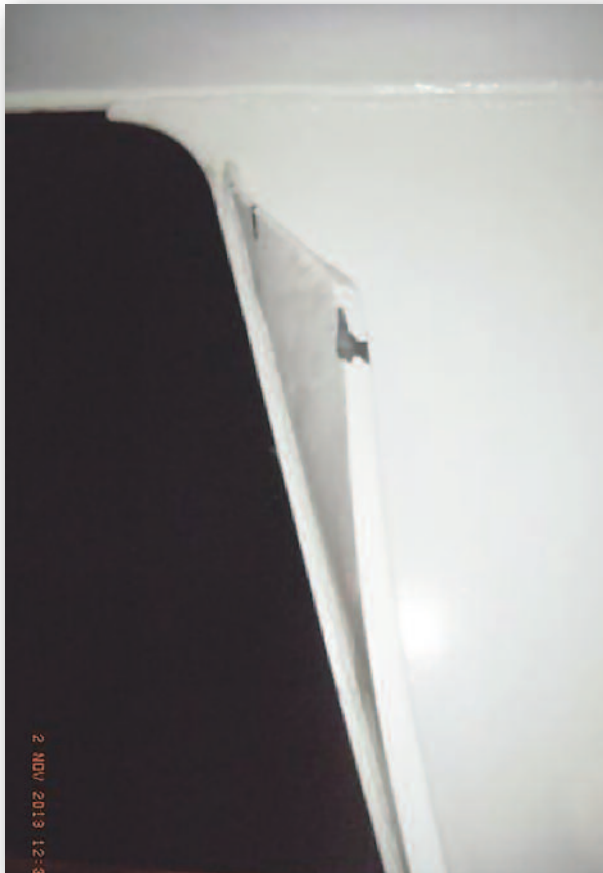
Photograph No. 5 - Damage to vessel where struck by ring

3.9 Examination of the quayside showed that the mounting point for the mooring ring had failed. It was later confirmed that, to secure the lines the linesmen, had placed a steel bar between the eyes of the two ropes used and jammed the bar against one side of the ring. The vessel suffered minor structural

damage to the accommodation area (please refer to Appendix 7.5 Photograph No. 5 and No. 6).

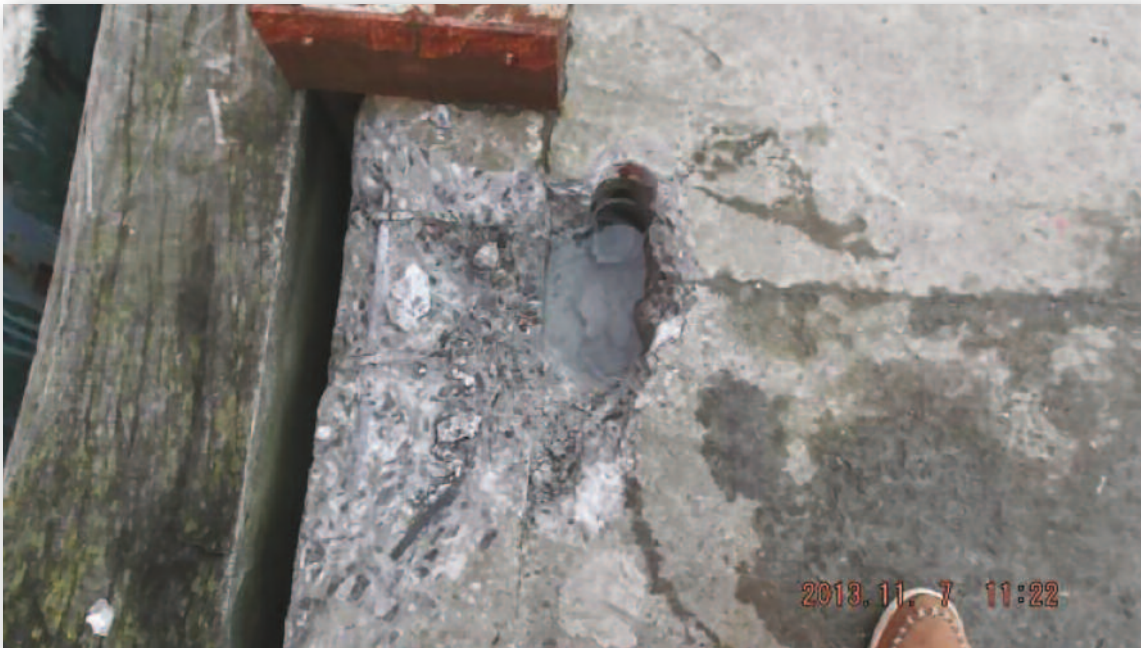
Photograph No. 7 - Hole in apron left by mooring ring, with cracks radiating out from bottom end

- 3.14 On the quayside the failed mooring point was examined, (please refer to Appendix 7.5 Photograph No. 7 and No. 8). Similar mooring rings nearby were

also examined. The eye that held the ring into the concrete apron was missing. There was nothing to indicate how the ring was held in the capping. The concrete in the area appeared spalled and there were stress cracks radiating out from the opening. There was no evidence of corrosion causing a failure.

- 4.2.9 The mooring rings were not bolted to the quay, rather they were held in place by an epoxy based adhesive.

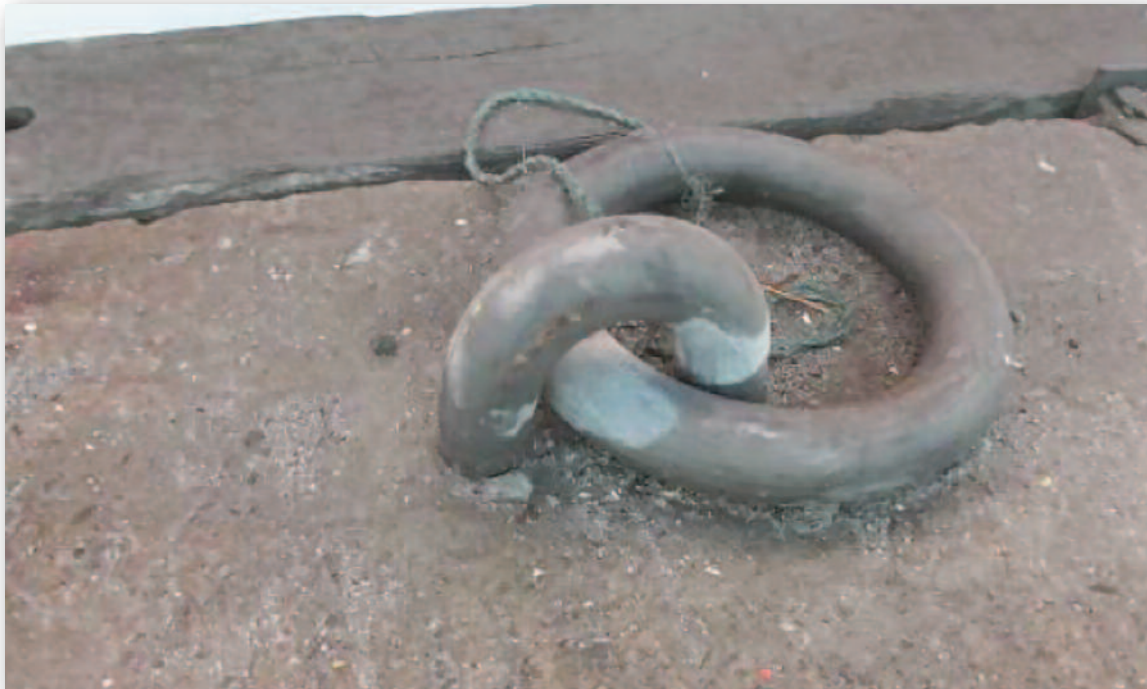
Photograph No. 9 - Similar ring showing how it is set into apron

- 3.15 It was noted that there were different types of mooring points used by the port, ranging from standard bollard to horn bollards and galvanised rings, (please refer to Appendix 7.5 Photograph No. 9 and No. 10). None bore any markings to indicate safe working loads. Some bollards were secured by bolts set through the apron. It is understood that the safe working loads for the moorings were:

Mooring Rings (total of 6 on pier): 5 tonnes (t).  
Mooring Bollards (total of 10 on pier): 30 t.

Note: Information obtained indicates that the mooring rings were only intended for use by fishing vessels and leisure craft. They were not designed for use by the larger ships using this port (see Appendix 7.6 showing the mooring bollard arrangement in Fenit).

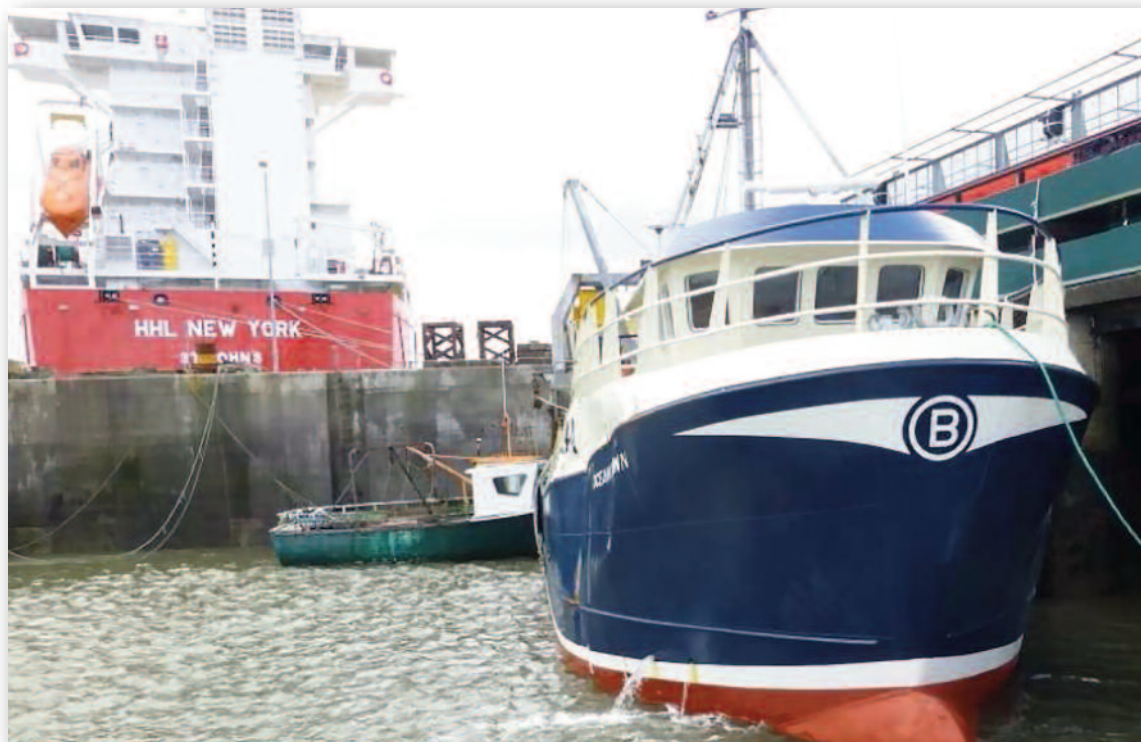
Photograph No. 11 - Damage to “MFV Ocean Dawn”

- 3.17.2 The vessel has sustained significant structural damage to her starboard side hull, both above and below the deck edge (please refer to Appendix 7.5 Photograph No.11, No.12 and No.13).
