MCIB

**REPORT OF INVESTIGATION
INTO A FATAL INCIDENT
TEMPLENOE, KENMARE BAY,
CO. KERRY
ON
31st JANUARY 2016**

**REPORT NO. MCIB/252
(No.9 OF 2016)**

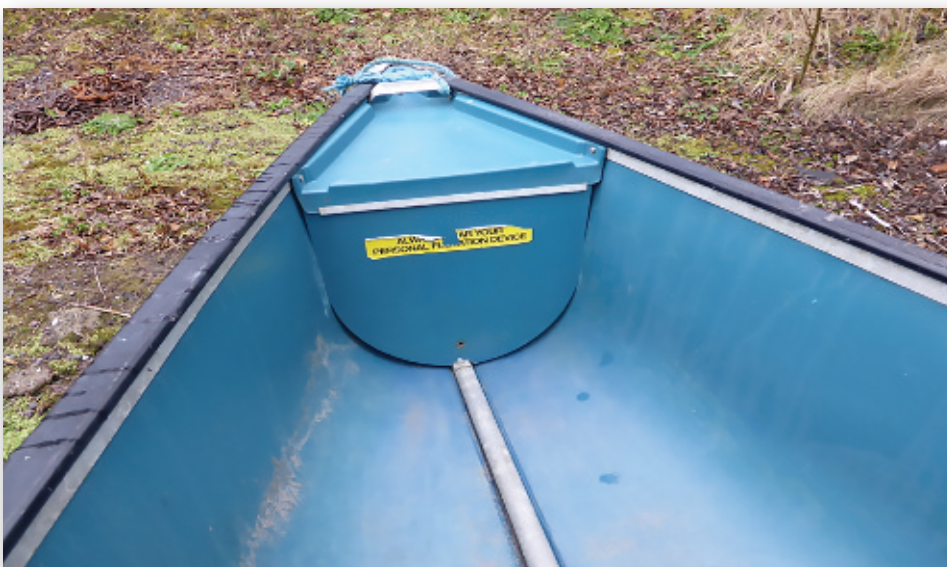
- 4.2 When canoeing one should always wear a floatation device, never paddle alone and always be aware of weather conditions.
- 4.3 There was a placard in the vessel stating “ALWAYS WEAR YOUR PERSONAL FLOATATION DEVICE” (see Appendix 7.1 photograph 4). In this incident, neither of the men were wearing a floatation device.

Photograph No. 4: Notice in Canoe stating "ALWAYS WEAR YOUR PERSONAL FLOATATION DEVICE"

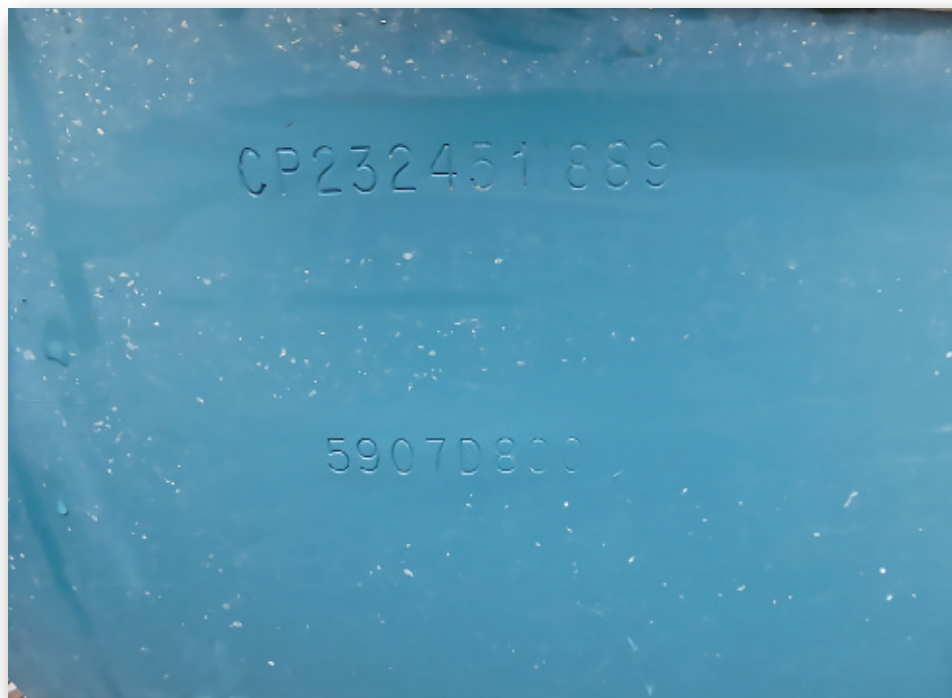
Photograph No. 5: Hull ID No. & Serial No. on the vessel.

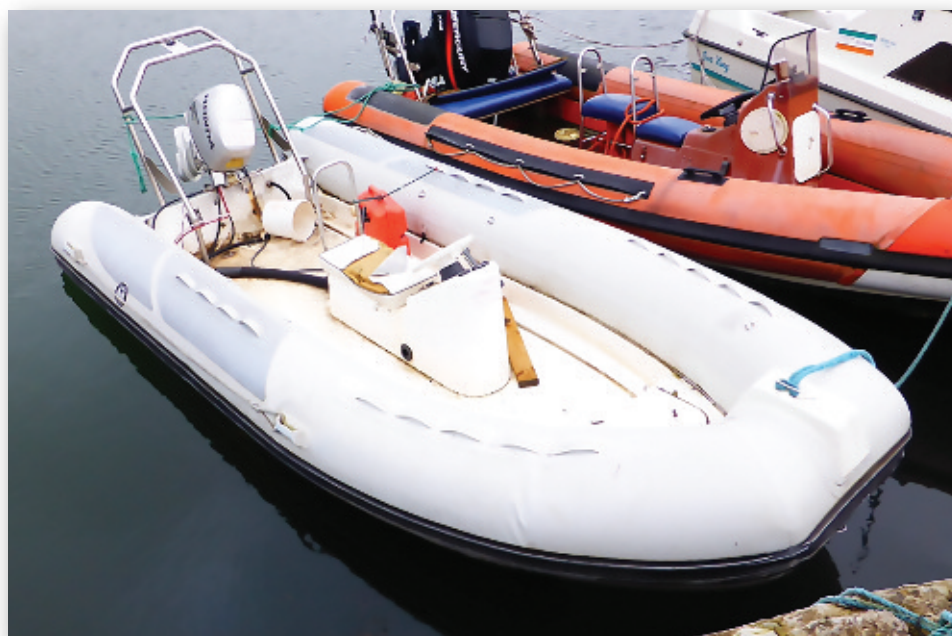
Photograph No. 6: Vessel used by Fire Brigade during initial response.

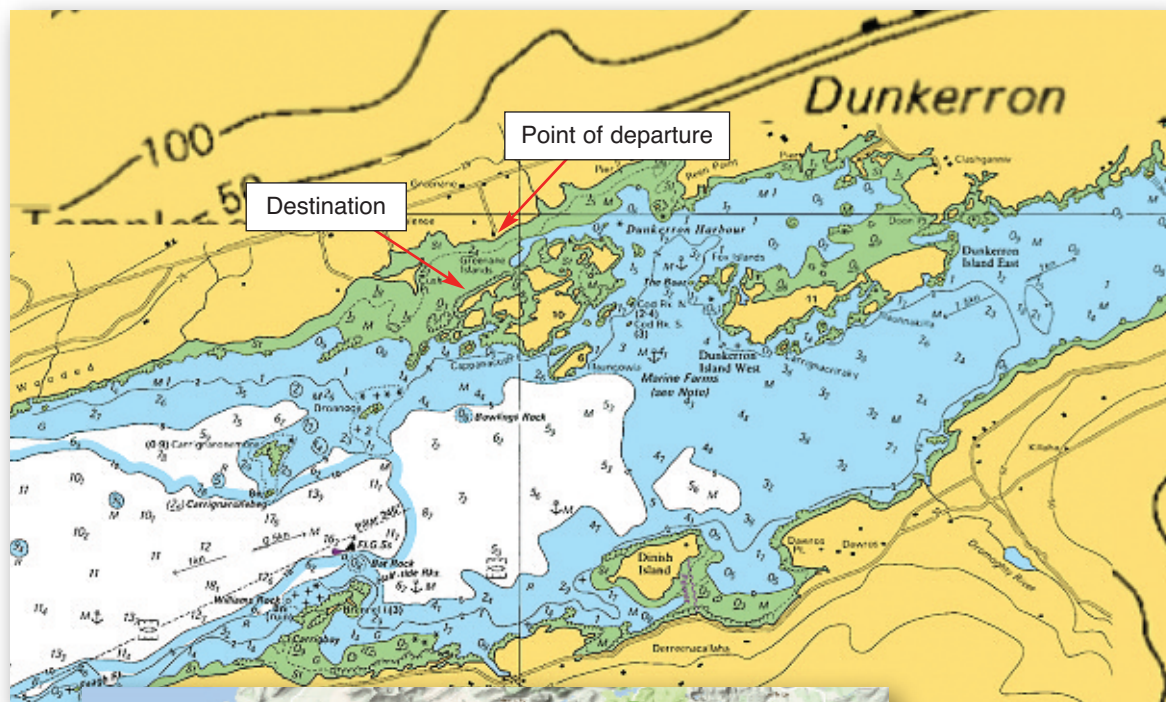
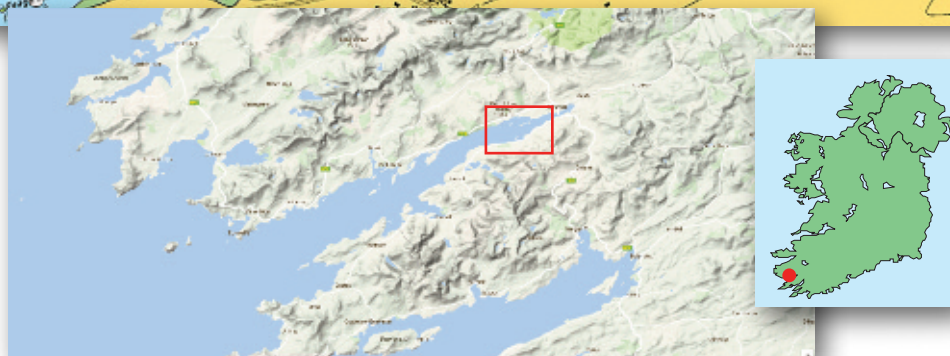
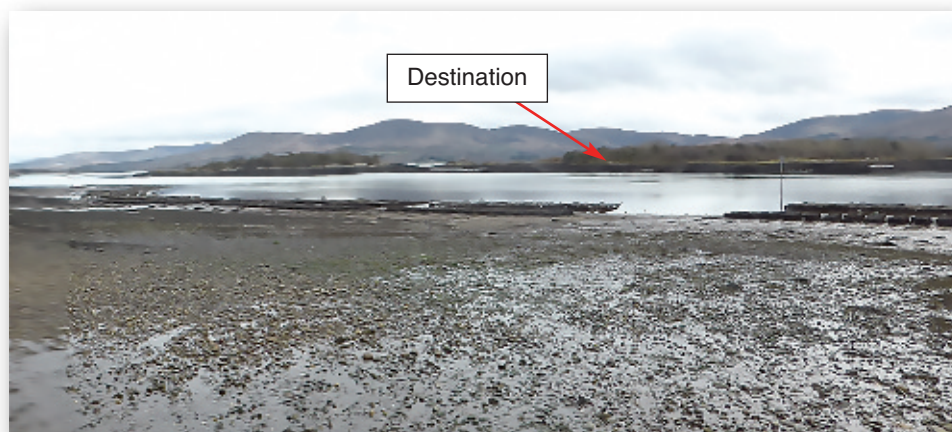
Appendix 7.2 Location of Incident.

Launching Location,
From launching location to destination a distance of approximately 250 m.
Photograph taken at similar tidal conditions to casualty.
