**REPORT OF THE
INVESTIGATION INTO
THE SINKING OF THE
'FV CARRAIG CHUIN'
25 MILES EAST OF
CLOGHERHEAD
ON
20th MARCH 2016**

**REPORT NO. MCIB/254
(No.2 OF 2017)**

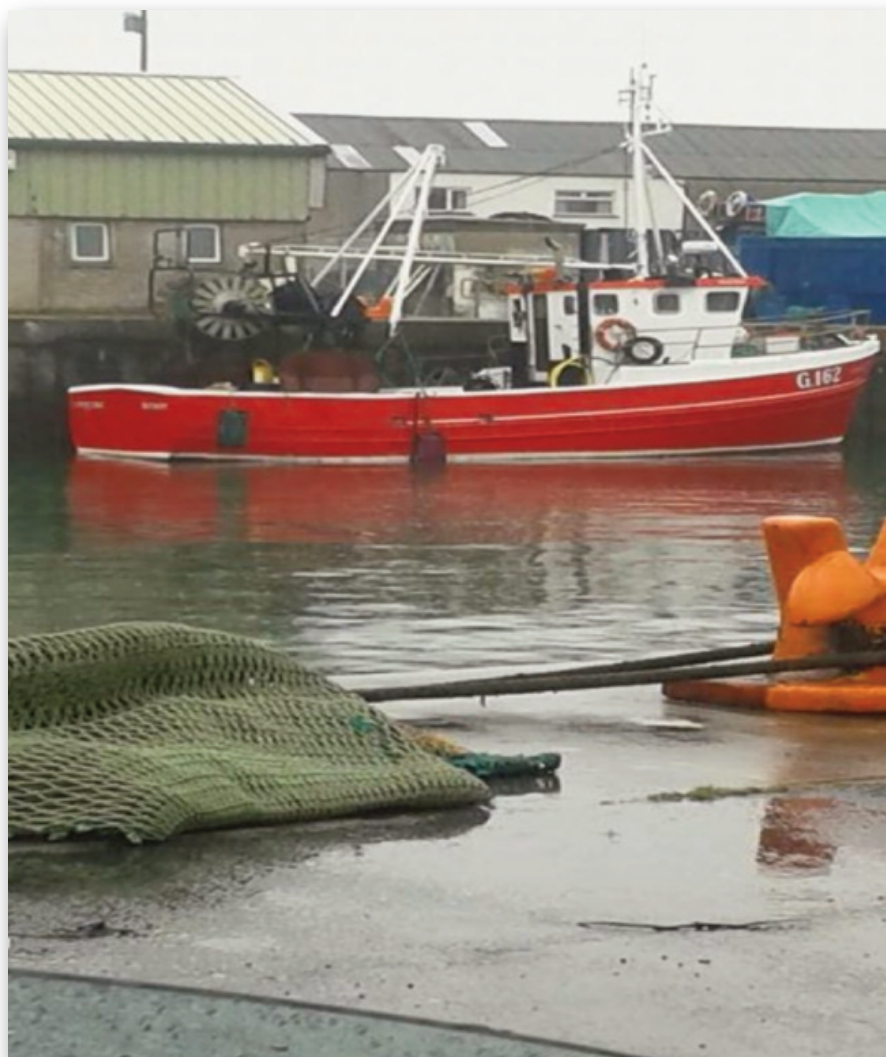
Photograph No. 1: 'FV Carraig Chuin'.

Name:	<i>'FV Carraig Chuin'</i> .
Type:	Fishing vessel.
Construction:	Hull -Timber, oak on oak, carvel style. Superstructure - Steel (see Appendix 7.1 - Photograph No. 1).
Year:	1981, Arklow.
Port of Registry:	Galway.
Year purchased:	2007.
Length:	13.96 metres (m).
Beam:	5.27 m.
Fishing No:	G 162.
Fleet No:	IRL 000110230.
Engine:	Caterpillar 3306 series.
Power:	141.76 kW.

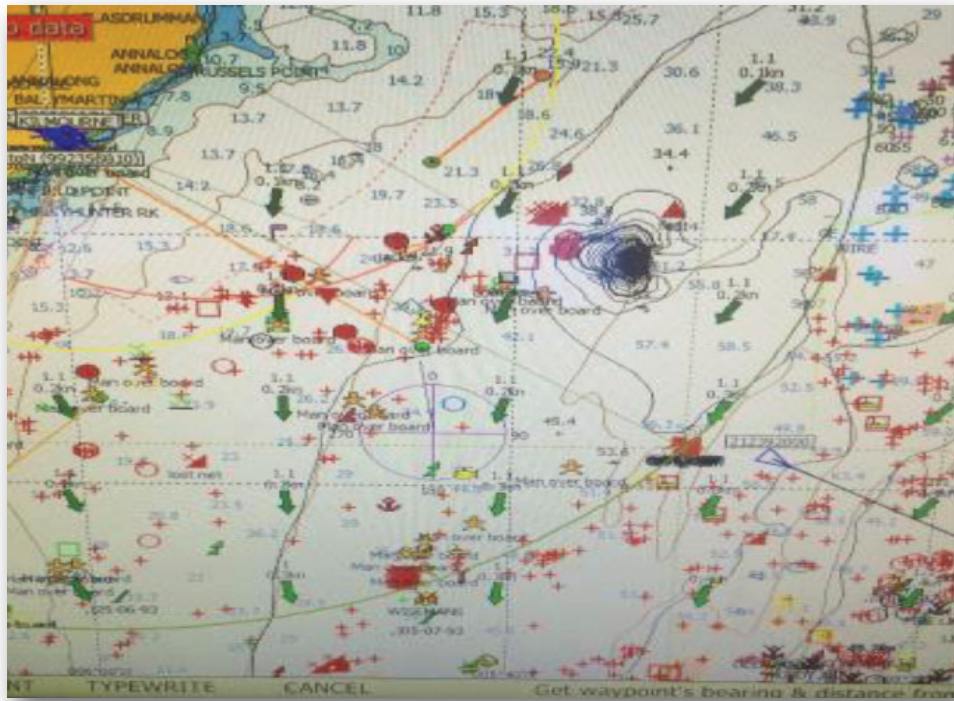
Photograph No. 2: Chart showing area of incident.

- 4.1 The vessel foundered in position 53° 51.07' N 005° 31.07' W. The depth of water was approximately 30 m. The wreck was not inspected.
- 4.2 Weather was not a factor to consider, apart from the sea water temperature.
