**REPORT INTO THE INCIDENT  
ON BOARD THE  
'MV ROSE OF ARAN'  
AT  
INIS OIRR PIER  
ON  
6th JUNE 2016**

**REPORT NO. MCIB/260  
(No.8 OF 2017)**

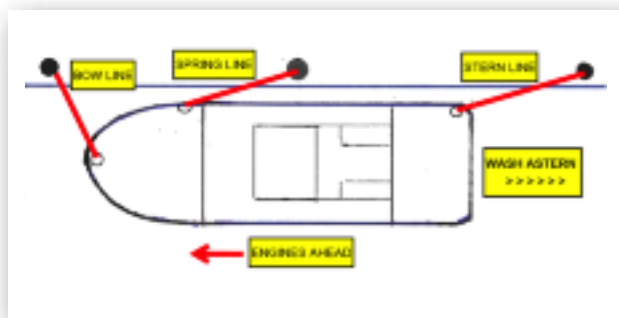
4.1.2. **Method A:** A spring line is secured from the forward shoulder and the engines are put ahead to keep the vessel alongside. A bow line and a stern line are secured. The vessel can be pinned alongside with engines and spring line alone as the rudder is active.

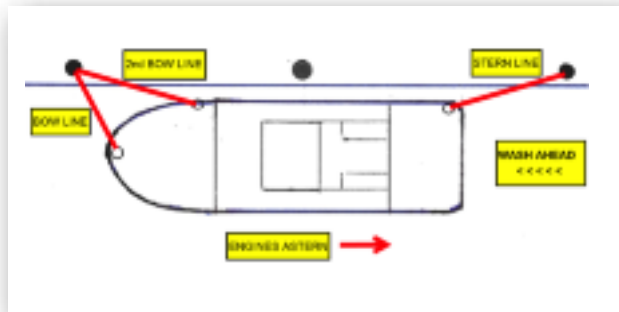
4.1.3. **Method B:** A bow line is secured from the shoulder and the engines put astern to pull the vessel alongside. A second bow line and stern line are secured. The stern line is essential as there is little control from the rudder with the engines going astern.

4.1.4. On the 'MV Rose of Aran' the gangway is forward of the wheelhouse and at low tide it prevents the deployment of the spring line in Method A. As the tide was low water springs, Method B was used on the 6th June. The ferry moored immediately astern had its engines running astern, its wash pushed the 'MV Rose of Aran' out from the pier.

**MCIB RESPONSE:** It should be noted that there were two head lines and a stern line and no breast line. See diagram at 4.1.3.

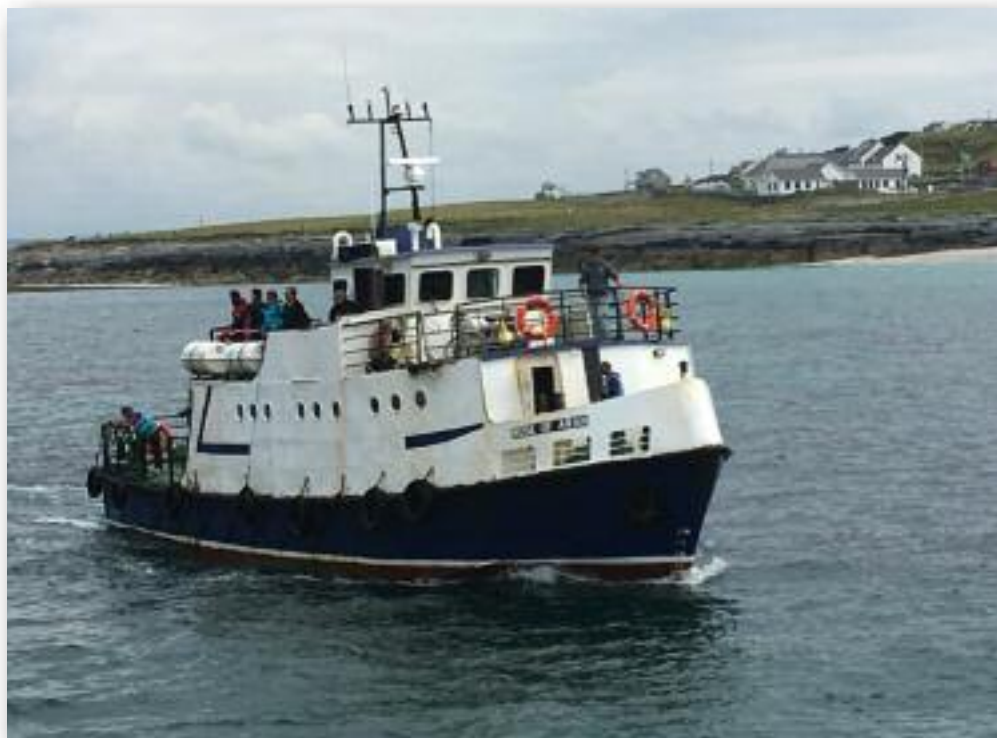
Photograph No. 1: 'MV Rose of Aran'.

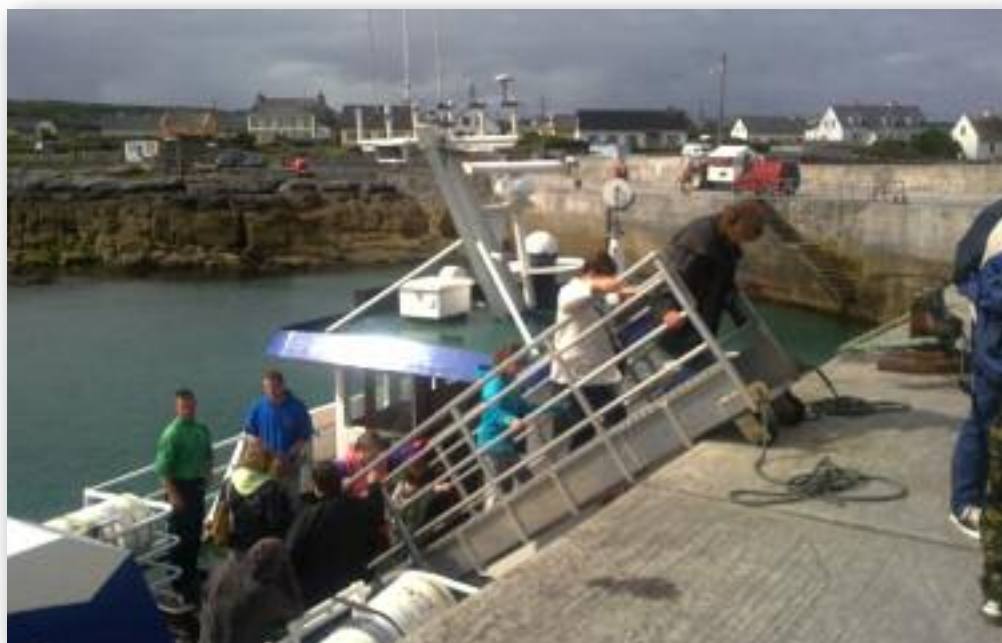
- 3.1.6. The gangway was put ashore on to the pier, it was secured on board with ropes on the vessel but just rested on the quay wall (see Appendix 7.1 Photograph No. 2 for arrangements at low tide). Passengers proceeded to disembark at about 11.55 hrs.

Photograph No. 2: Gangway from a ferry at Inis Oirr at low tide. Note steps from the pier on right hand side do not reach all the way to the water at this state of tide, also note marine growth at this level.

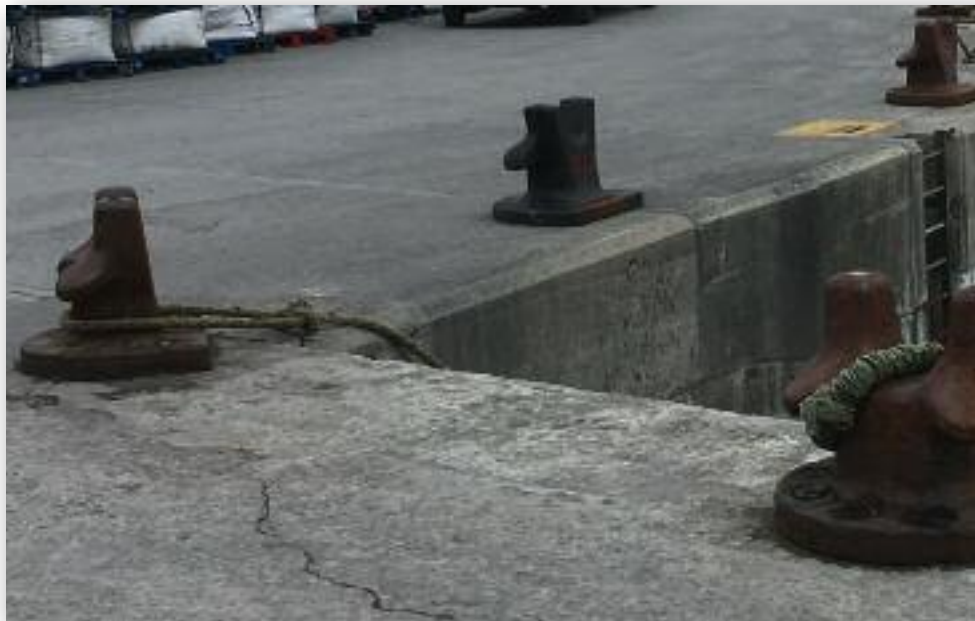
Photograph No. 3: Staghorn Bollards.

**MCIB RESPONSE:**  
Noted, refer to Photograph No. 3 which shows how lines are secured to bollards. There is a correct method for securing the lines. No one could state how the stern line was secured as it was not checked. See paragraph 4.1.8.

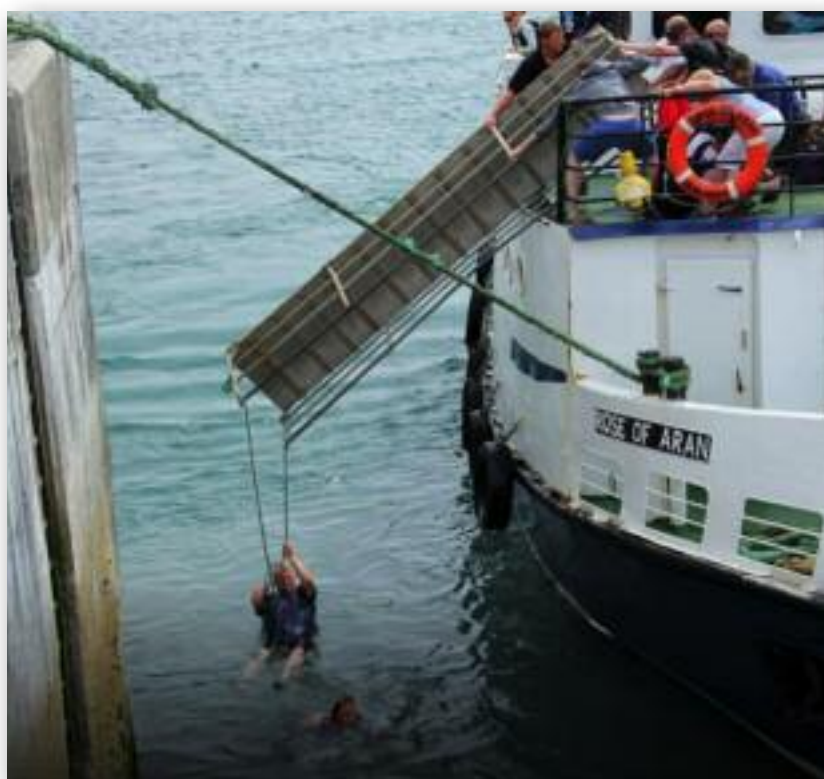
3.2.2. The crewmember at the gangway stopped passengers disembarking, and called to the passengers on the gangway to get ashore quickly. Two people close to the quay jumped ashore, but a man in the middle of the gangway stopped and froze. There was also a woman on the gangway behind him. The end of the gangway on the pier slipped off the pier and fell downwards towards the water, turning sideways. The woman fell into the water and started to swim towards a ladder on the quay wall. The man slipped down the gangway and held on to the ropes at the end. One crewmember and some passengers held on to the gangway to prevent it falling into the water on top of the two people (see Appendix 7.1 Photograph No.4).

Photograph No. 4: The incident with gangway detached, one person swimming towards ladder and one person hanging on to gangway. Note no life-ring deployed at this stage, bow line and stern line have been taken back on board.

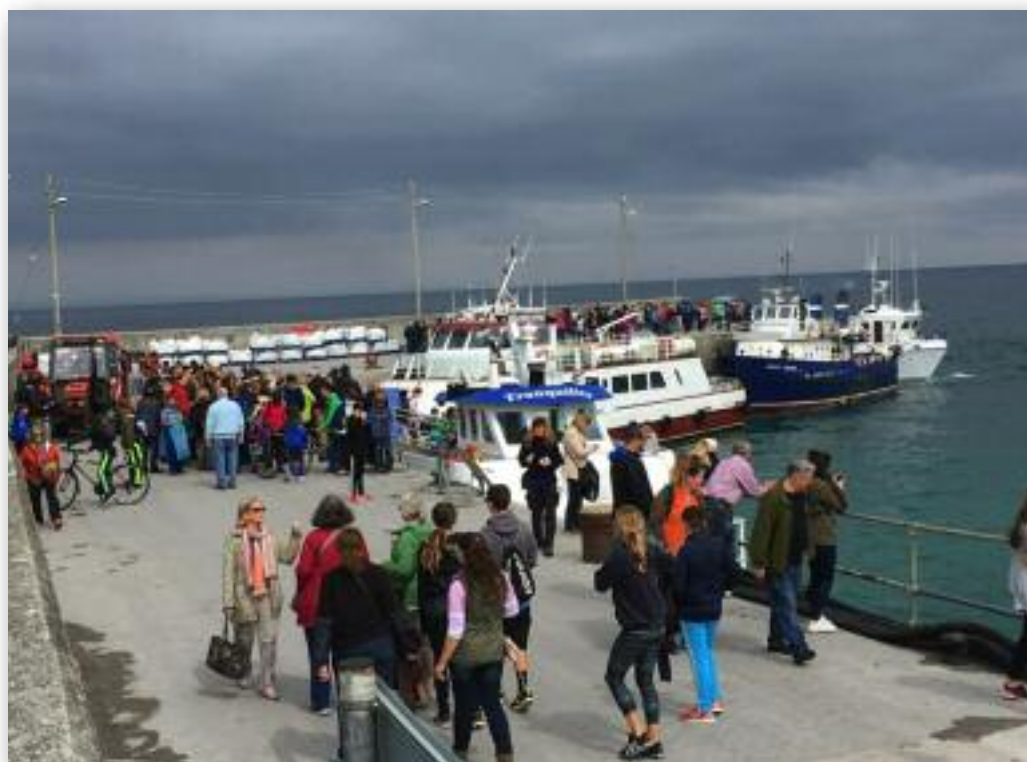
- 4.1.8. The reason the stern line became loose is not clear. It was secured to the bollard by a bystander and this may not have been done correctly. If it was not placed under the knuckle of the bollard it could easily have come free. It is noted by the investigation that there are no designated mooring persons on the quay during embarking and disembarking and that passengers were asked to secure the line onto the bollard. In addition, the ferry which came in astern of the ‘MV *Rose of Aran*’ used the same bollard to secure its head line. The ‘MV *Rose of Aran*’s’ stern line could have been released inadvertently at this point. The waiting passengers on the quay crowd around the edge of the quay as the ferries are berthing, obscuring the view of the bollards and impeding the mooring procedures of the crew. On the 6th June it was estimated that there was in excess of 500 people waiting on the quay, most returning from a weekend stay on the island (see Appendix 7.1 Photograph No. 5).

On one visit to the pier the life-ring nearest to the point where this incident took place was obscured by bags of stones (see Appendix 7.1 Photograph No. 5).

Photograph No. 5: View of Inis Oirr Pier. Four ferries alongside and approximately 100 people on pier. Note vehicular traffic on pier and access to life-ring obstructed by cargo on pier.
