**MCIB**

**REPORT OF AN INCIDENT  
INVOLVING  
'PV MARY ANN OF DUNLOE'  
ON  
LOUGH LEANE,  
KILLARNEY,  
CO. KERRY  
1st SEPTEMBER 2016**

**REPORT NO. MCIB/264  
(No.10 OF 2017)**

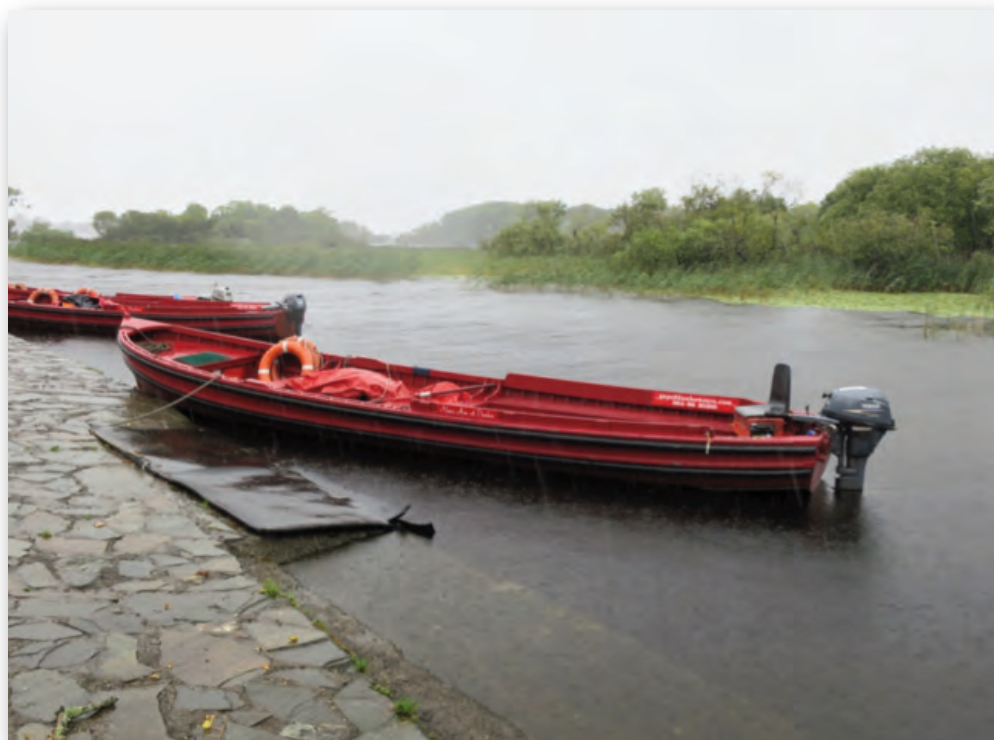
Construction: Traditional Irish clinker built, timber vessel of open configuration (see Appendix 7.1 Photograph No. 1).

Photograph No. 1: General view of vessel.

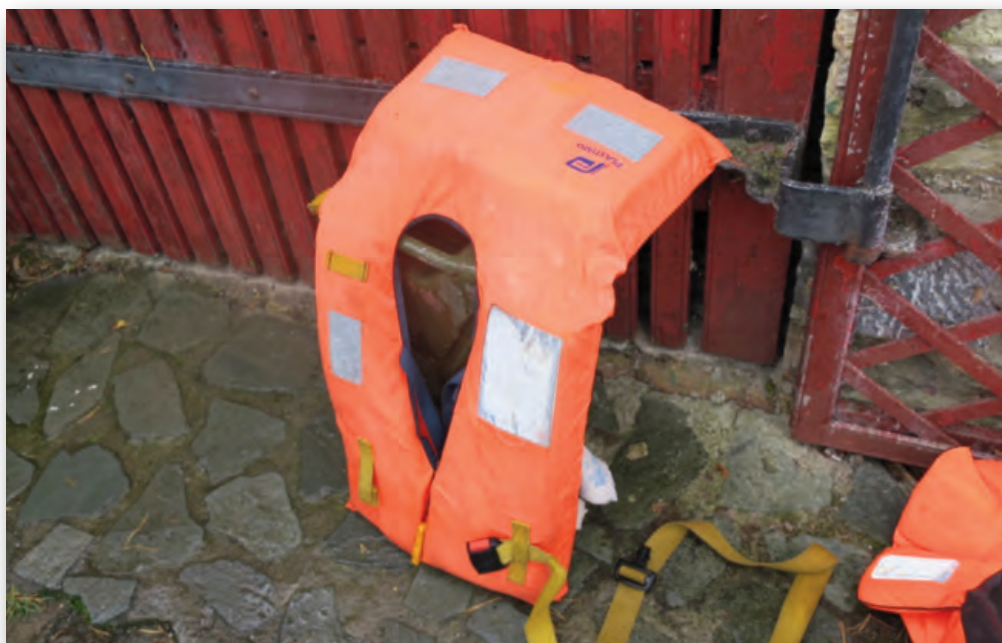
- 3.1 Prior to departure very basic safety instructions were given by the Master of the vessel. All passengers were provided with lifejackets which were donned before departure (see Appendix 7.1 Photograph No. 2).

Photograph No. 2: Typical lifejacket provided.

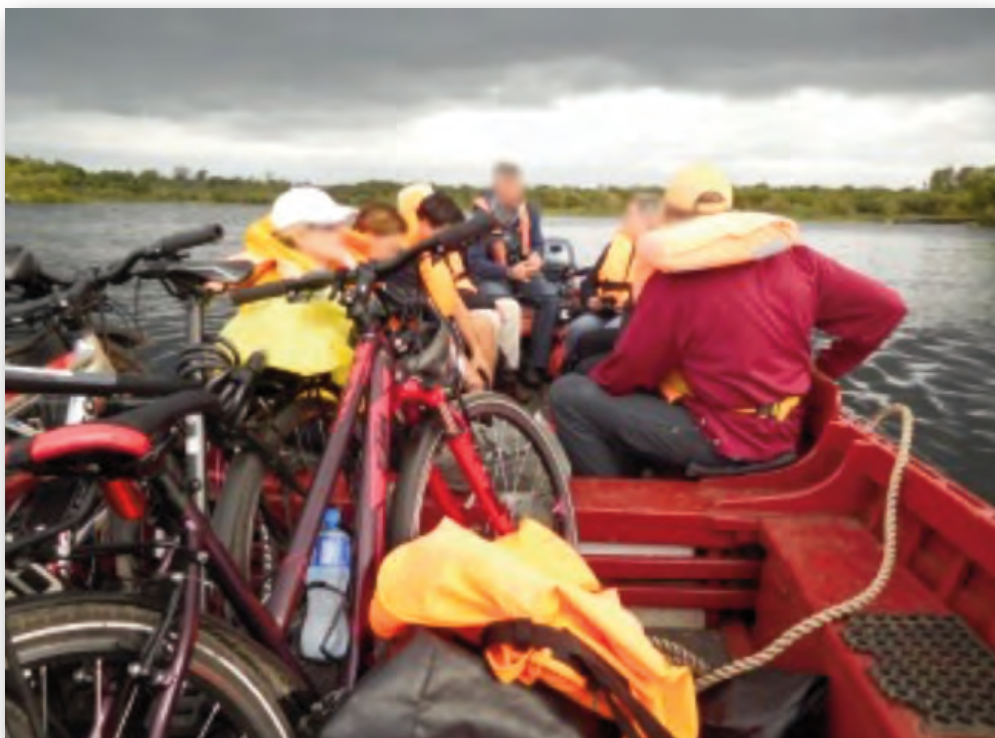
- 3.2 The vessel departed Reen Pier, Ross Castle, Killarney, for the Gap of Dunloe at approximately 11.00 hrs on the 1st September 2016, with twelve passengers, a Master and four bicycles on board (see Appendix 7.1 Photograph No. 3).

Photograph No. 3: Taken shortly after departure Ross Castle.

1. I note in the covering report from 'The Marine Casualty Investigation Board, that names of the parties involved in the incident and in natural justice process will not be included. Yet I note with dismay that photograph number 3 clearly identifies me. I am seeking confirmation that when the photograph is used that my face will be blurred out. I have no objection to the photograph being used if my face is blurred. This photograph supports my account of the weather conditions on the day and also shows that the boat was evenly balanced when setting off and was sitting high on the water.

6. The weather conditions were favourable and calm when the boat departed as can be seen in photograph number 3 appendix 7.1
7. The "PV Mary Anne of Dunloe" was built in 2004 under MSO Survey and at the time had a current P2 passenger boat licence for the carriage of 12 passengers and two crew on the 23<sup>rd</sup> of September, 2016. The Licence was issued by the Marine Survey Office.

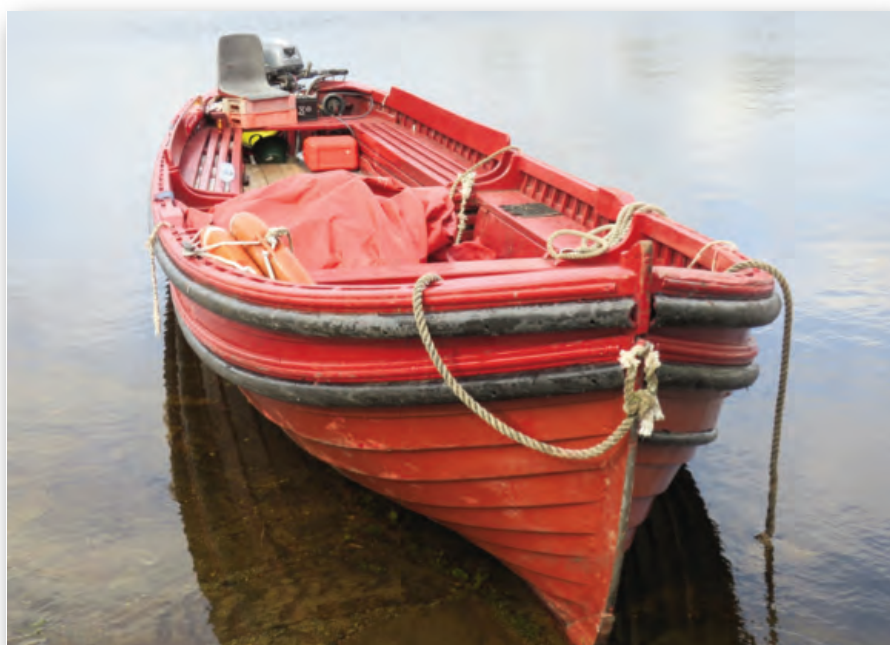
- 4.2 A requirement of the P2 licence is that an open vessel, be fitted with sufficient approved built-in buoyancy to enable the vessel to remain afloat and upright in the event of the vessel being swamped. The legal requirement is as follows: “(d) in the case of open cockpit vessels, be fitted with side benches which form watertight or buoyant compartments secured in place to provide a safety standard for the vessel to remain afloat to the satisfaction of the Minister and in the case of an open passenger boat, have sufficient built in buoyancy to provide a safety standard for the vessel to remain afloat to the satisfaction of the Minister.” The vessel did comply with this requirement (see Appendix 7.1 Photograph No. 4).

Photograph No. 4: Vessel internally.
