**REPORT OF THE INVESTIGATION
INTO A FATAL INCIDENT
INVOLVING
'FV SHANIE BOY',
WEST OF PERCH ROCK,
SKERRIES, CO. DUBLIN
ON
26th MAY 2017**

**REPORT NO. MCIB/271
(No.4 OF 2018)**

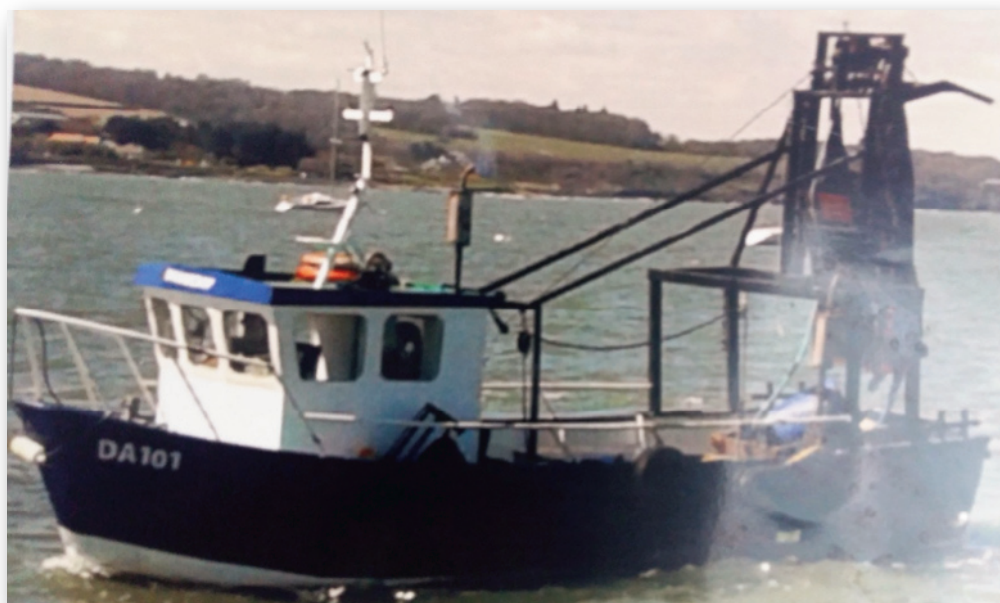
Photograph No. 1: 'FV Shanie Boy'.

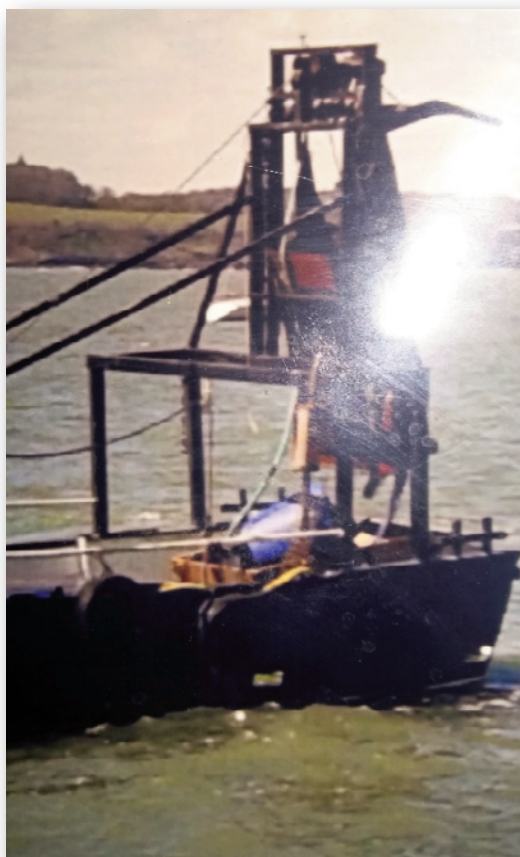
- 4.2 The 'FV *Shanie Boy*' was an open decked vessel with a small wheelhouse at the forward end. The catch was kept in barrels stored on deck to port and starboard. A steel gantry extending up to approximately twice the height of the wheelhouse was mounted aft, near the transom from which the heavy steel dredge was suspended when not in use and when being emptied of the catch (see Appendix 7.1 Photograph No. 3). The dredge was hung from two arms, one on either side of the gantry, and hoisted into position with a winch. The added weight of rocks and stones in the dredge when hoisted to the top of the gantry would have had a negative impact on the stability of the vessel. When the dredge slipped off the gantry starboard arm, all the extra weight hanging over the side would have had a further negative effect on stability.

Photograph No. 2: Detail showing the gantry at the stern of 'FV Shanie Boy'.

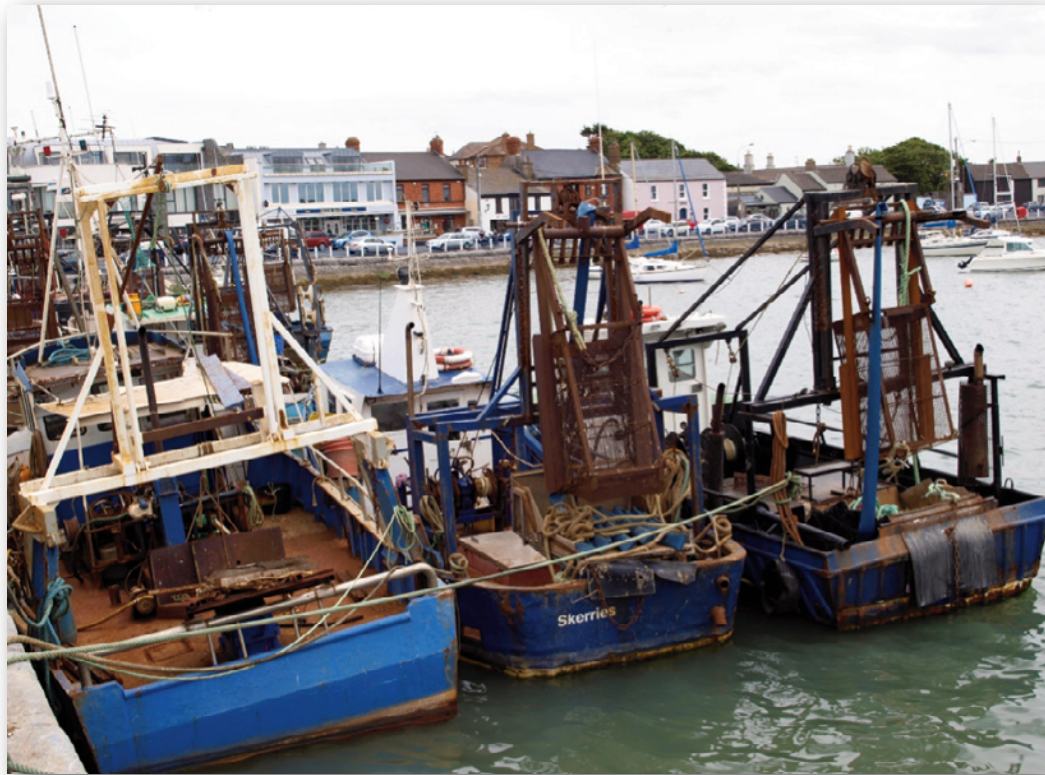
Photograph No. 3: Similar vessels showing the dredge in a stowed position on the gantry.
