**REPORT INTO AN INCIDENT
INVOLVING THE
'FV DILLON OWEN'
OFF ARDGLASS HARBOUR
23rd OCTOBER 2019**

**REPORT NO. MCIB/295
(No.5 OF 2020)**

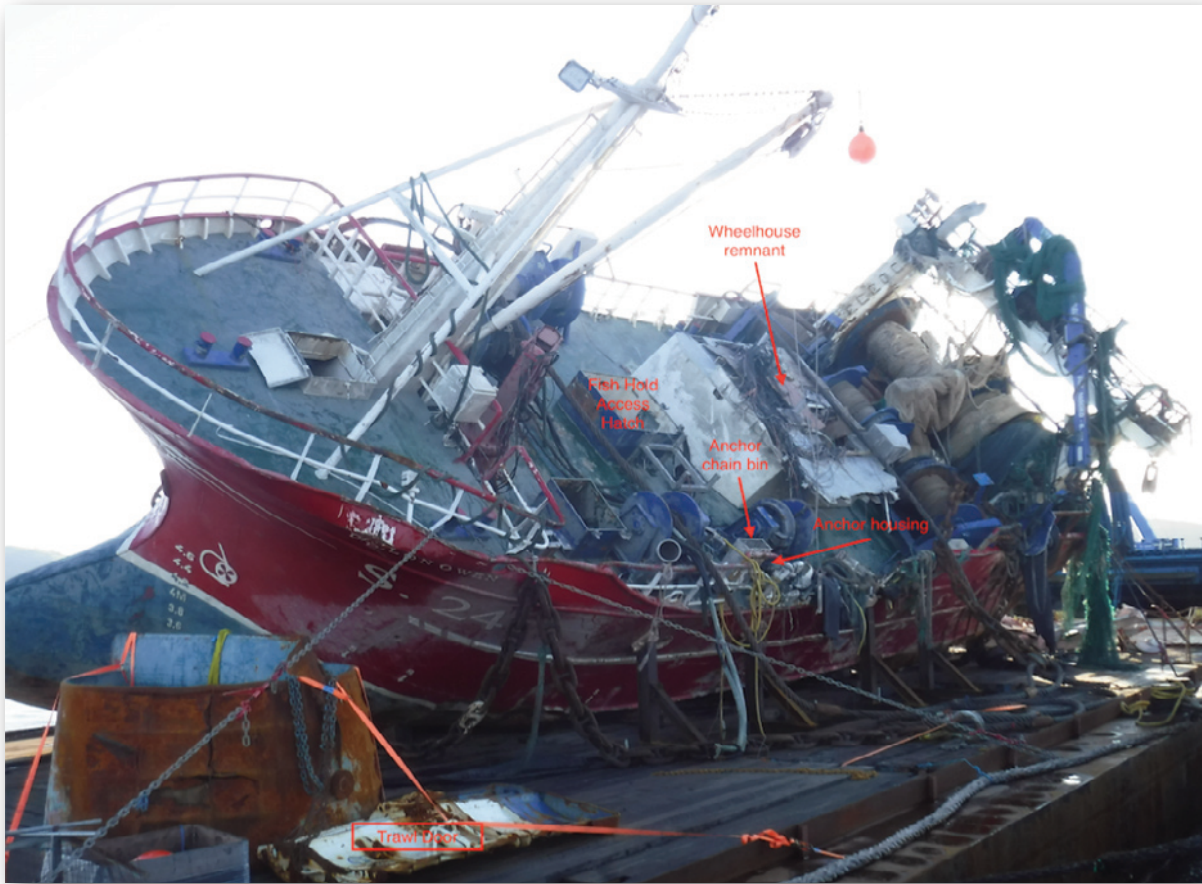
Photograph No.2 - 'FV Dillon Owen' wreck as lifted off the seabed.

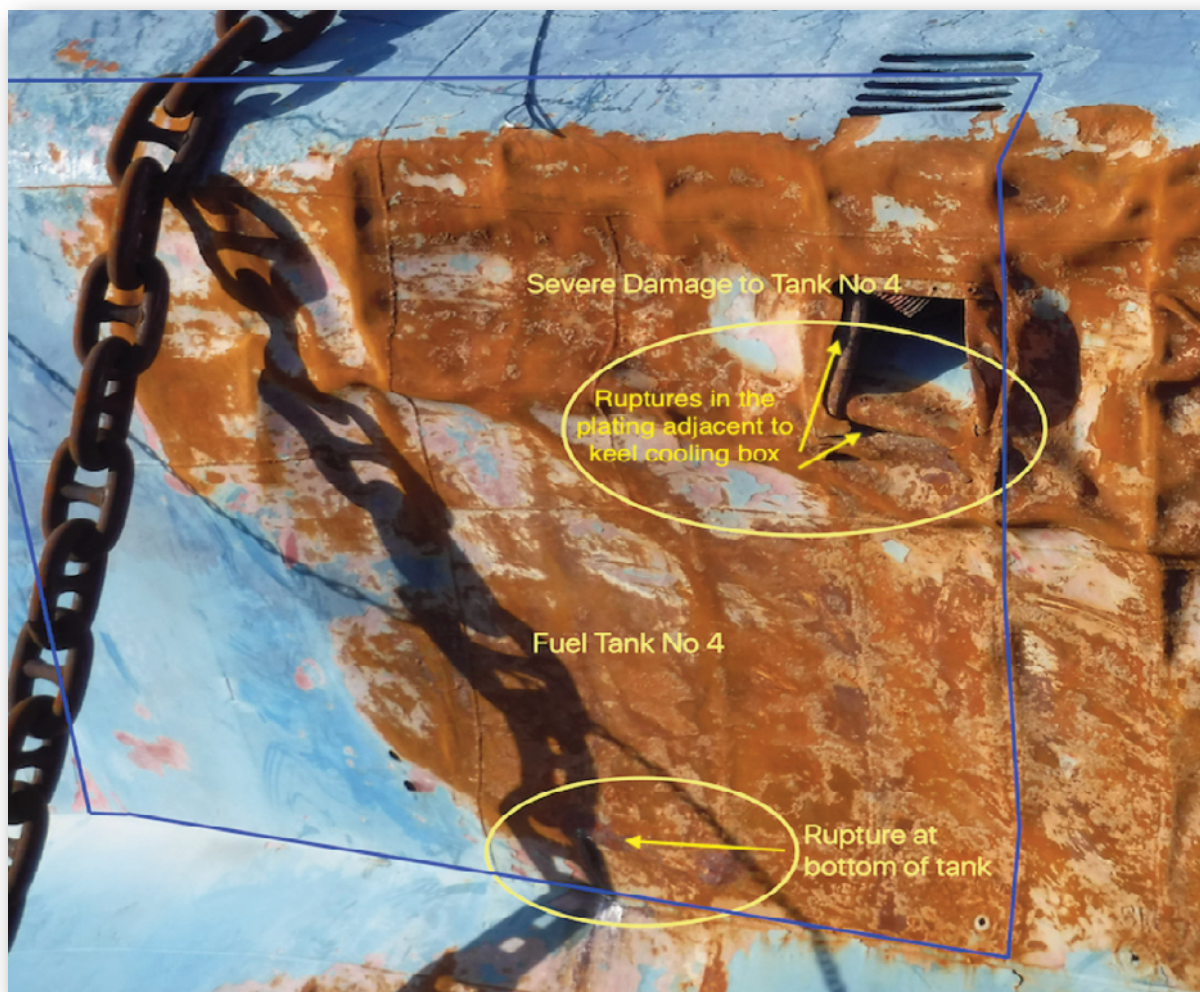
damaged and the plating ruptured in way of fuel tank No.4 adjacent to the keel cooler box. The keel cooler box bottom grid was missing and the keel cooler box bottom aperture through the hull significantly deformed. No.4 fuel tank was open to the sea through the ruptured plating.

- 5.3 The rupture of No.4 fuel tank immediately filled the tank with seawater and the practice of continually circulating fuel oil through the CJC filter in turn contaminated the daily service tank supplying fuel to the main engine and the generators, causing the vessel to lose electrical and propulsion power. If the transfer and recirculation of fuel from the bunker tank through the CJC unit into the Day Tank had been stopped as the vessel approached shallow waters and restricted navigation, or if a procedure was in place to stop this pump should a suspected grounding event occur, then the Day Tank fuel contents would not have been contaminated and the vessel would not have lost power after the first grounding.

Photograph No.4 - Damage to No.4 fuel tank showing hull plating rupture adjacent to the keel cooler box and at the bottom of the fuel tank.

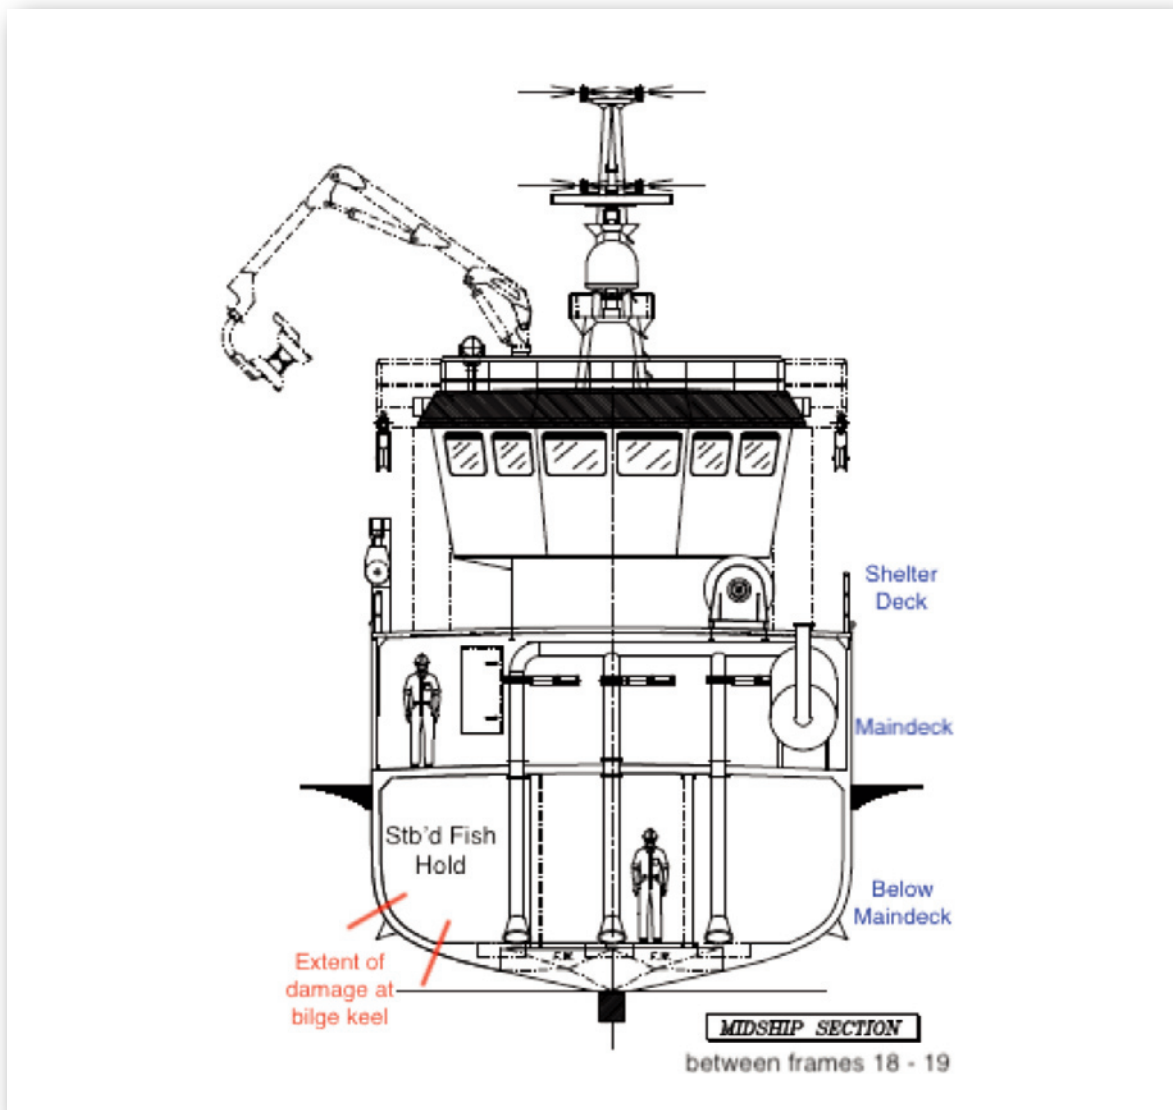
Both No.4 fuel bunker tank and the Day Tank were situated at the 'Below Maindeck' level, within the engine room and below the waterline (on the occasions when the vessel was in the loaded condition). This was the situation as the 'FV Dillon Owen' approached Ardglass Harbour.

The evidence that no water was found in the ships spaces at this time indicates that seawater ingress from the first grounding event was contained to No.4 fuel bunker tank and starboard fish hold only.

Fig.2. Orientation of hull damage to the vessels compartment(s) (Elevation).
