**REPORT INTO THE
FIRE AND LOSS
OF
MFV SUZANNE II
EAST OF ARKLOW
ON
2nd MAY 2019**

**REPORT NO. MCIB/291
(No.1 OF 2020)**

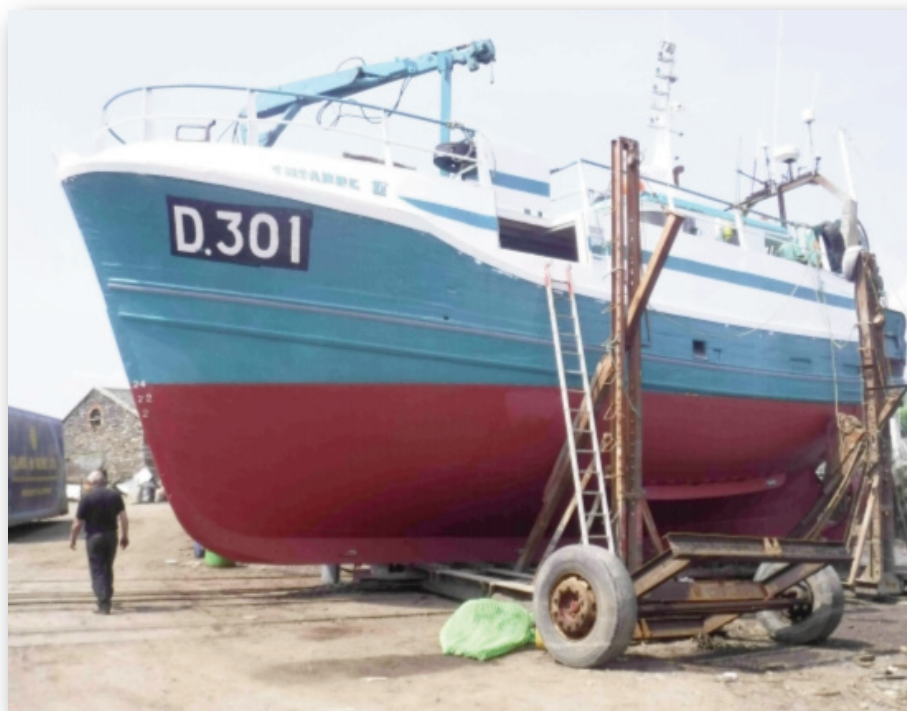
Type:	Fishing Vessel - built as a trawler but fitted with a pot hauler in 2018 (see Appendix 7.1 Photograph No. 1).
Port of Registry:	Drogheda.
Length Overall:	17.67 metres (m).
Registered Length:	15.54 m.
Beam:	5.44 m.
Loaded Draft (midship):	2.776 m.
Gross Tonnage:	42.62 t.
Net Tonnage:	24.96 t.
Displacement:	92.908 tonnes loaded.
Maker:	Unknown.
Built:	1965 in France.
Vessel Construction:	Hull: Timber carvel - oak planks on oak frames.
Shelter Deck:	Aluminium.
Engine:	Main engine: Volvo Penta TMD 121C. Power: 253.67 kW. Shaft generator and auxiliary DAF engine located forward.
Fuel Type:	Marine gasoil. Estimated quantity of 200 litres onboard.

Photograph No. 1 - Vessel at survey.

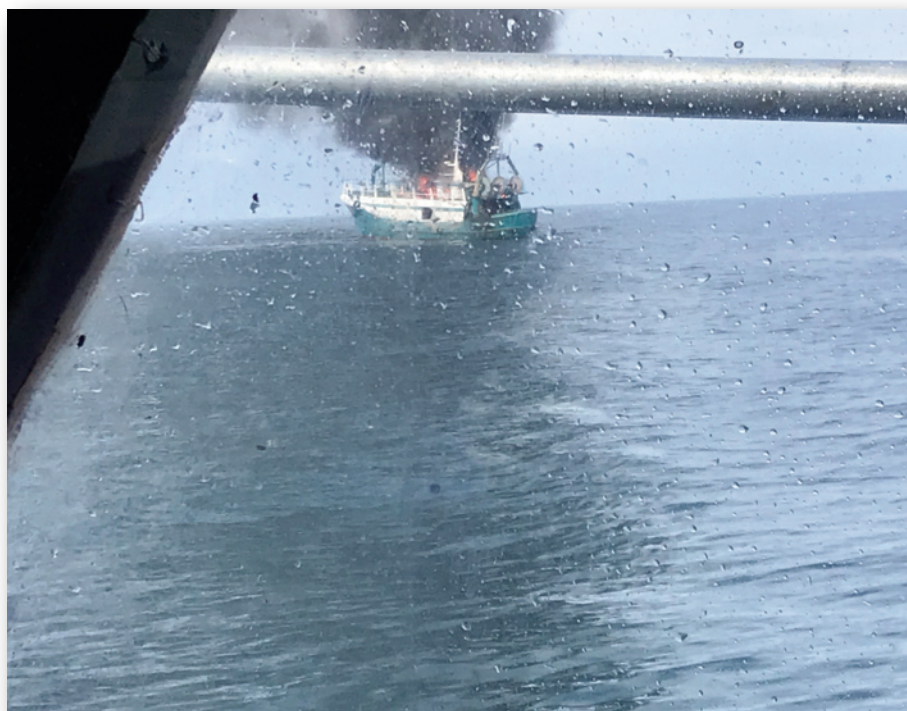
- 5.1 The source of the fire is unknown. It started in the engine room and rapidly got out of control. Once the fire was well established it engulfed the vessel and being of timber construction it continued to fuel the fire until the entire vessel was ablaze (see Appendix 7.1 Photographs No. 2, 3 & 4).

Photograph No. 2 - Vessel on fire, as first seen by angling vessel, approximate time 15.04 hrs.

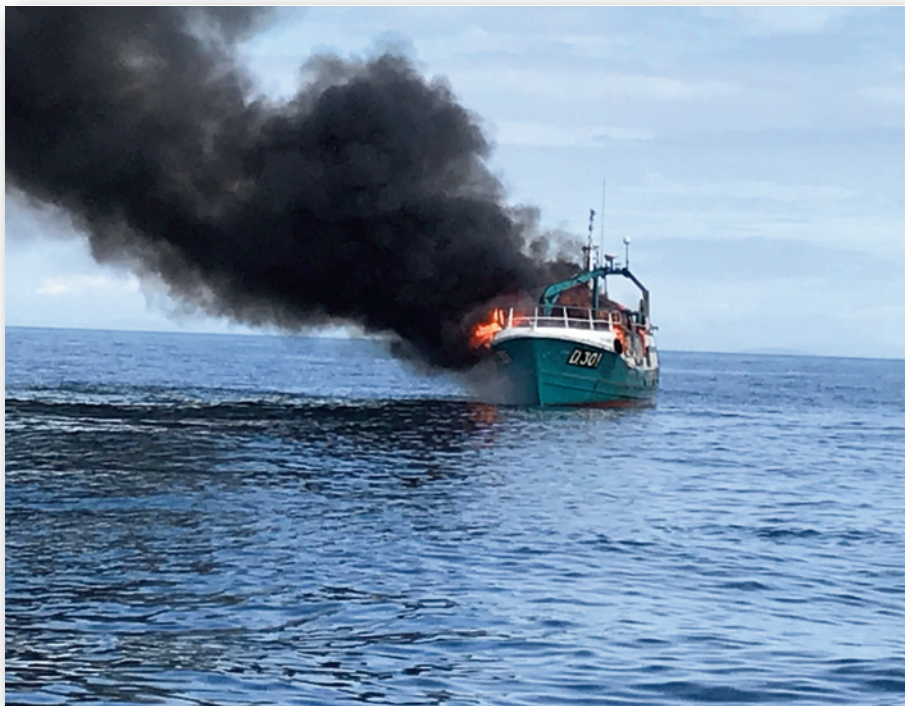
Photograph No. 3 - Fire continues.

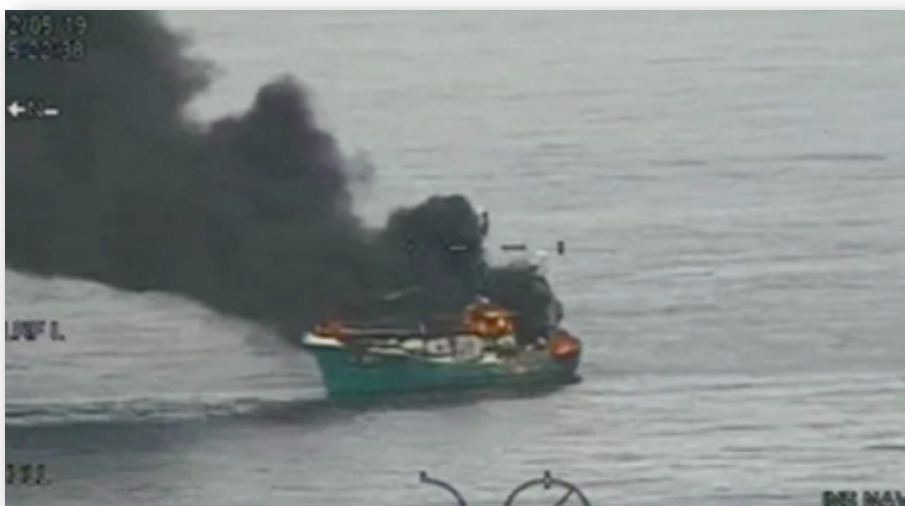
- 4.17 From arriving on-scene the tug with fire fighting capabilities continued to fight the fire but failed to get it under control or extinguish it. The photographs in Appendix 7.1 clearly show that by the time the tug arrived the entire vessel was engulfed in flames.

Photograph No. 4 - Vessel as seen by rescue helicopter at approximately 15.21 hrs.
