**REPORT INTO
A FATAL INCIDENT
INVOLVING THE VESSEL
'TOMMY R'
IN DUNMANUS BAY,
WEST CORK,
9th OCTOBER 2019**

**REPORT NO. MCIB/294
(No.8 OF 2020)**

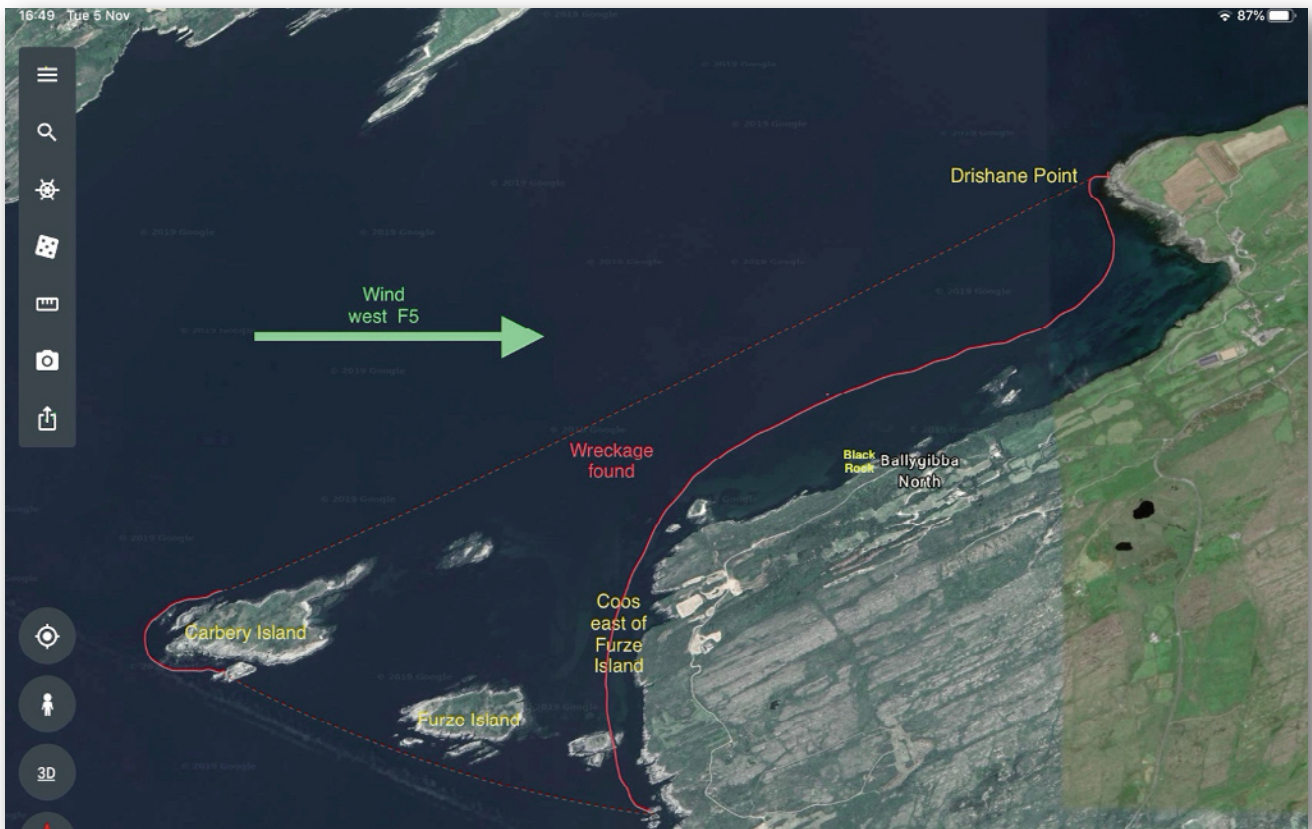
Chart 3 - Satellite image indicating Wreckage Plume.

3.4.5 Wreckage of the '*Tommy R*' was found on the west shore of Carbery Island and along the high tide shoreline between Drishane Point and east of Furze Island. The distribution of the wreckage could be described as a plume extending from its point at Carbery Island to it widest extremities along the Dunmanus shores. The body of the Casualty was recovered by divers from the sea at the north west corner of Carbery island. It may reasonably be deduced that the '*Tommy R*' foundered and broke up somewhere off the west shore of Carbery Island and that wreckage of the boat drifted east under the influence of the wind sea direction and the flood tide before the tide turned to ebb after 14:45hrs local time on the 9th October.

4.5.5 Wreckage of the 'Tommy R' was found within a 'plume' extending east from Carbery Island's west shore and spreading out to wash up on the shoreline between Drishane Point and the inlets east of Furze Island. It would be reasonable to deduce that the wreckage drifted east from the site of the wreck of the 'Tommy R' under the influence of the wind sea direction and the flood tide before the tide turned to ebb after 14:45 hrs (see Appendix 7.4 Wreckage area Chart 5. Wreckage plume).

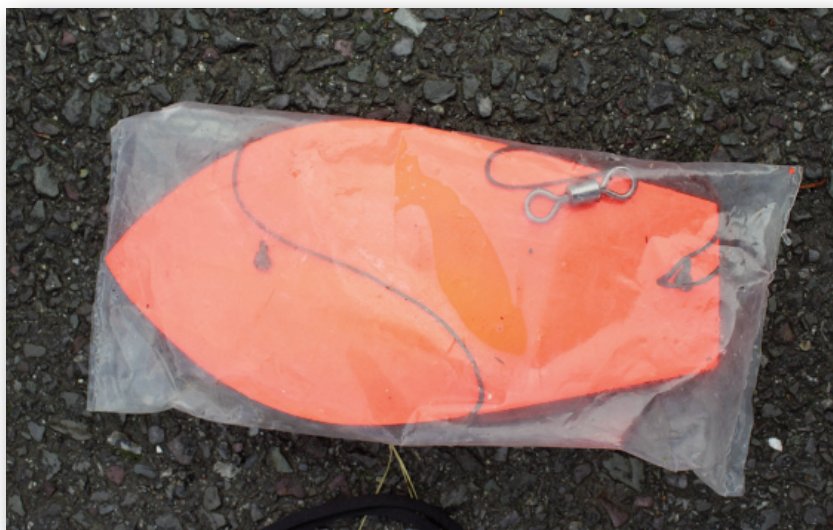
Photograph No.4 - Pollock Diveboard.

- 3.4.3 A pollock diveboard, unused and in a wrapper, was found in the wreckage recovered along the shoreline east of Furze Island. Also found with the diveboard was a short wooden fishing board wrapped around with a long length of fish line with mackerel lures attached. Both items were reported as being similar to fishing equipment used by the Casualty.

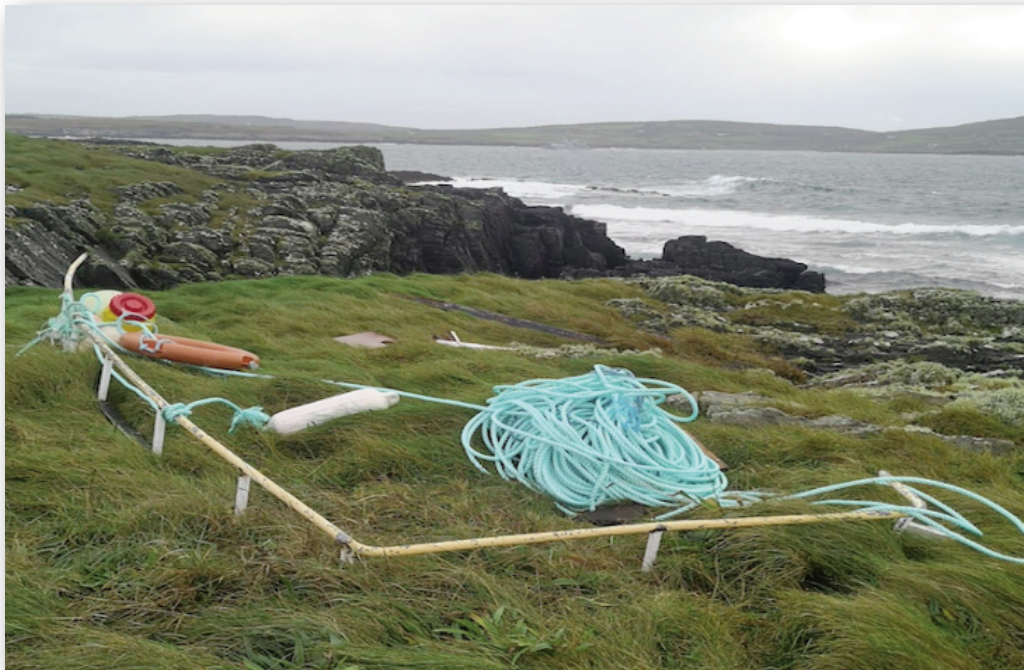
Photograph No.6 - Wreckage found on Carbery Island - west shore.

Photograph No.6, wreckage found on Carbery Island - west shore.

- 4.5.6 Wreckage found on Carbery Island comprised mostly of small undamaged items which would likely float free as the boat broke up. A large section of deck rail (fitted around the boats work deck gunnels from the port side of the wheelhouse along the ports side, around the transom and partly along the starboard side) would be expected to sink under its own weight. However, the rail appeared to have been buoyed by the attached assortment of buoys, fenders and the watertight flare canister, all of which were relatively unmarked. The rail was not distorted or bent out of shape and still had a section of the boat's gunnel capping attached. All items were found within reach of the Carbery Island shoreline searchers or cast up on the islands rocky shore (see Appendix 7.2 Photograph No.6 - Carbery Island west shore - wreckage).

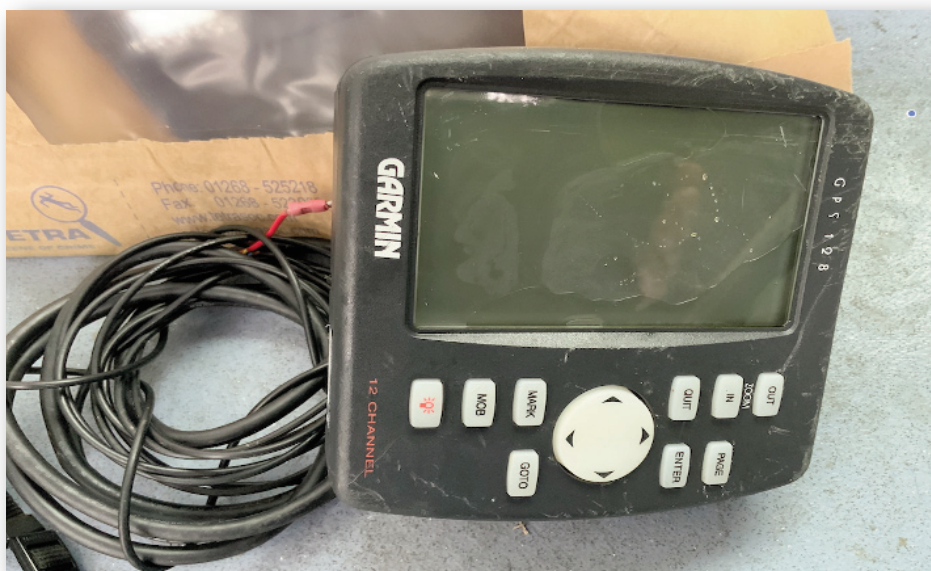
Photograph No.7 - Garmin GPS 128.

3.2.4.4 Navigation Equipment. The navigation equipment onboard the ‘*Tommy R*’ and recovered with the wreckage included a GARMIN GPS 128 and a GARMIN GPS Map 450 chart plotter. The chart plotter was beyond functioning when recovered. The GPS 128 was operable and likely to have been in operation at the time of the incident, however, data recovery of voyage history and boat track was not possible due to some internal damage as a result of water immersion.

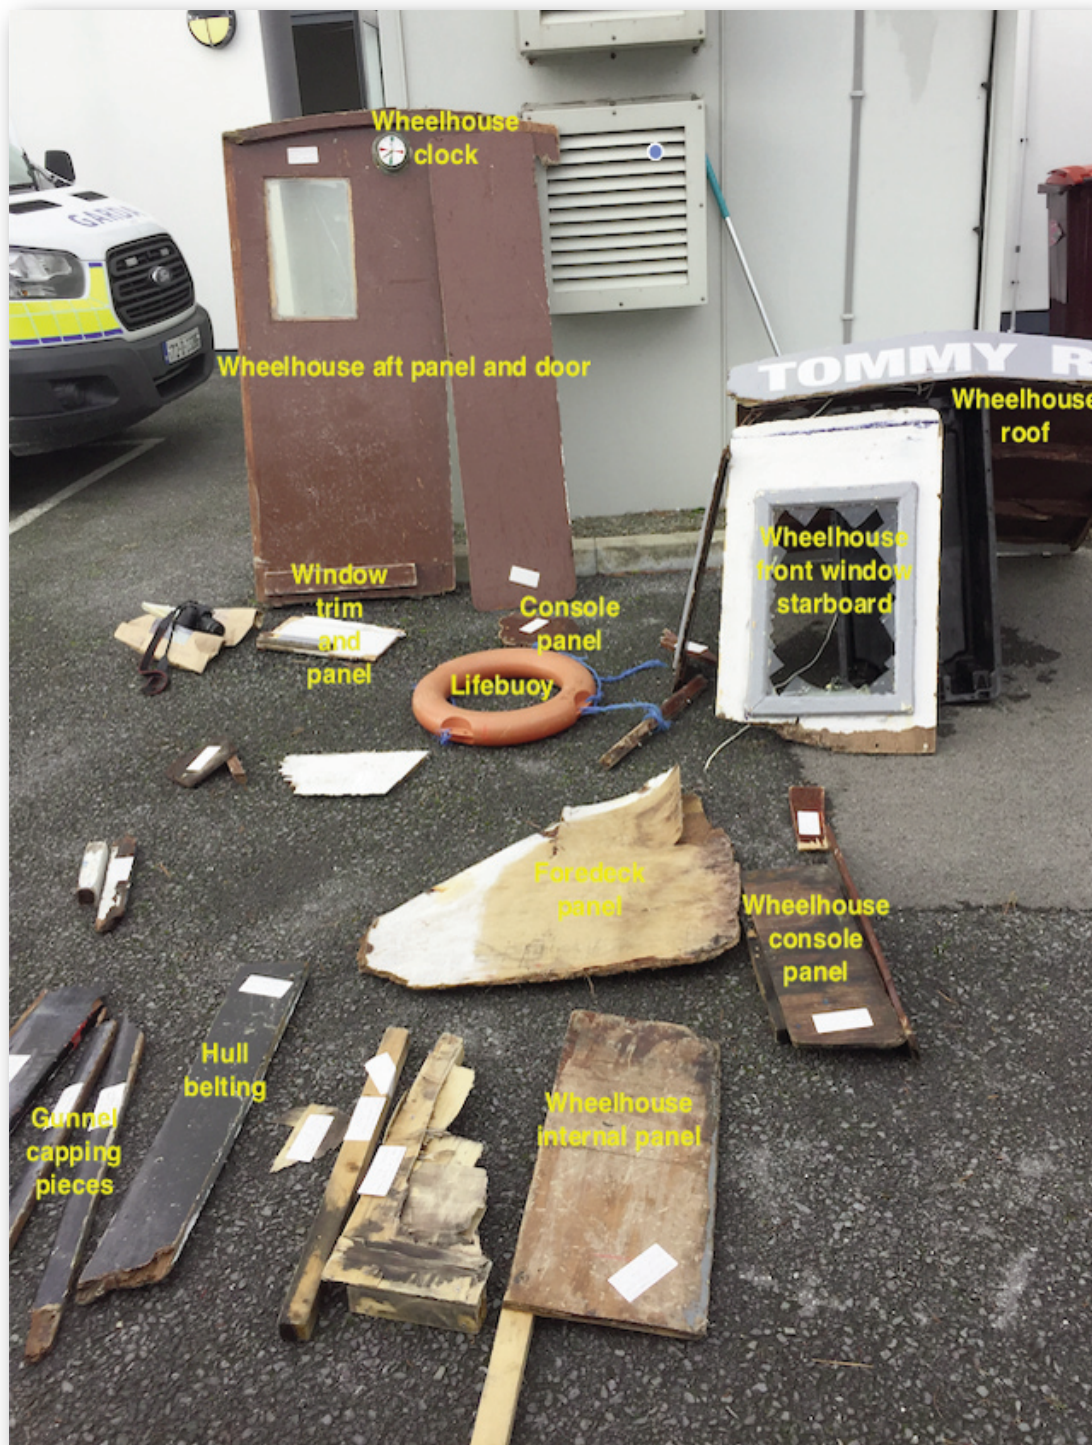
Photograph No.8 - Wreckage found east of Furze island - wheelhouse,

- Multiple locations along the Shoreline in coos east of Furze Island: -
 - wheelhouse sections including roof, rear panel with clock attached, rear panel door, port side panel (partial section), front starboard panel with glass window (broken window) and with bubble compass and electrical wiring/conduit attached.

Photograph No.8, wreckage found east of Furze Island -wheelhouse.)

- 4.5.7 Wreckage found along the shoreline between Drishane Point and east of Furze Island comprised of large sections of the wood ply wheelhouse, a lifebuoy, small timber components originating from the wheelhouse console and the foredeck, and hull topside belting and gunnel capping pieces. Some sections of the wheelhouse were large, relatively unmarked and had come apart at the joins. The roof and rear section including the wheelhouse door panels were found mostly intact (see Appendix 7.2 Photograph No.8 - Wheelhouse sections and assorted timbers).

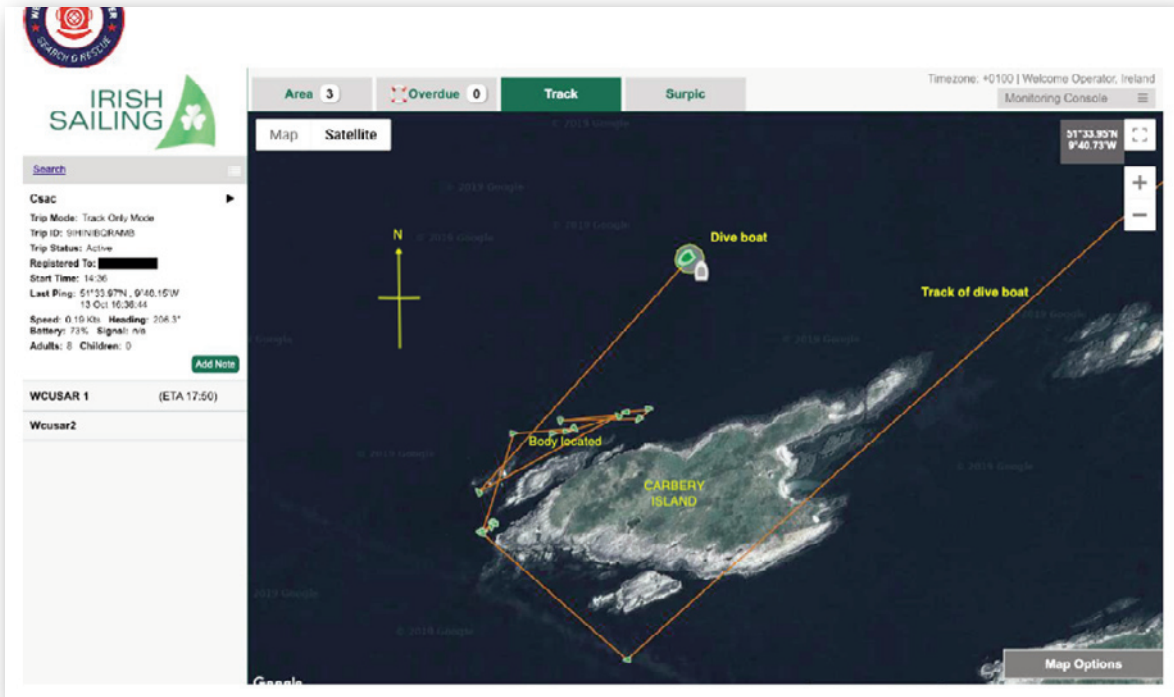
Chart 5 - Satellite image - Dive boat track and body location 13th October.

2.6.4 On the 13th October 2019 at 16:19 hrs (local time - UTC+1) a body was found by divers in the water northwest of Carbery Island at a depth of 11 m in a gulley/crevice. The body was recovered and brought ashore at Dunmanus Harbour and identified as that of the missing Casualty. Search operations and SRU's were stood down shortly thereafter (see Appendix 7.4 Diver Search Areas, Chart 5. Satellite image - Dive boat track and body location 13th October).
