**MCIB**

**REPORT OF AN INVESTIGATION  
INTO A MARINE CASUALTY  
INVOLVING THE SAILING VESSEL  
INISH CEINN  
BALTIMORE, CO. CORK  
6 JUNE 2023**

**REPORT NO. MCIB/327  
(No.3 OF 2024)**

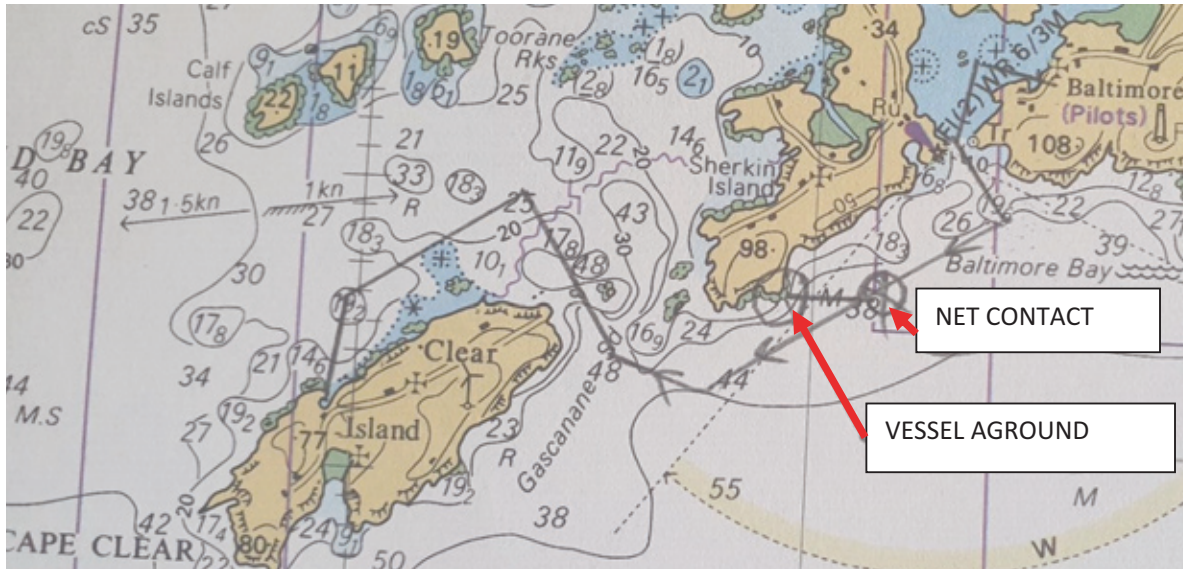
Course planned and estimated position of contact with the net and aground position shown

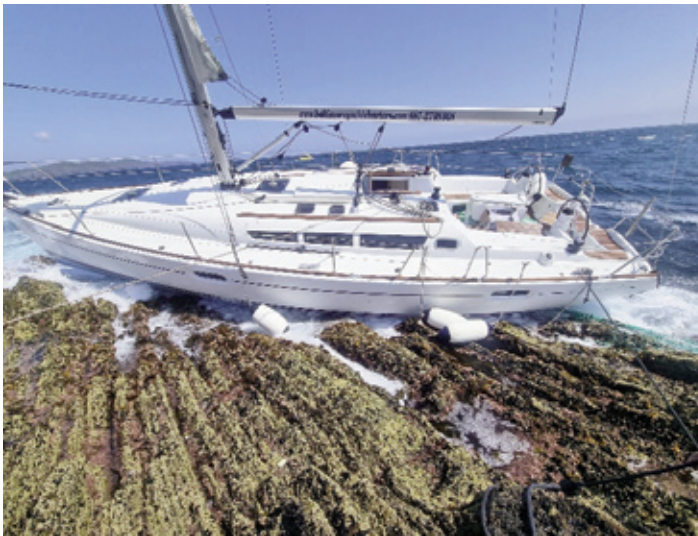
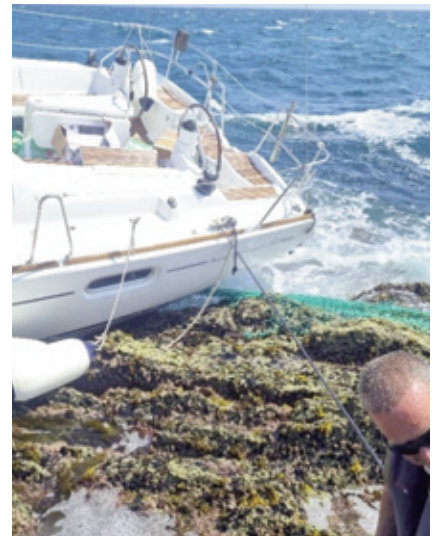
- 3.2.5 As the vessel was starting to lift onto the rocks the Skipper had to also abandon the vessel and he climbed onto the rocks. It was at this stage he noticed the large bright green trawl net that was wrapped around the keel, rudder and propeller. Up to then he was unaware of what had fouled the hull.
- 3.2.6 The net can be clearly seen in the photographs below taken by crewmembers who were on the rocks.

As the tide was rising and wind and waves were blowing onshore, the boat was being lifted onto the rocks as seen in the photographs. The net can also be seen.

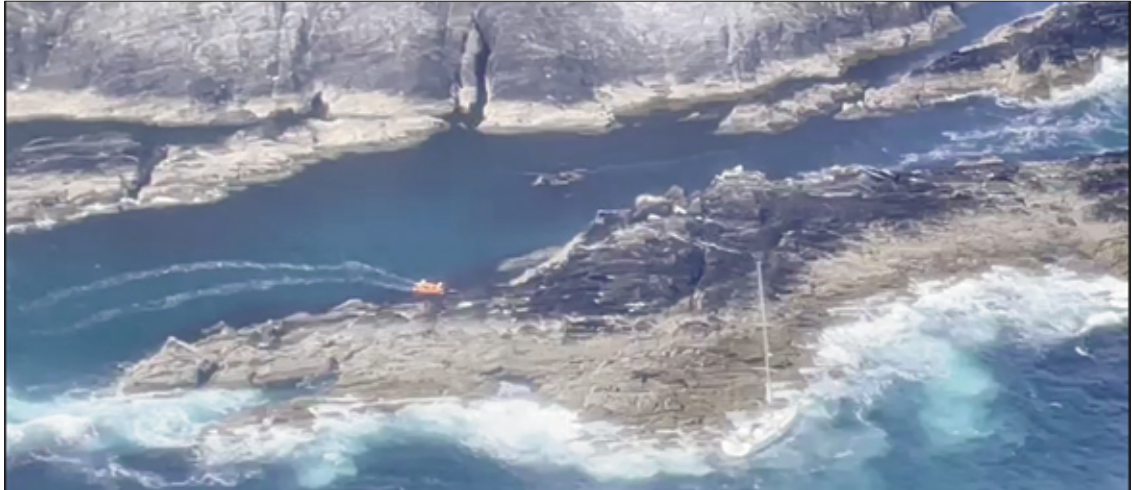
Screen shot from rescue helicopter R115 shows the yacht on the rocks and Y boat collecting crewmembers
