MCIB
Marine Casualty Investigation Board

**REPORT OF THE
INVESTIGATION INTO
THE COLLISION BETWEEN
CORK PILOT LAUNCH "SONIA"
AND SAILING YACHT
"MAUREEN" IN CORK HARBOUR
ON THURSDAY 27 AUGUST
1998.**

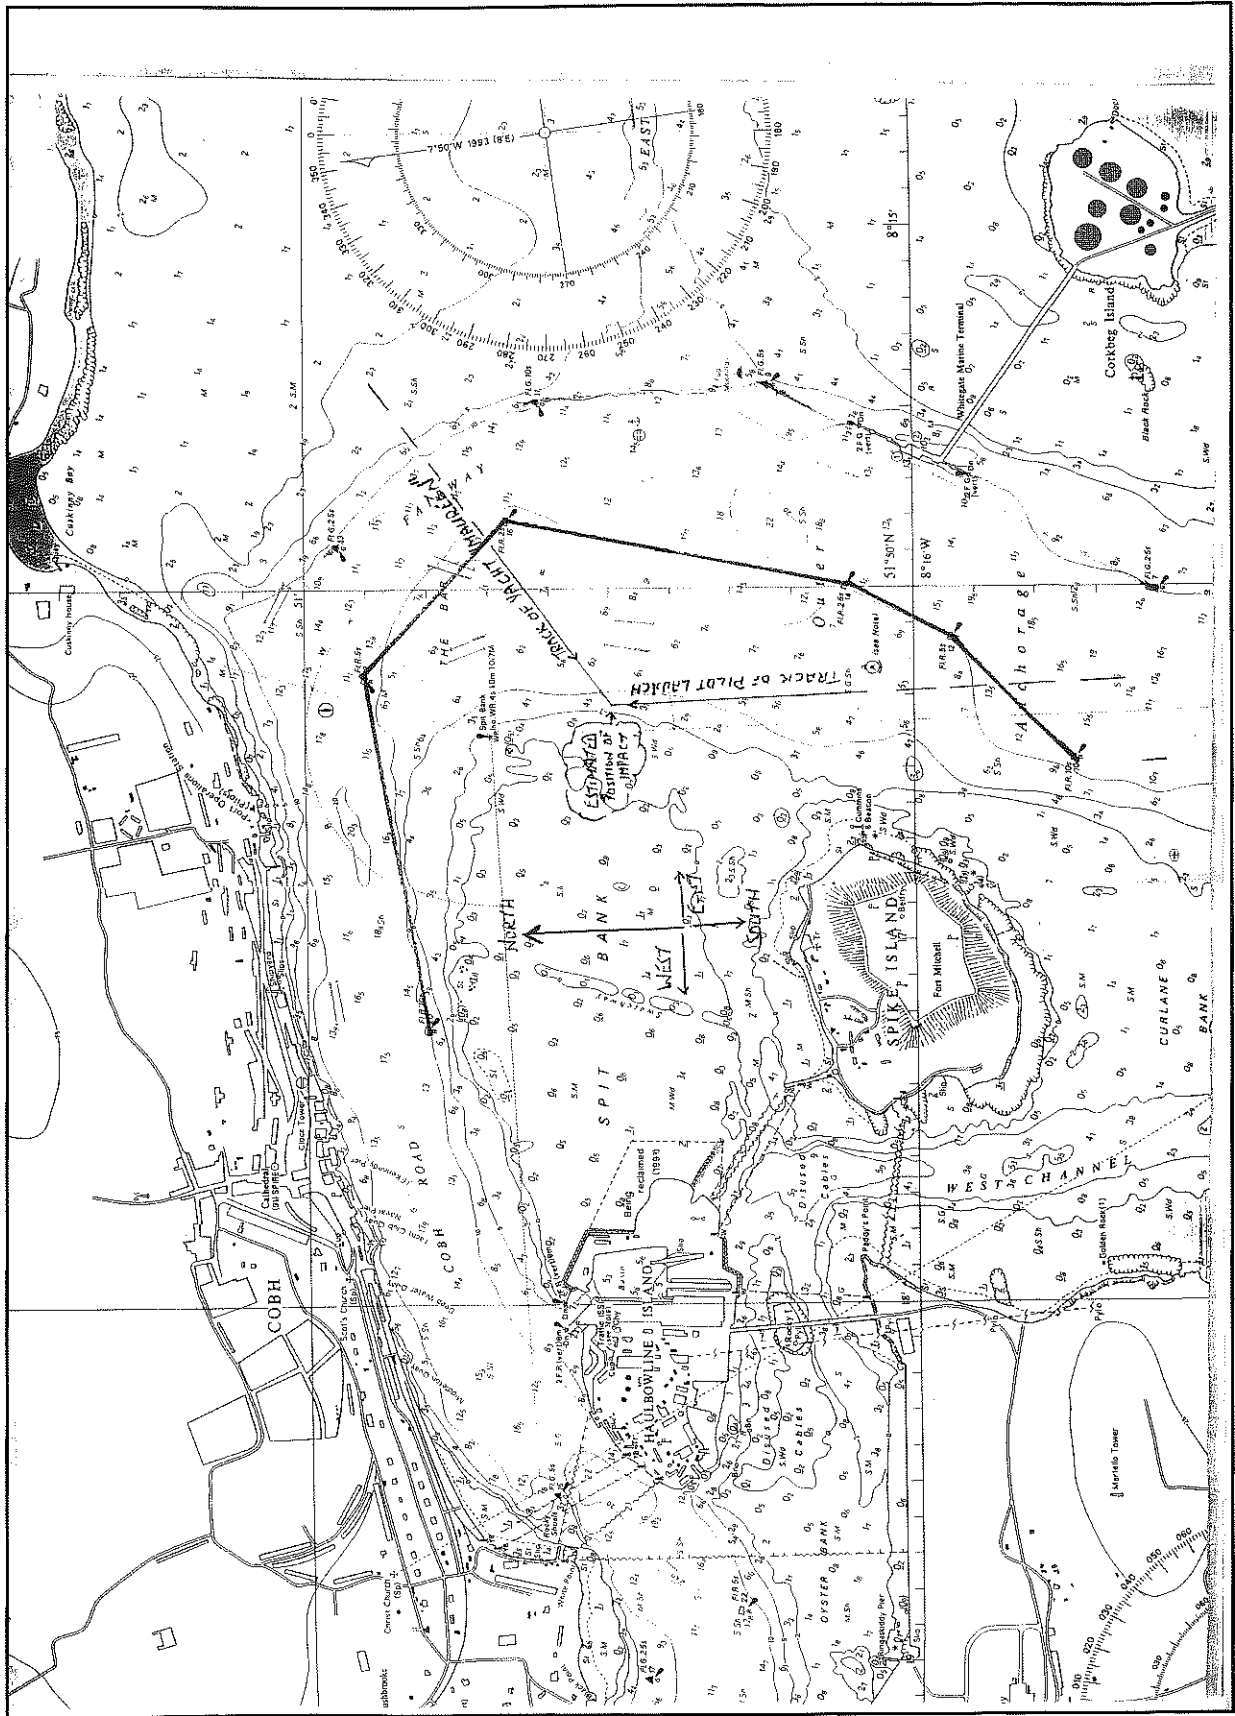
8.4 Chart with the estimated tracks taken by both vessels.

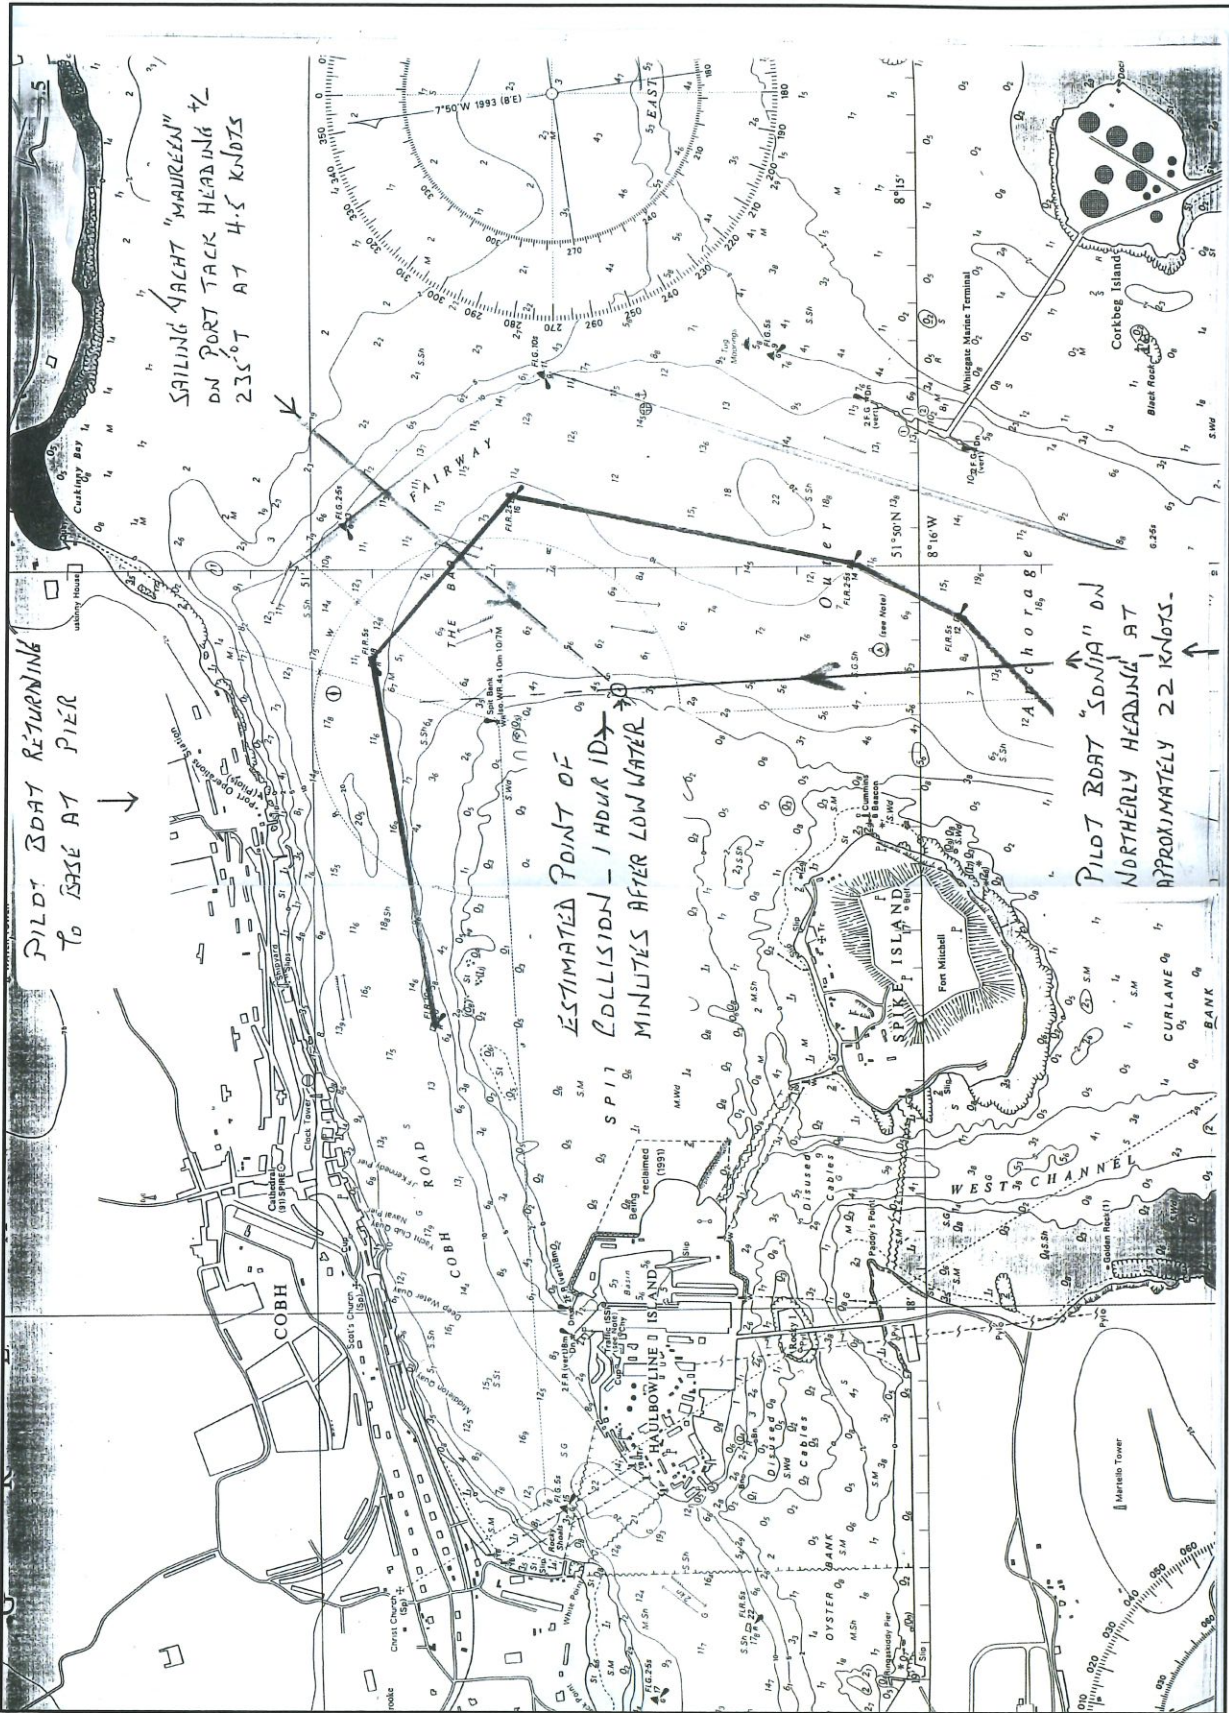
8.5 Estimated tracks of both vessels and Angle of Impact.

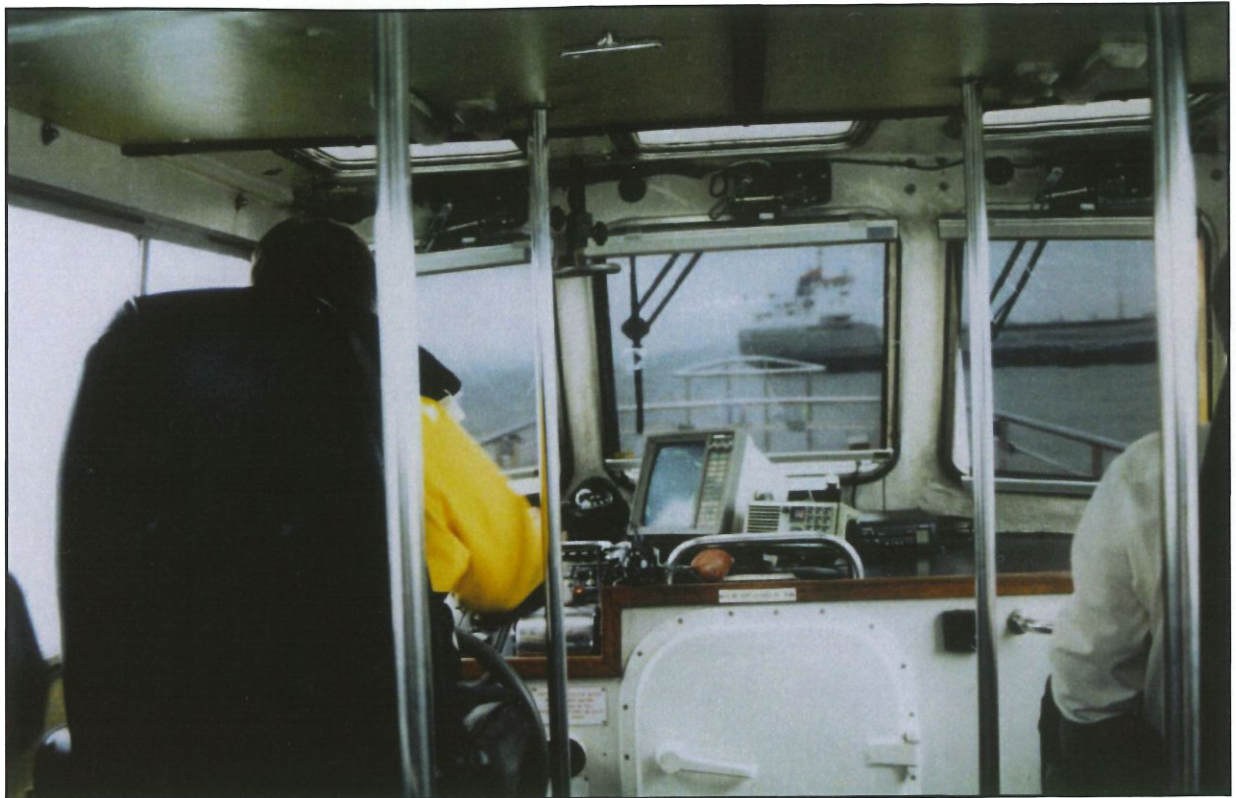
- 6.3.2 The crew stated that chairs are especially designed for truck drivers and that crews have in the past raised the problem of "the arc of visibility". There are three different sized windows with wide vertical support pillars fitted and the smallest window is right in front of the coxswains' position.

- (a) The above does not appear to have had any significant bearing on this accident particularly as the relative bearing of other vessels change and the lookout is only required to make the appropriate slight head or body adjustments in order to maintain full visibility.
- (b) The aspect of the design of the chairs is a matter for Port of Cork Company to address separately. Refer to Section 6.2.

8.6 Photograph showing front view through the window of "Sonia".

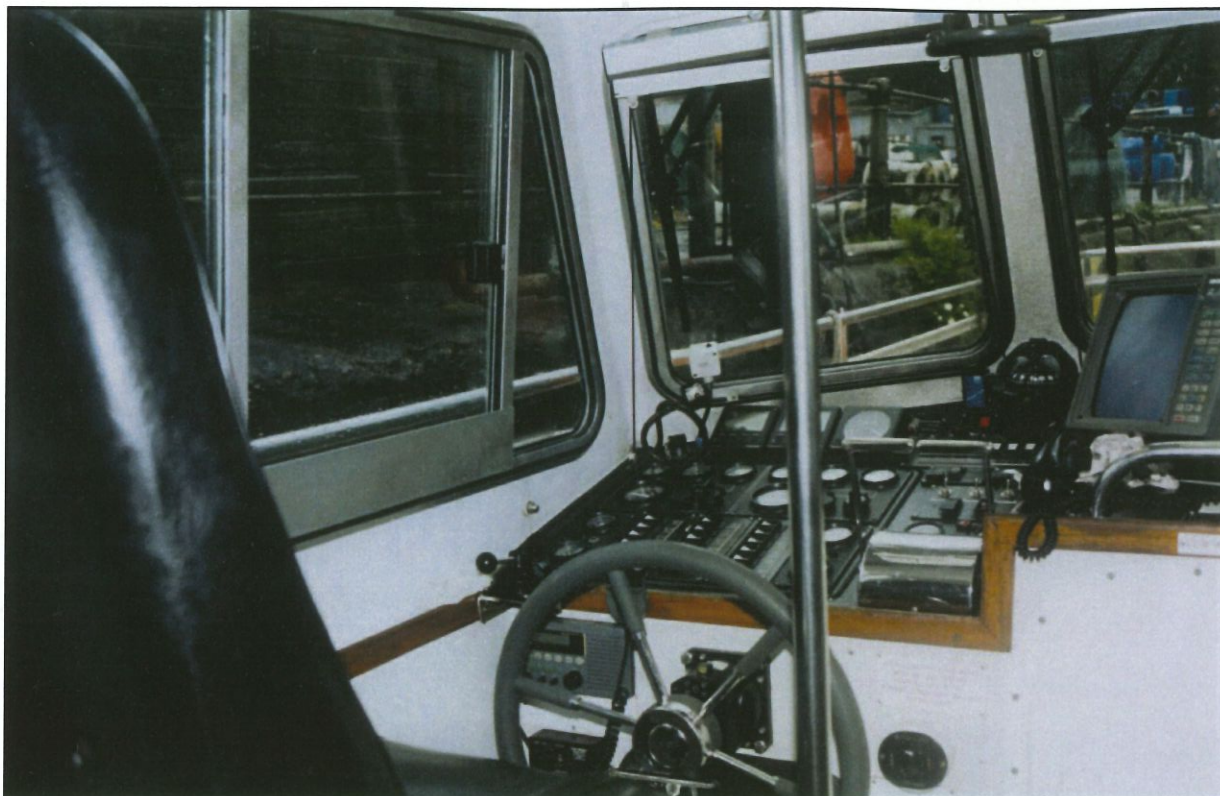
8.7 Photograph showing a closer view at the Navigators position.

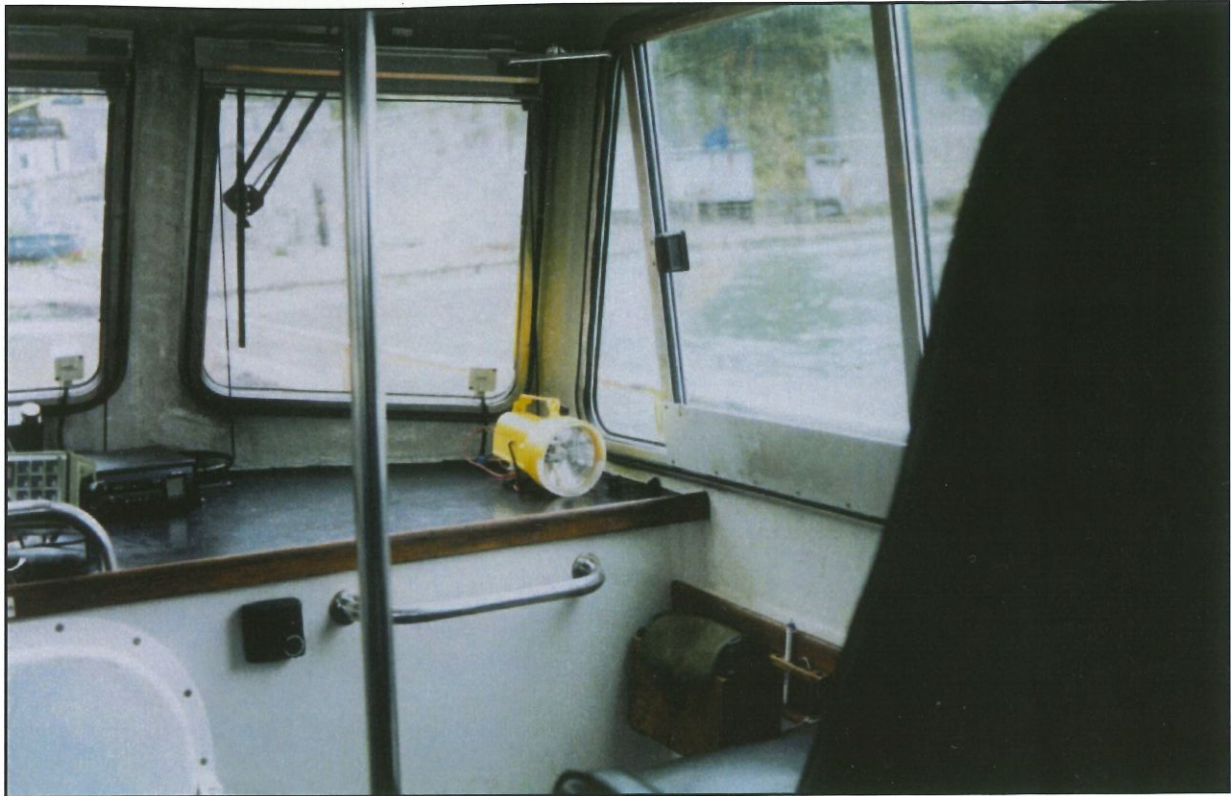
8.8 Photograph showing a closer view of the starboard crew chair.

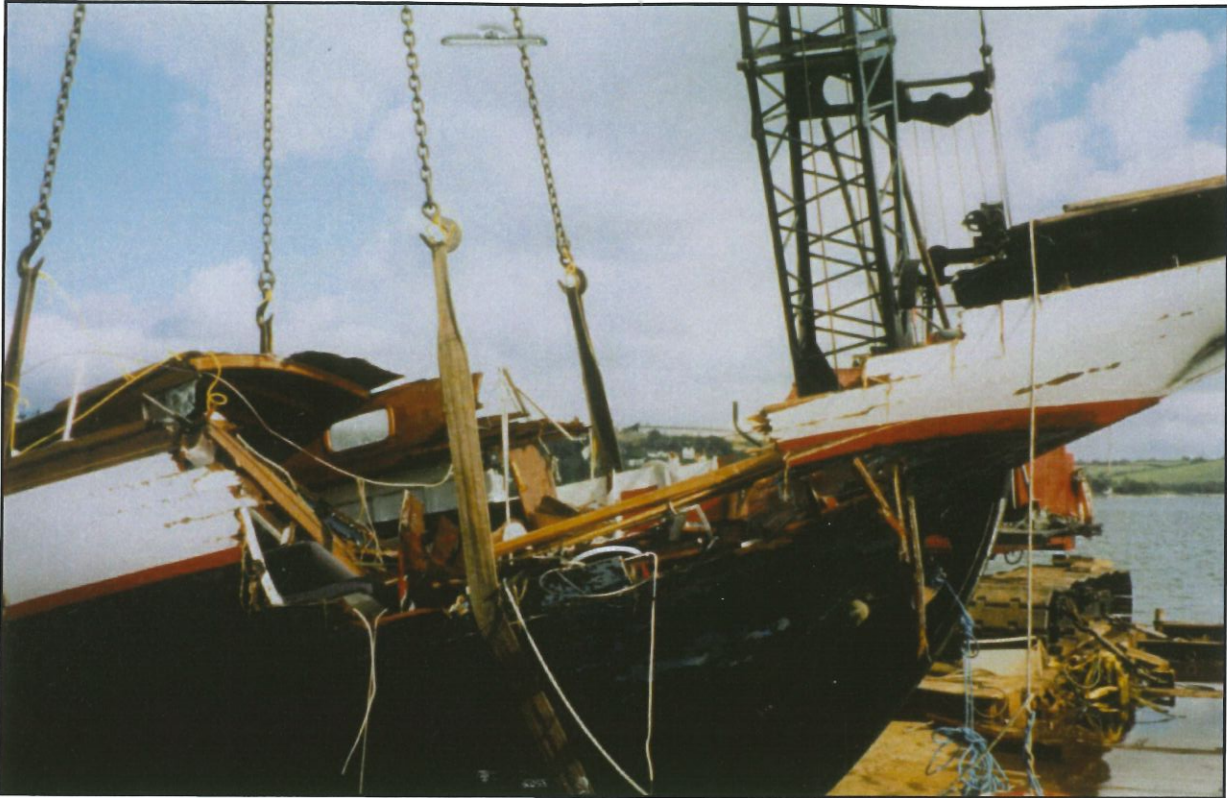
8.9 Photograph showing the damage to the port quarter of "Maureen".

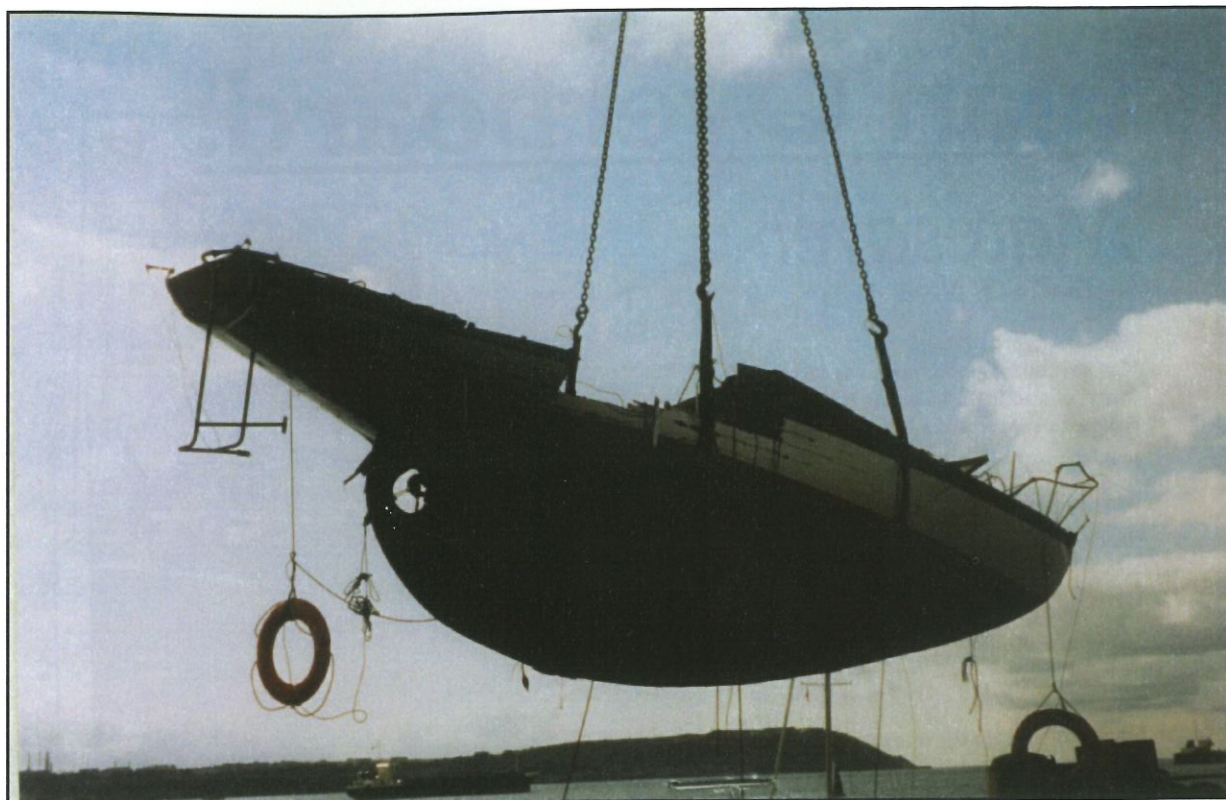
8.10 Photograph showing the damage on the starboard side of "Maureen".
