**REPORT OF AN INVESTIGATION
INTO A MARINE CASUALTY
INVOLVING THE SAILING YACHT
JELLY BABY
IN OR AROUND
CORK HARBOUR, CO. CORK
24 OCTOBER 2021**

**REPORT NO. MCIB/314
(No.5 OF 2024)**

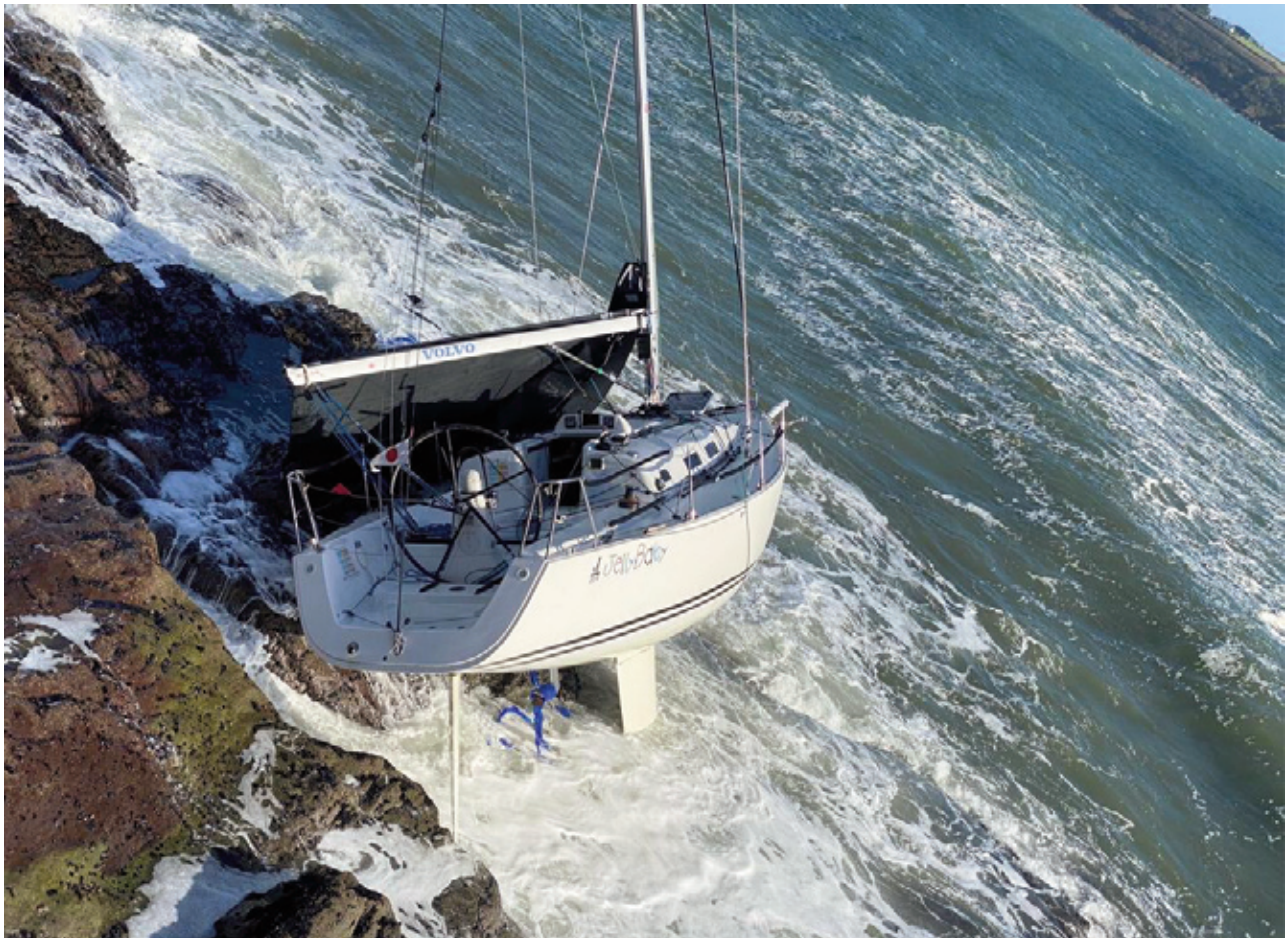
Appendix 7.2 Yacht Jelly Baby Aground on Bull Rock, Weavers Point

- 1.3 The Bowman was successfully recovered and the crew were uninjured, but the yacht remained aground until floated on the following flood tide and was then towed to Crosshaven. The damage to the yacht was such that its insurers declared it to be a constructive loss (i.e. deemed a total loss). The yacht was repaired and the MCIB was advised it sails on Belfast Lough.

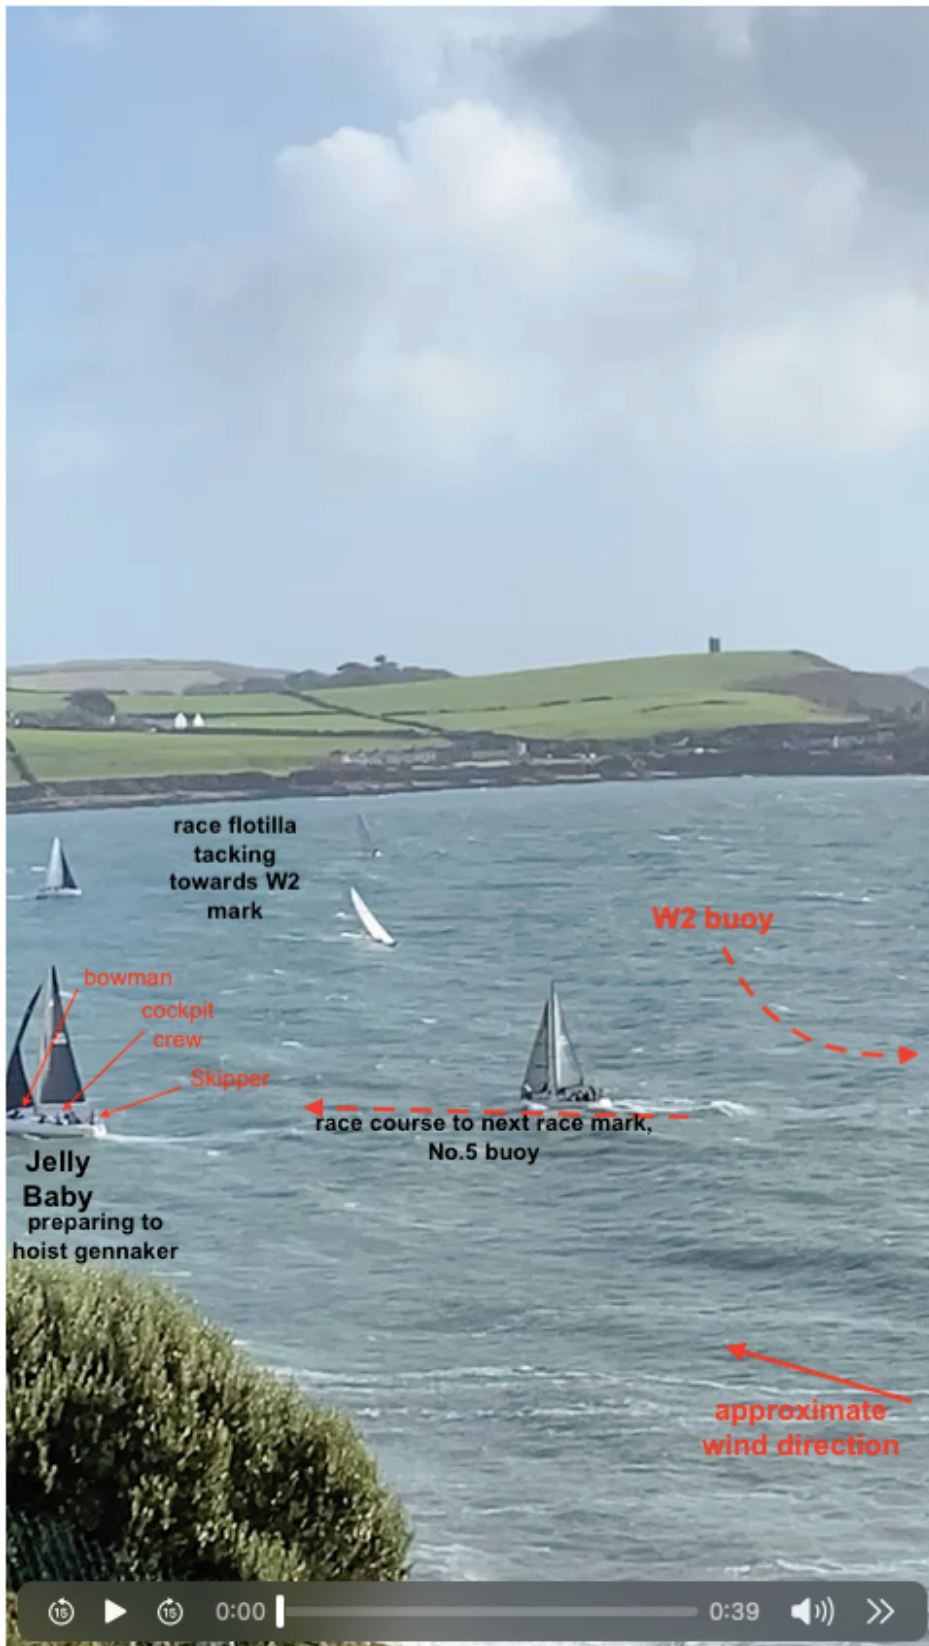
Appendix 7.13 Video Stills of Incident

Video Still 00/39 Crew preparing to hoist gennaker.

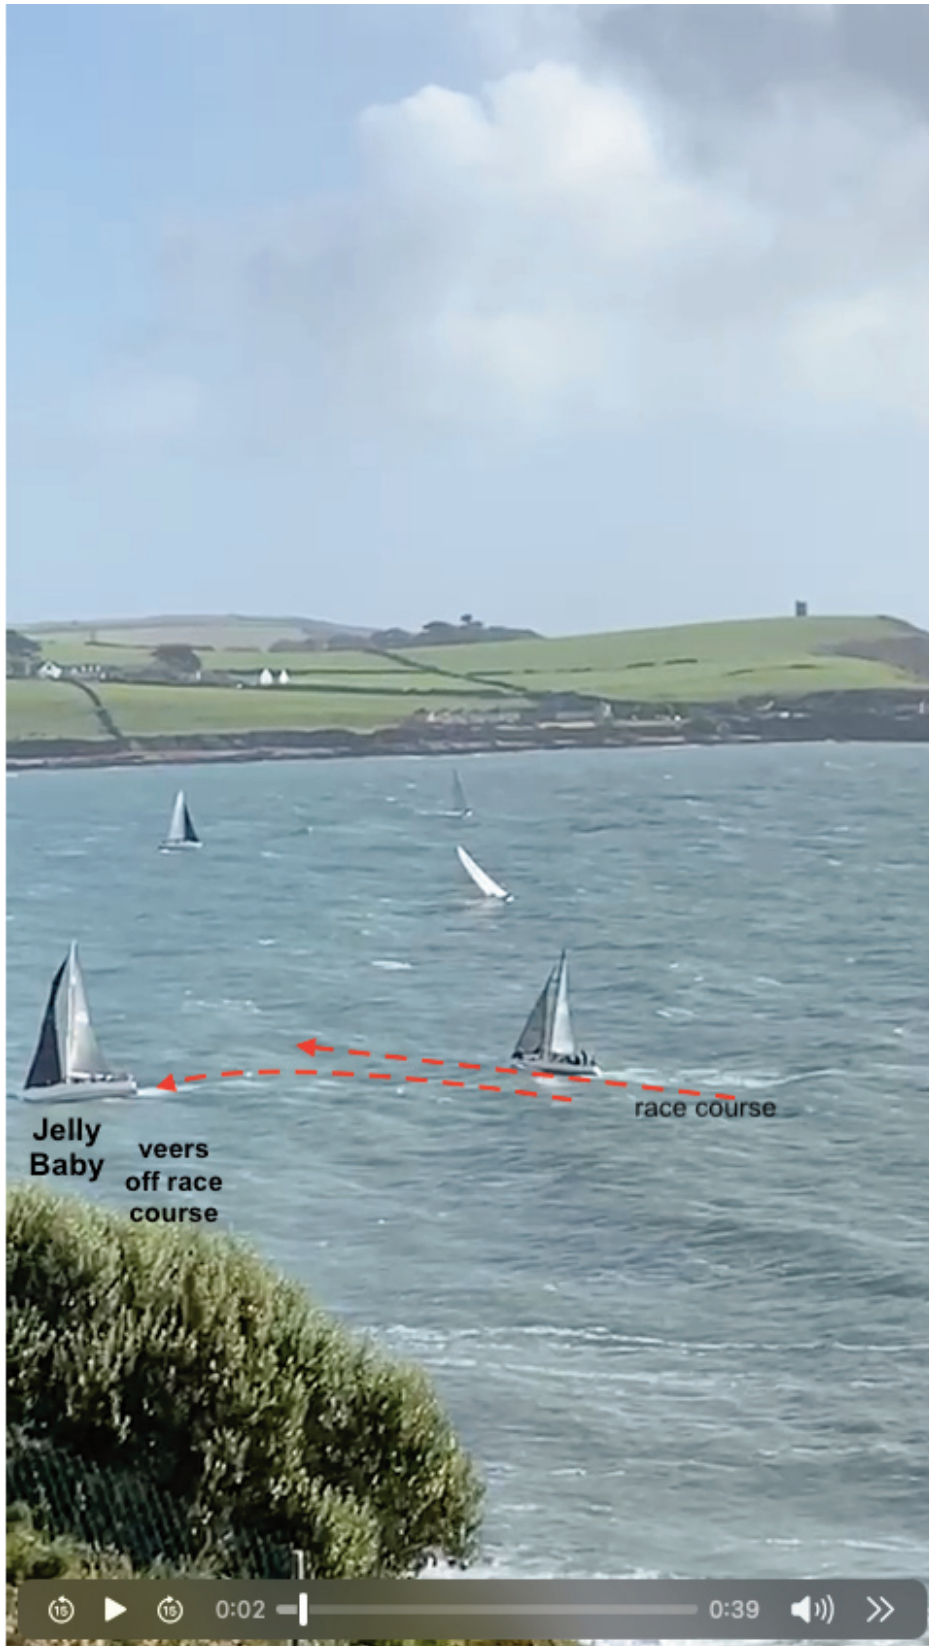
Appendix 7.13 Video Stills of Incident

Video Still 02/39 Yacht steers off course to port.

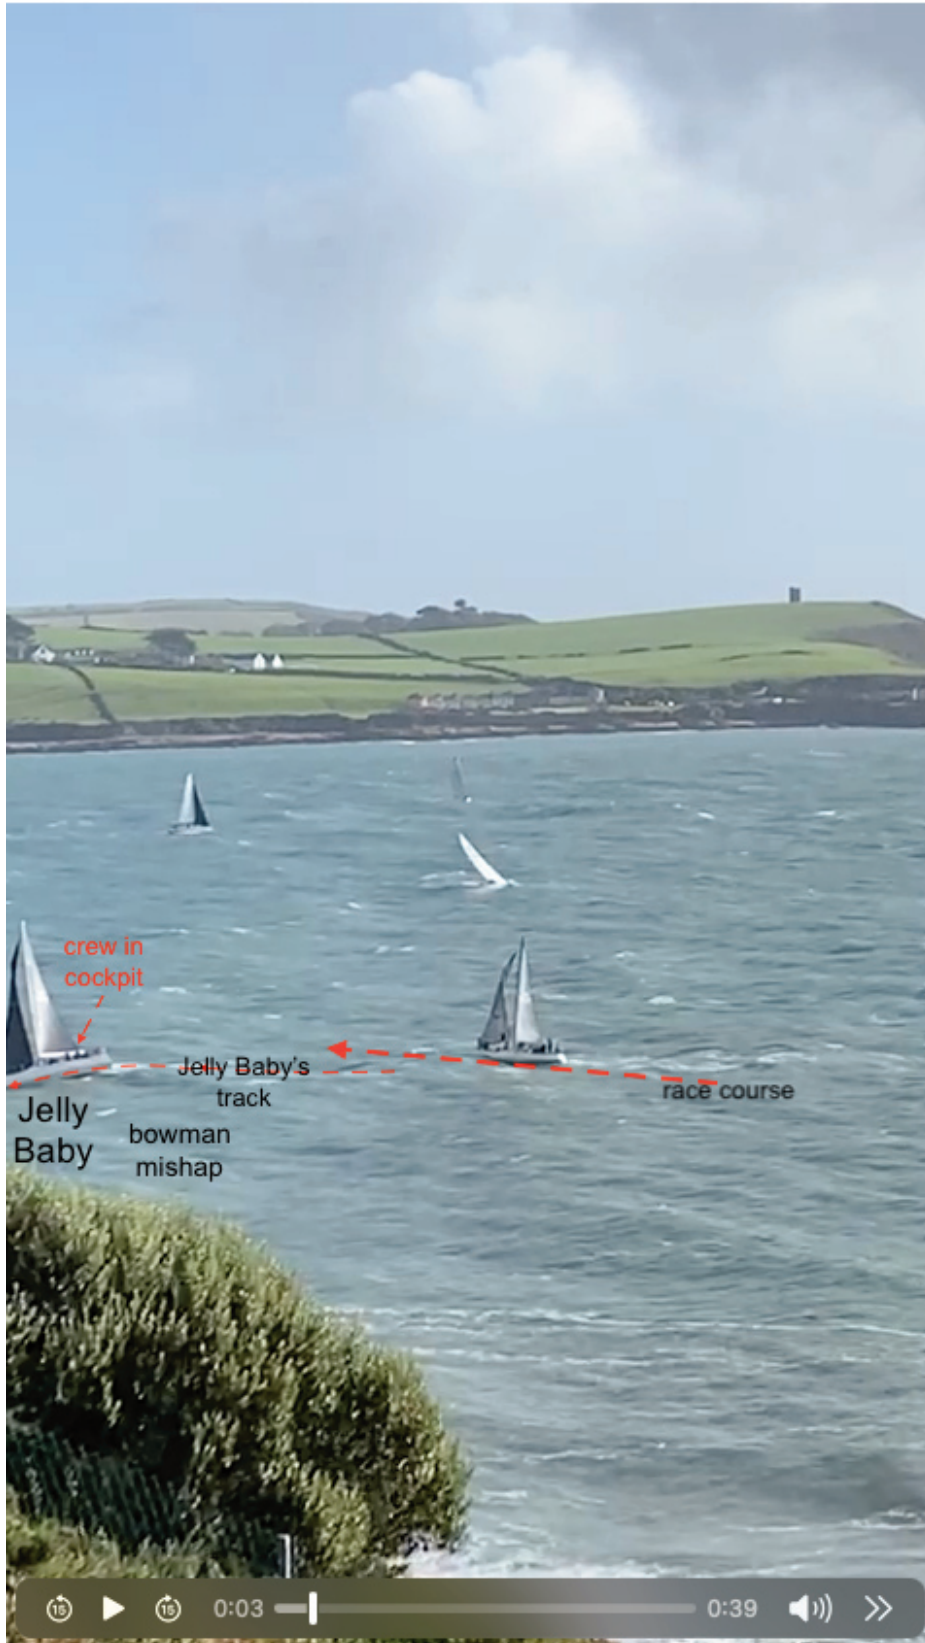
Appendix 7.13 Video Stills of Incident

Video Still 03/39 Bowman slips over the side.

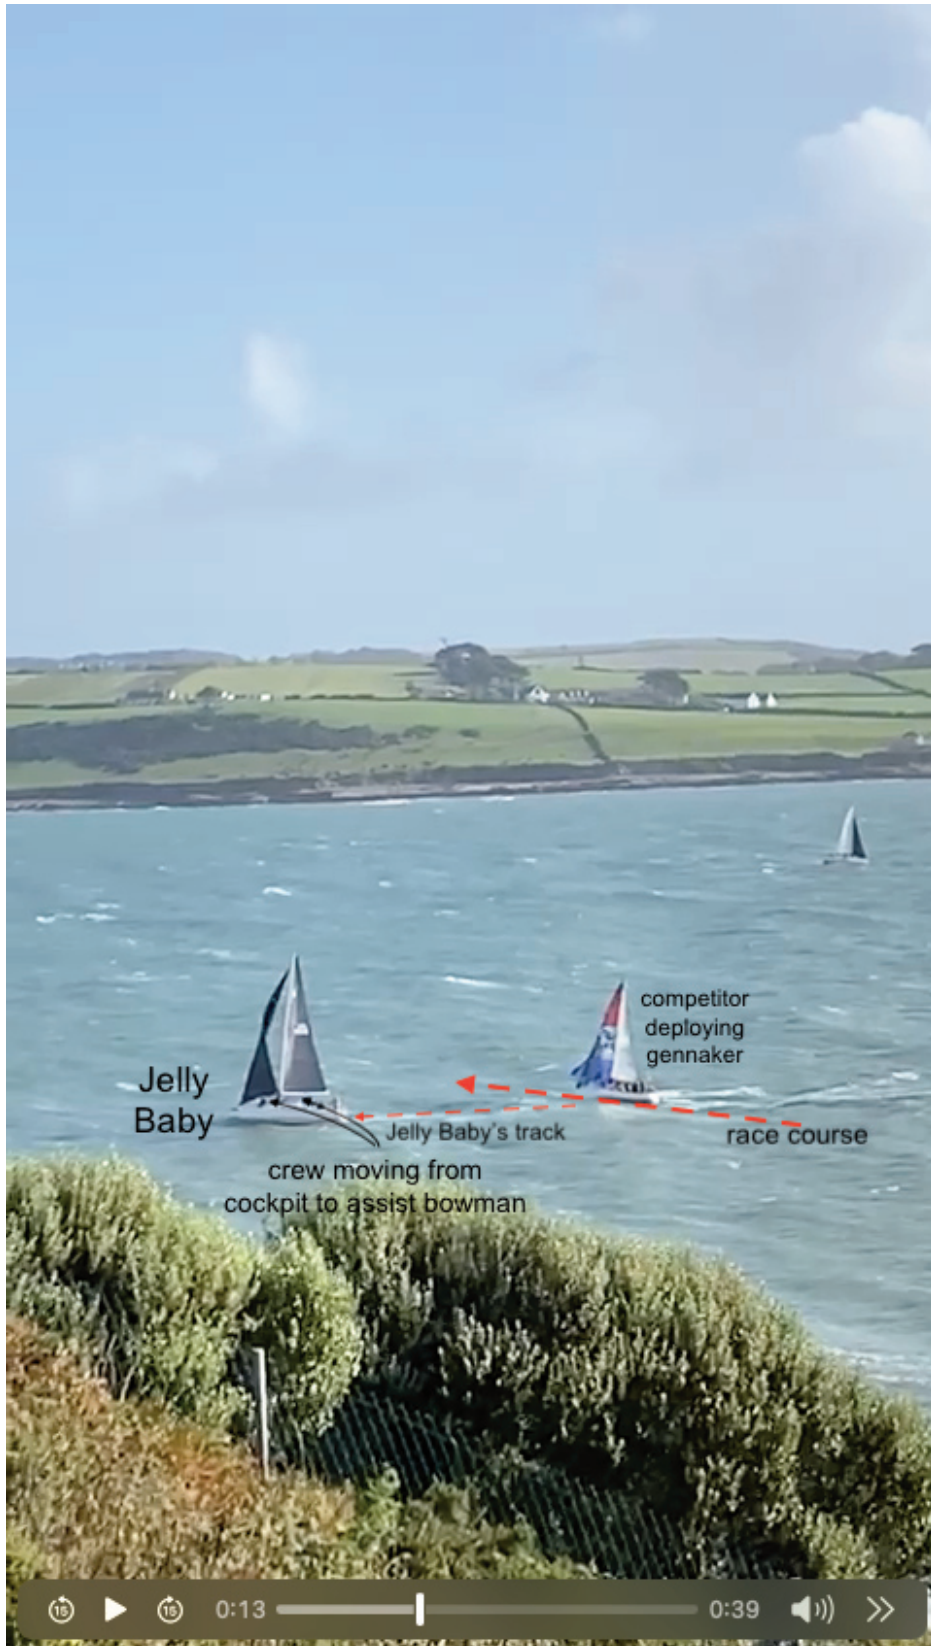
Appendix 7.13 Video Stills of Incident

Video Still 13/39 Crew moves forward.

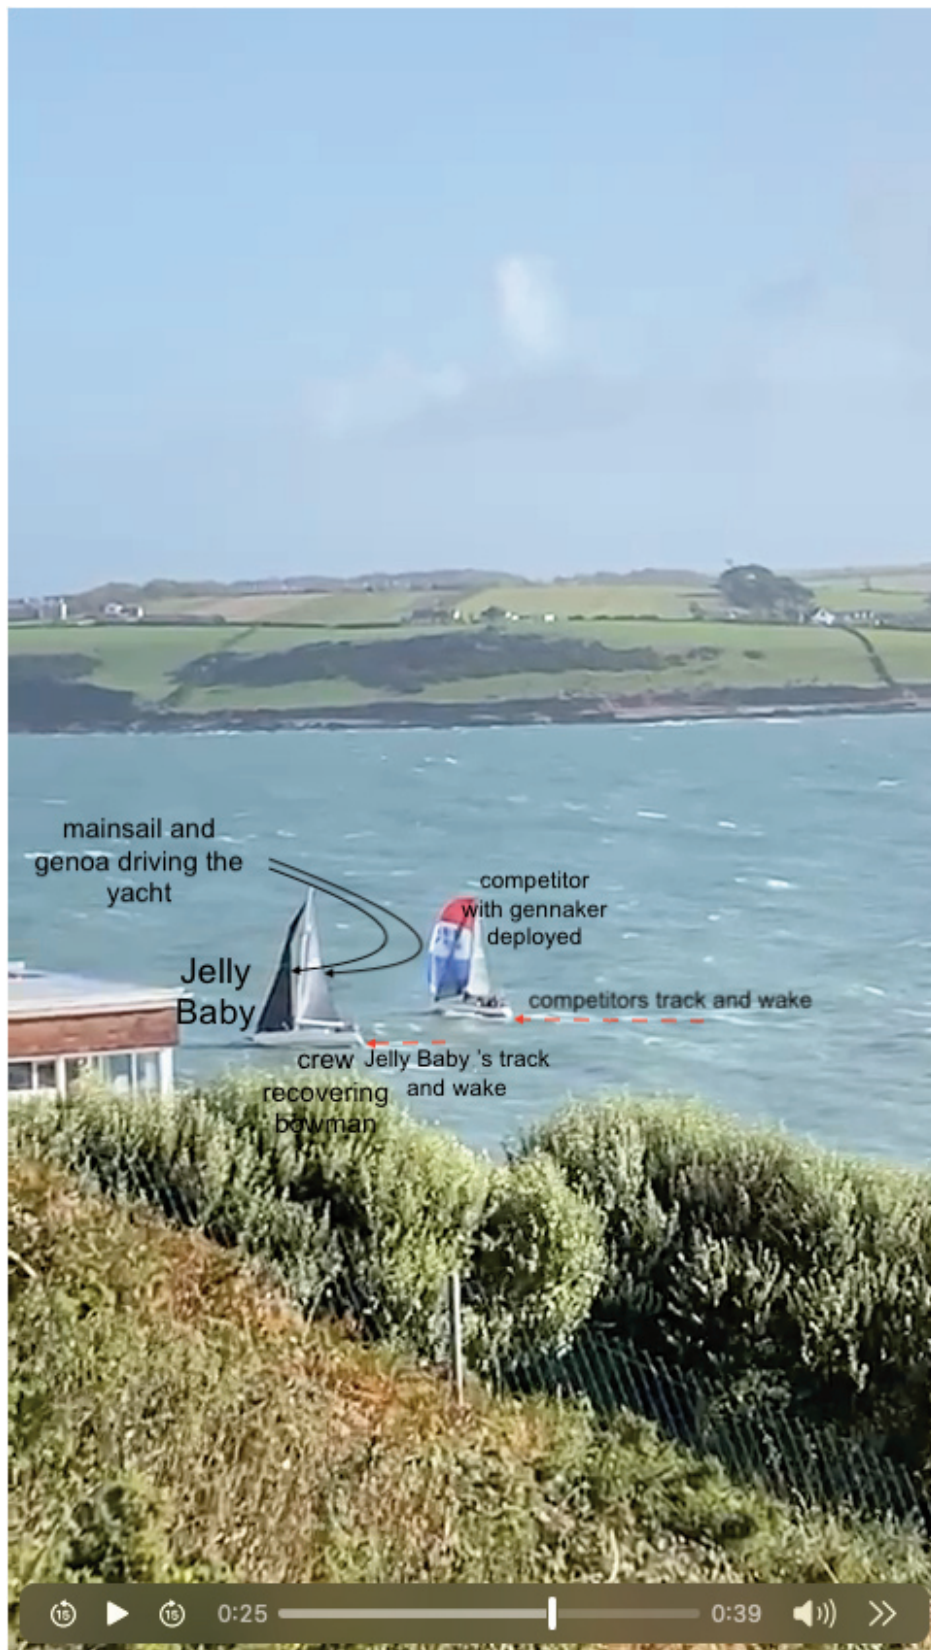
Appendix 7.13 Video Stills of Incident

Video Still 25/39 Gennaker over the side.

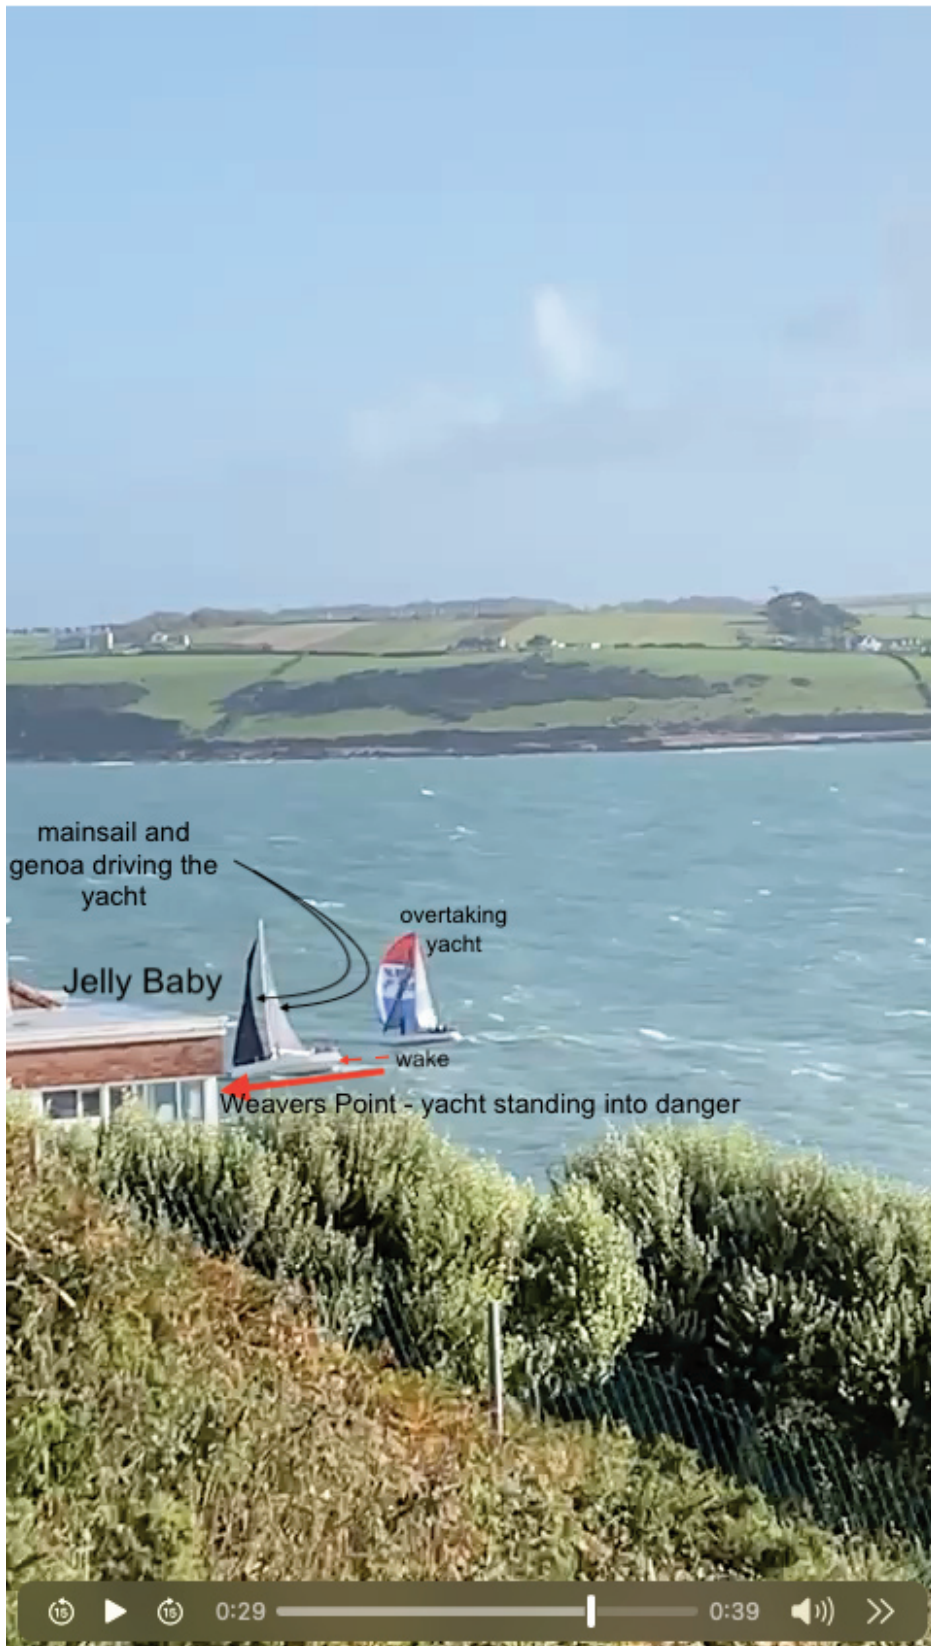
Appendix 7.13 Video Stills of Incident

Video Still 29/39 Yacht - standing into danger.

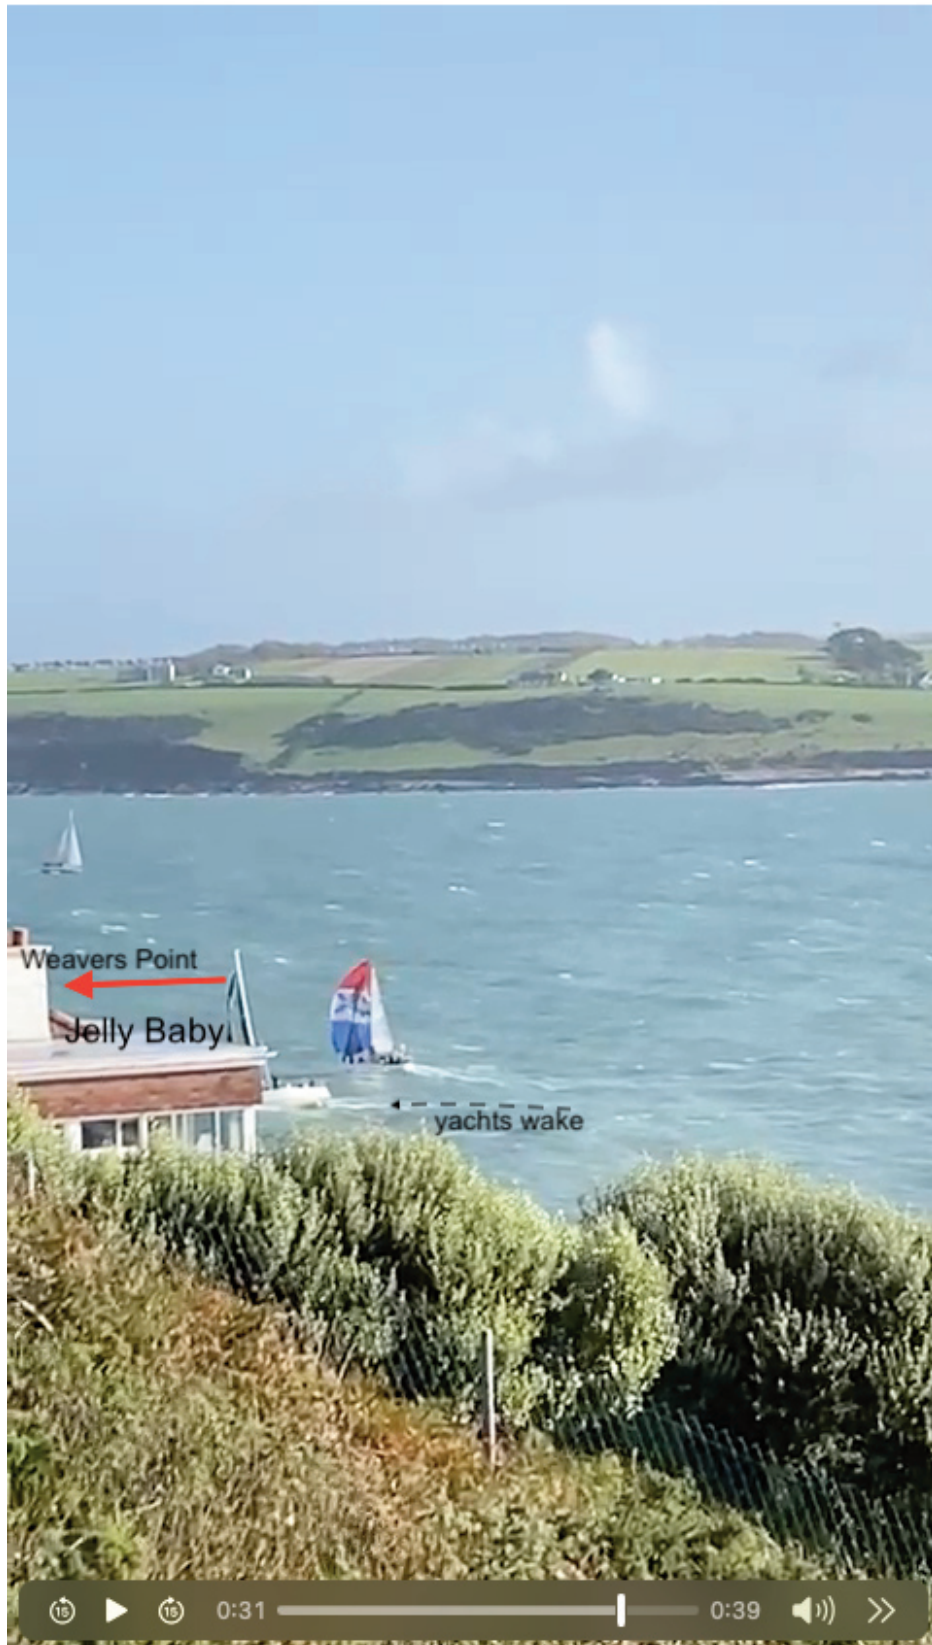
Appendix 7.13 Video Stills of Incident

Video Still 31/39 Yacht - not under control.

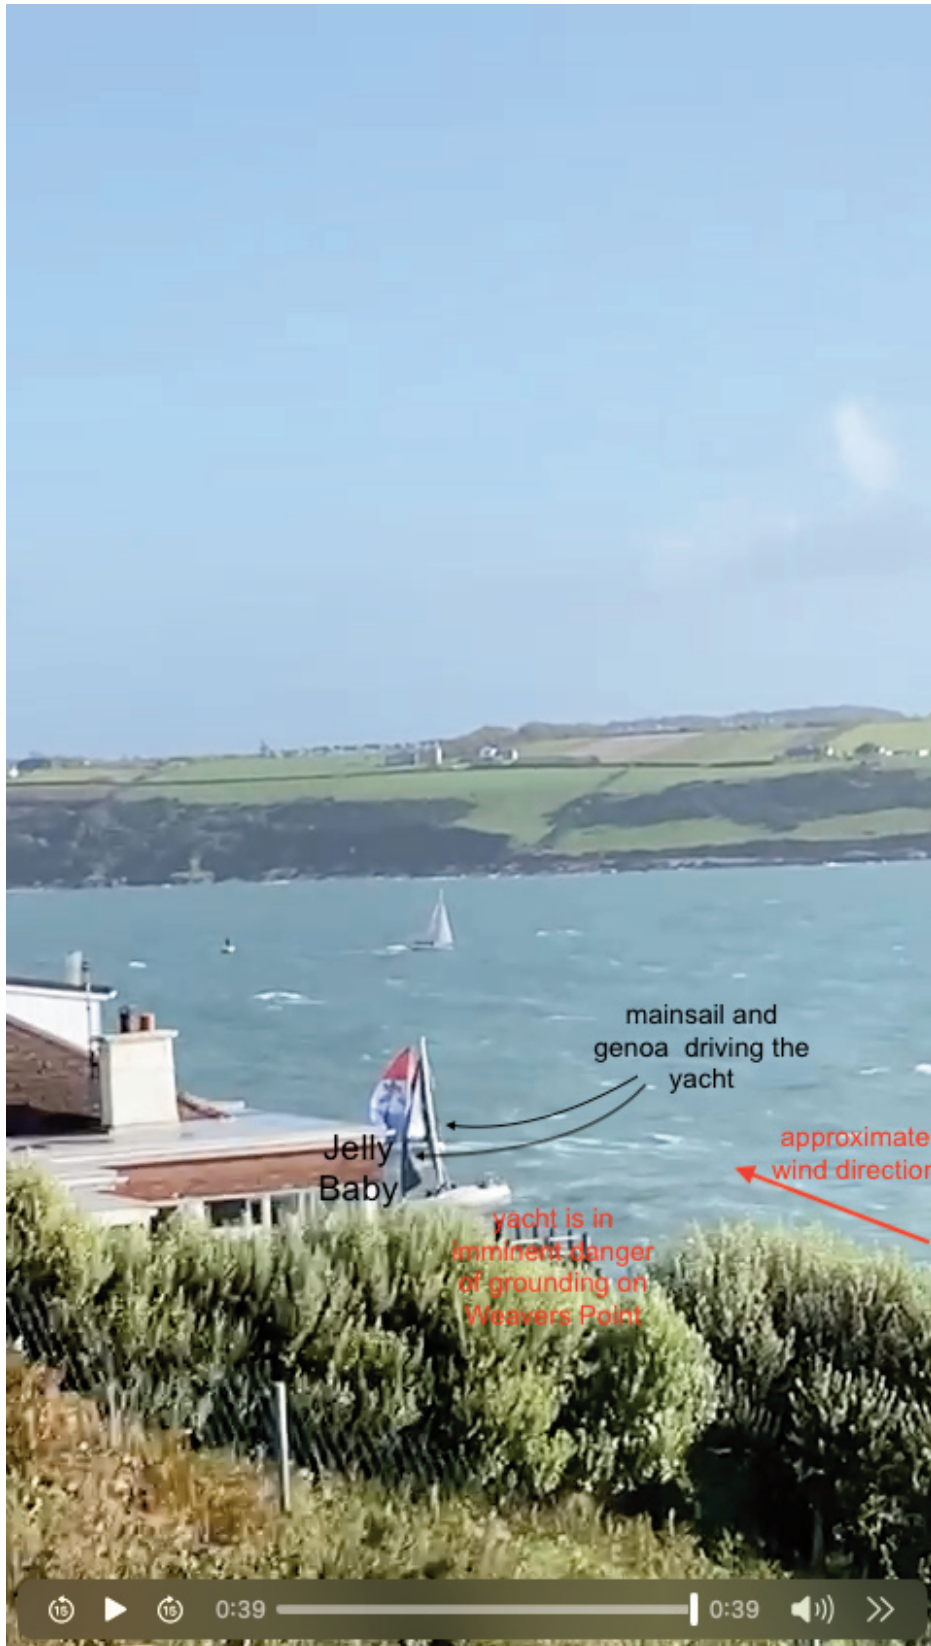
Appendix 7.13 Video Stills of Incident

Video Still 39/39 Yacht - imminent grounding.
