**REPORT OF INVESTIGATION  
INTO LOSS OF THE  
MFV "AINMIRE"  
30 MILES NW OF BUTT OF  
LEWIS, SCOTLAND  
ON  
29th APRIL 2010**

**REPORT No. MCIB/183  
(No.11 of 2011)**

Report MCIB/183 published by The Marine Casualty Investigation Board.  
Published 26th August 2011.

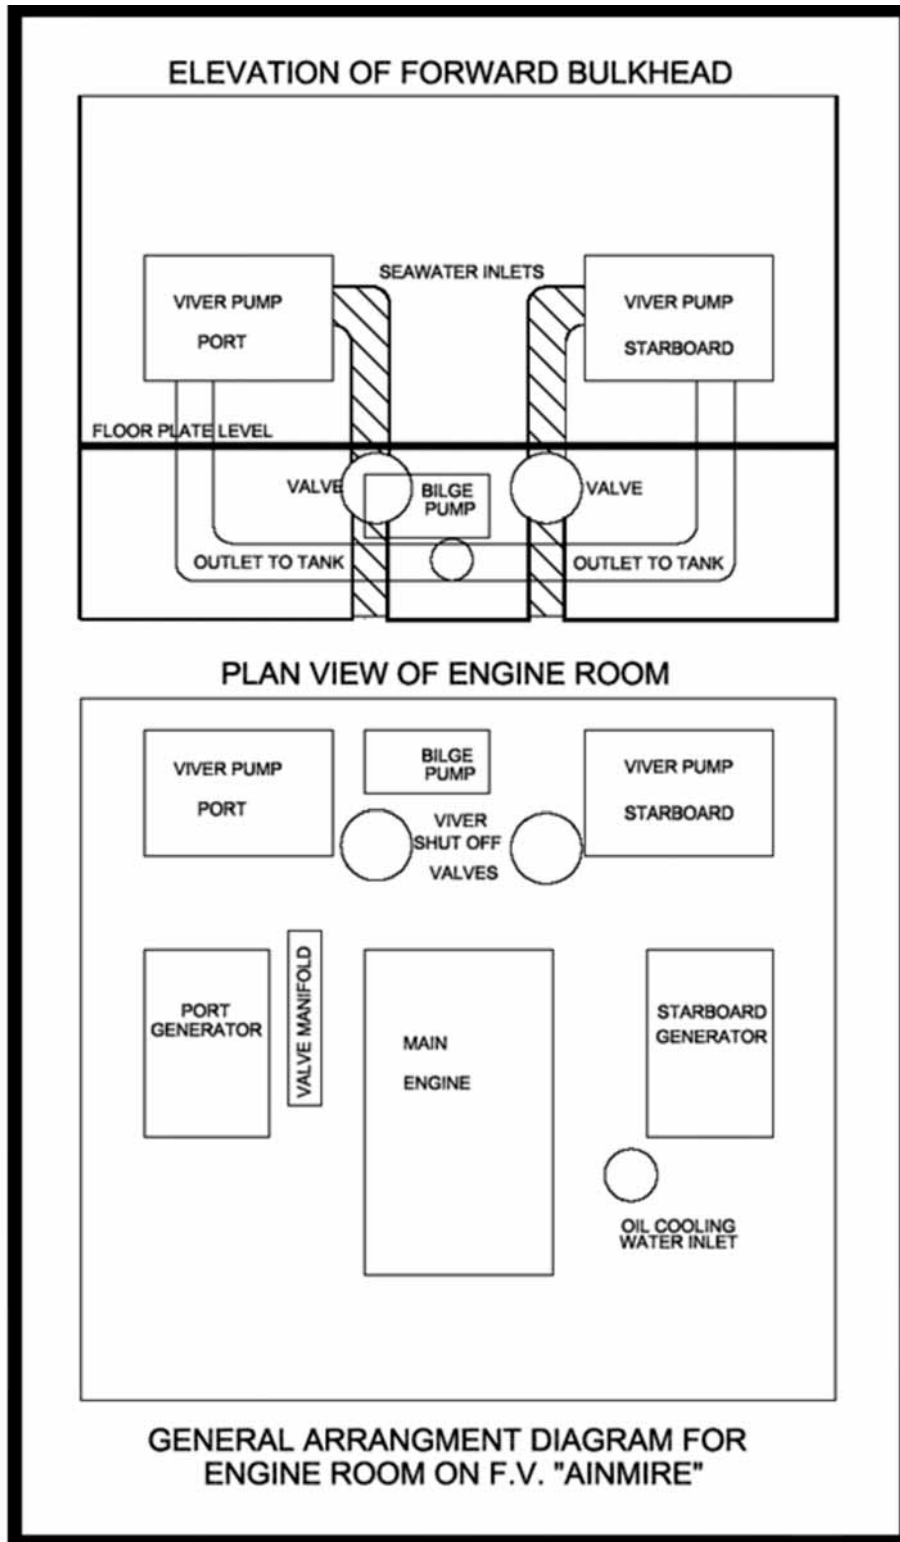
### Appendix 9.3 General arrangement of engine room.

2.3.3 The suctions for these pumps were in the forward end of the engine room and were 130mm (5 inch) diameter pipes which had butterfly valves about 600 mm (approx 2 ft) above the bottom of the hull.

- 2.4.3 There were two electric pumps for the Viver system with 130mm (5 inch) diameter seawater inlets at the forward end of the engine room. The butterfly valves were approximately 600mm above the shell plating. There were grids on the outside of these pipes bolted to the hull.

- 2.4.4 The other engine room seawater inlet was a 76mm (3 inch) diameter inlet at the starboard side of the engine for the hydraulic oil cooling.
- 2.4.5 There was an electric bilge pump with suction through a valve manifold so various compartments could be pumped out. A second general service pump could also be connected to this manifold. Both these pumps were electrically powered and located just underneath the engine room floor plates. There was no manual pump or pump outside the engine room.

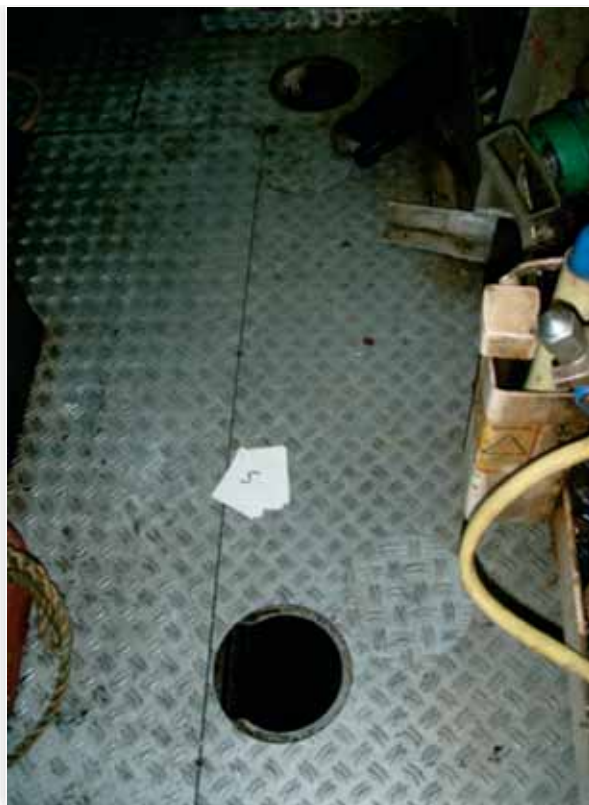
(a) Access to the port & starboard valves for VIVER suction.

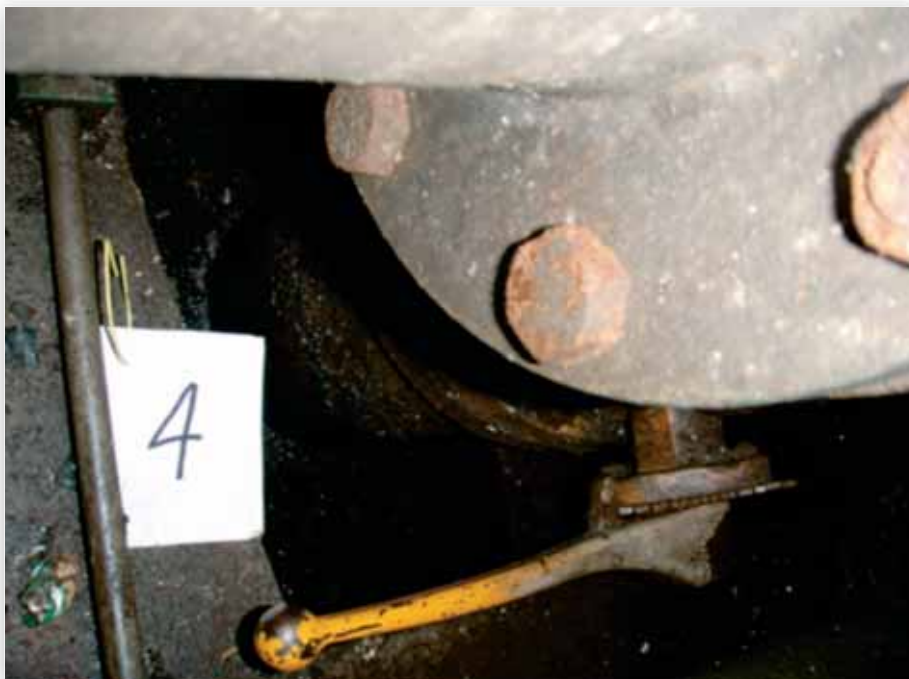
- The Viver inlet pipes had butterfly valves about 600 mm inboard of the hull connection. Failure of one of these sections of pipe would have resulted in the inrush of water experienced.

- The pipework between the hull and the valves on all 3 fittings was constructed of galvanised steel and had never been renewed during the life of the vessel (17 years). These pipes had seawater passing through them continuously when the vessel was at sea. The inlets were regularly cleaned due to build up of marine growth, and this fouling could have damaged the galvanising and left the steel exposed. There is no record that the thickness of these pipes was measured by ultrasound or other means.
- There was corrosion in the welds in the Vivier tank and anodes were fitted in the tank. Sections of the piping on the high pressure side of the Vivier system were replaced due to corrosion over the years with heavy grade stainless steel pipe, particularly on the bends. This would indicate that corrosion was a

potential problem in the system, particularly along welded joints.

(b) VIVER suction valve showing inlet pipe to hull.

- 8.1 Large sea water inlets in the engine compartment of this type of vessel leave it vulnerable to severe flooding if they fail. These pipes should be checked for signs of corrosion annually, particularly around the welded joint at the hull. Periodic ultrasonic thickness testing of the pipes between hull and valve should be considered.

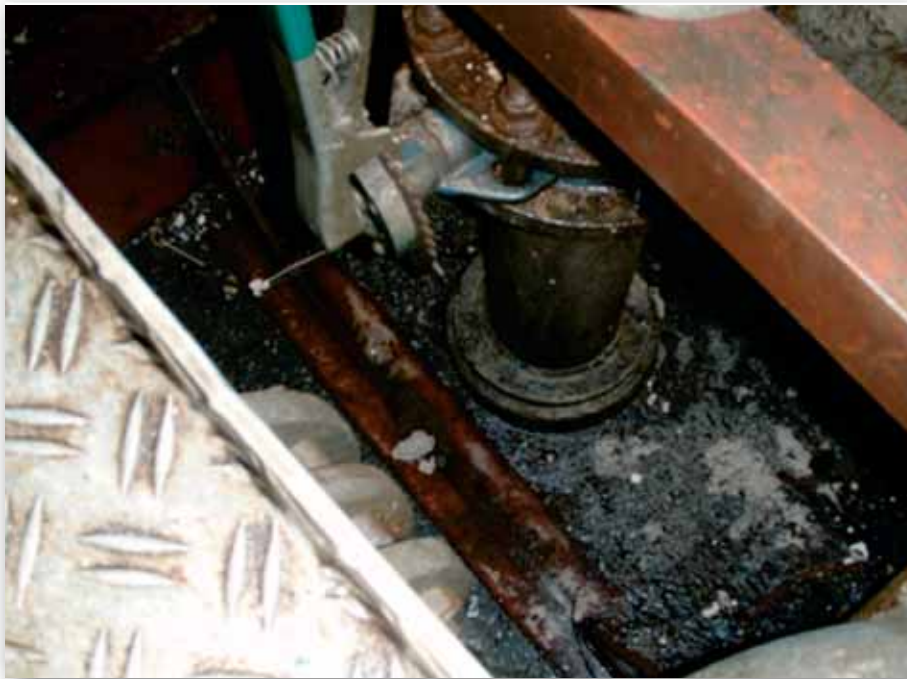
- The Hydraulic oil cooling water inlet pipe had a valve about 400 mm inboard of the hull. Failure of this section of pipe would have resulted in the inrush of water experienced.

(c) The hydraulic oil cooling water inlet.

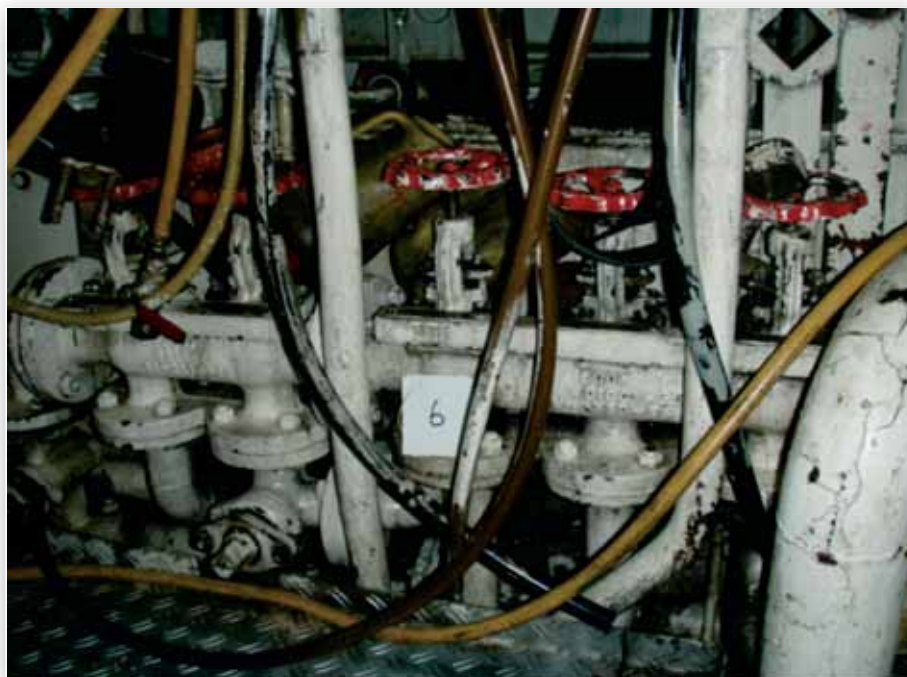
- 4.3 Mr. Ross Classon then started the electric bilge pump and opened the engine room suction valve on the manifold. The bilge pump was located at the forward end of the engine room just under the plates and was under water at this point.

(d) Bilge valve manifold.

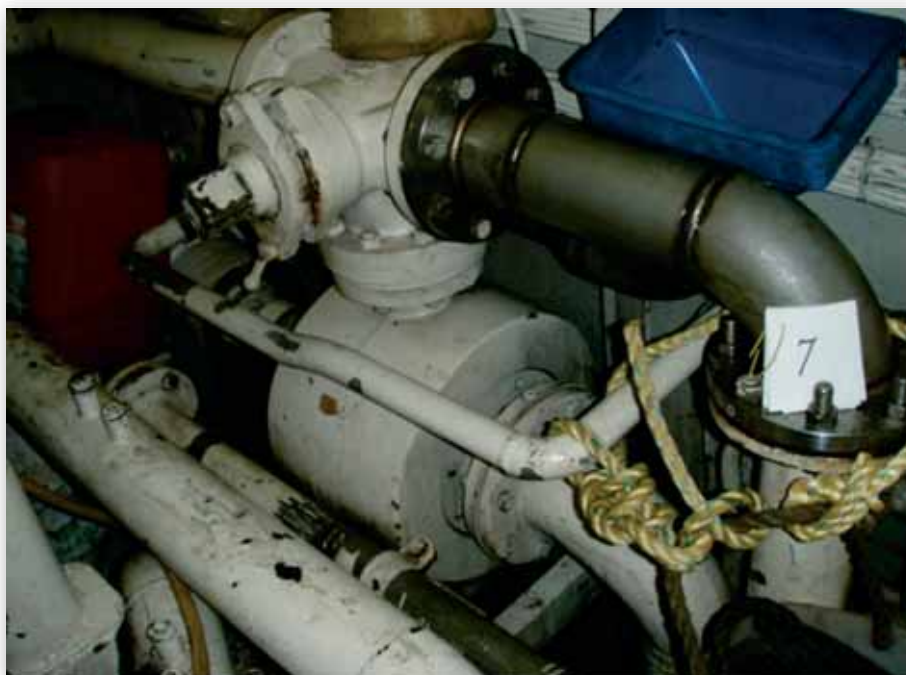
(e) IVER Pump (note stainless outlet pipe on bend).

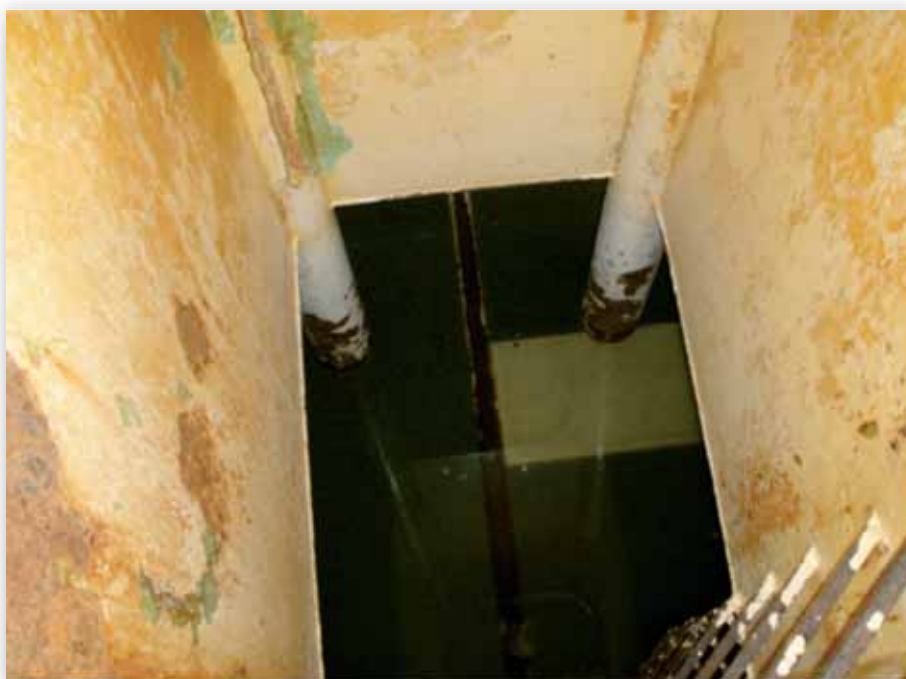
(f) VIVER Tank.
