**REPORT OF THE  
INVESTIGATION INTO THE  
FAILURE OF THE PILOT  
LADDER FROM THE  
M.V. "ALEXIA"**

Published by The Marine Casualty Investigation Board  
18th April 2005

**EXAMINATION, SAMPLING AND TESTING BY  
REALISATION METHOD TO DETERMINE ROPE  
RESIDUAL STRENGTH AND LIKELY CAUSE OF  
FAILURE of PILOT'S LADDER from  
'MV ALEXIA'**

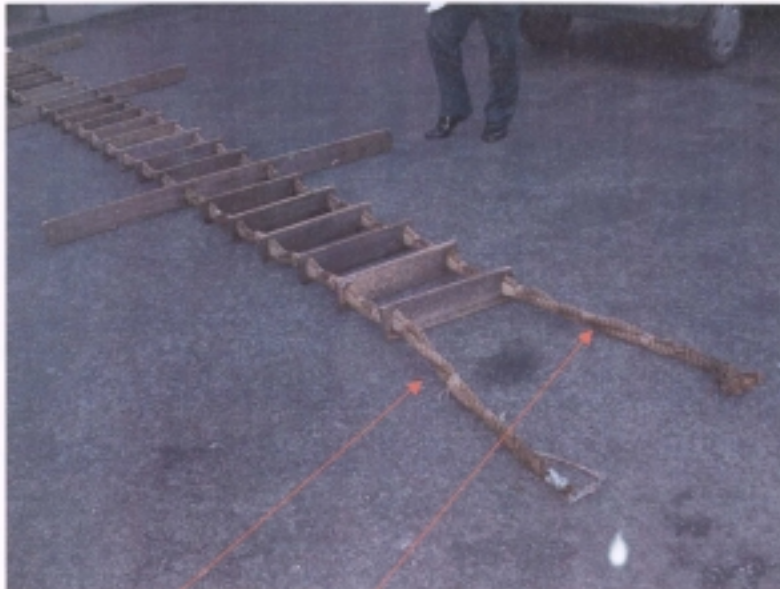
Photo 1 General view of ladder part

Photos 1 –5 are photographs of the ladder supplied by DepCMNR. From these photographs and subsequent inspection by TTI, the ladder was found to have failed just above the splices in both legs.

The first observation is that, from Photograph 1, the failure point on each leg are the same distance from the uppermost ladder span. From Photograph 3, the length from the shackle to the failure point of each leg is different. It may also be seen from Photograph 3 that the free end emerging from each knot is also different, and corresponds to the shackle-to-failure point difference; ie the shorter free end has a longer shackle-to-fail point length..

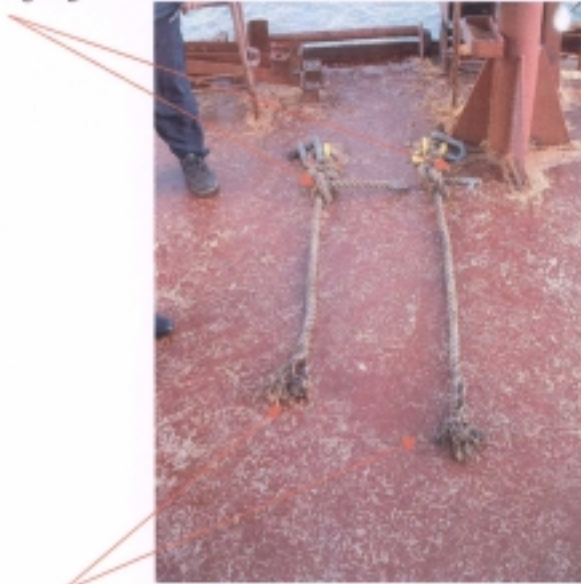
**Photo 3 Securing ropes laid on deck**

Differing length of free ends

Differing lengths from shackle to fail point, corresponding to difference of free end length. Left hand securing rope is Item A, right hand securing rope is Item B, identified by the appearance of the free end end taping.

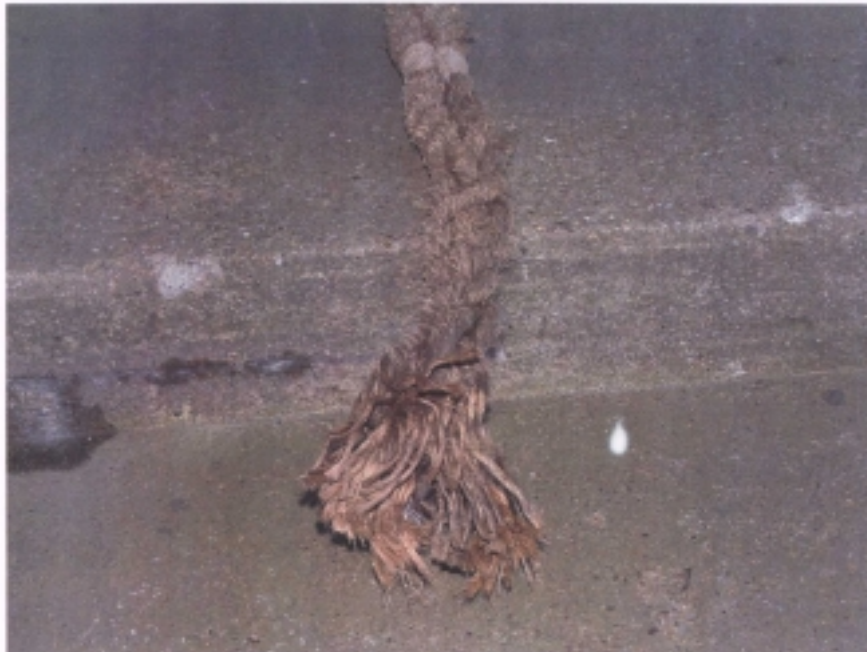
**Photo 4** Close up of failure zone, Item A'

The fact that both rope legs failed just above their respective splices suggests very strongly that flex fatigue and/or stress raising has critically added to the deterioration in the rope at these very localised positions. TTI has seen instances of these mechanisms causing rope failures just beyond splices in other investigations.

The second observation is that the failure zone in both legs is just above the splice.

Photograph 4 is a close up of the failure zone in the ladder part, Item A'

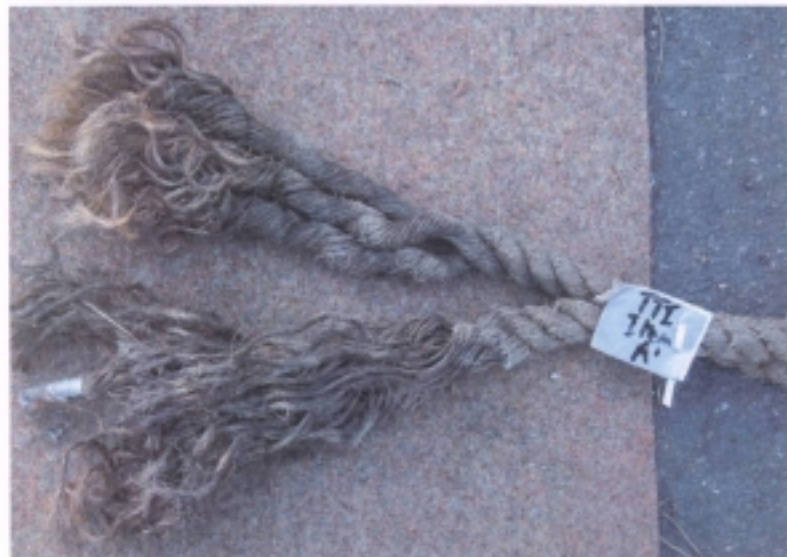
**Photo 8**

Photograph 8 is a close-up of the splice/fail zone of Item A'

Evidence of external abrasion is seen, and this was a constant finding throughout the whole visual examination. Photograph 9 shows the splice/fail zone for Item B'

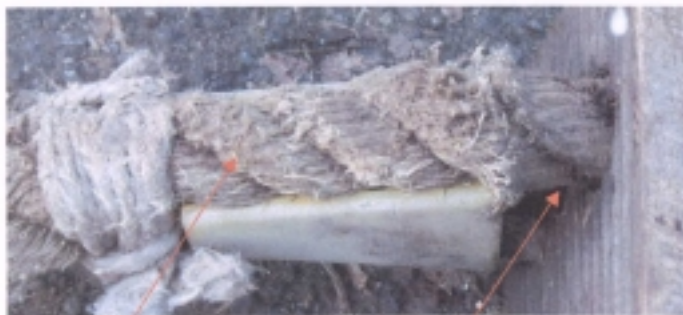
**Photo 10**

Photograph 10 is a close up of a ladder span where the rope was threaded through it. It can be seen that there is surface abrasion of the exposed rope between the spans a loss of rope material associated the span eye, where there has been repeated relative movement between the span and the rope.

Surface abrasion

Loss of rope material due to repeated rubbing of ladder eye

This photograph is representative of the condition of the entire ladder part.

In the ladder part of the assembly, there were two sources of damage, one being general external abrasion, the other being localised damage caused by repeated rubbing of the ladder span eyes on the rope threaded through them.

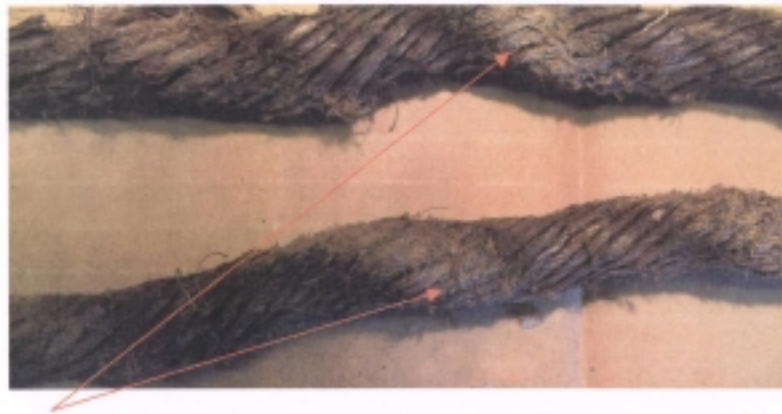
**Photo 11 Strand from Item A**

Photograph 11 is a close up of the a typical strand, taken from securing rope part Item A.

Abrasion is clearly seen where the surface of the strand has been to the outside of the rope

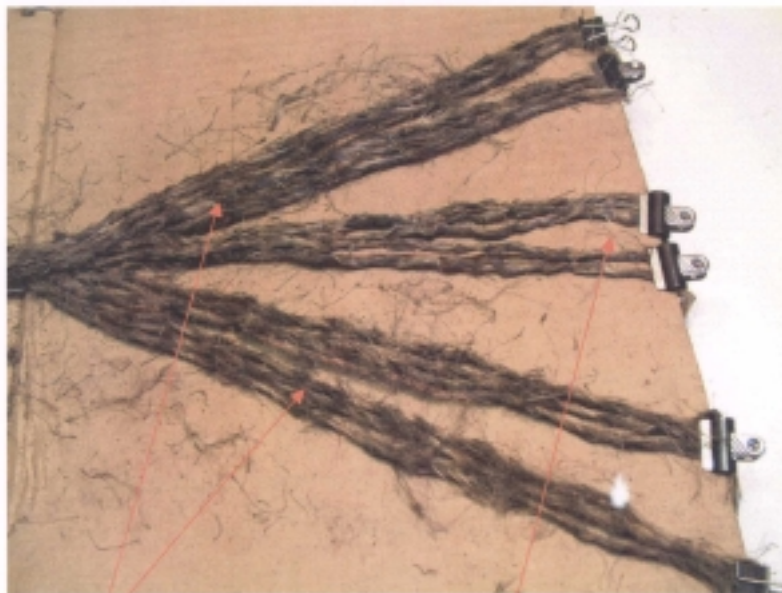
**Photo 12 General view of opened out strand**

Photograph 12 shows a strand from Item A opened out to reveal its constituent inner and outer rope yarns. Abrasion damage can be seen to the outer yarns, whilst the inner yarns are in relatively good condition. The amount of loose fibre released during the investigation is further evidence of the degree of damage suffered by the outer rope yarns.

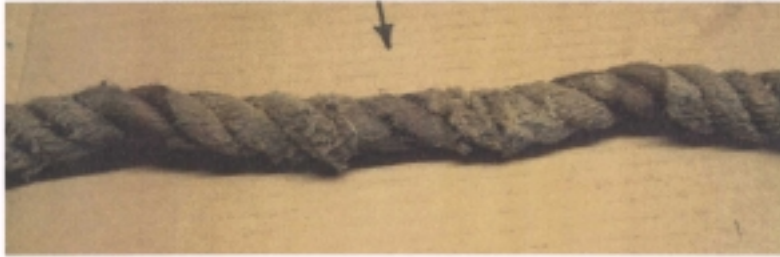
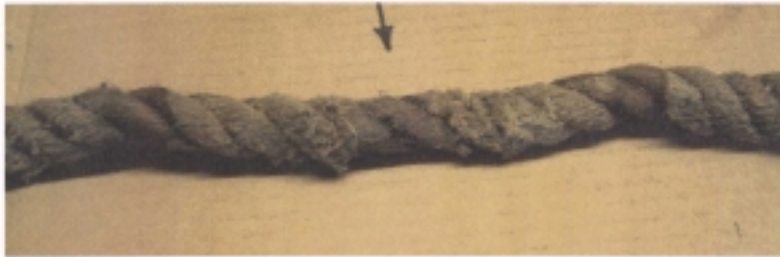
**Photo 15 Rope from ladder part Item A'**

The arrow indicates the part of the rope that has been threaded through a ladder span eye. In general, the rope diameter at these positions was found to be circa 21 mm, a loss of approx 20% on the nominal 'as-new' diameter [lighting shadow partially obscures this diameter loss, but at higher magnification, this can be clearly seen]

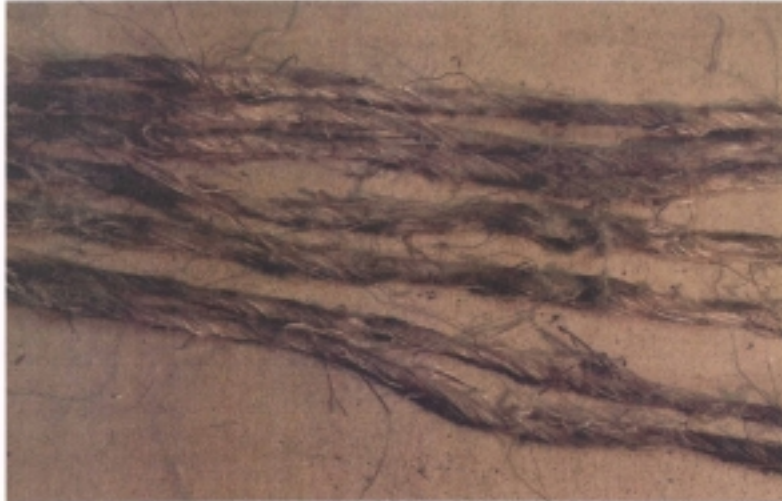
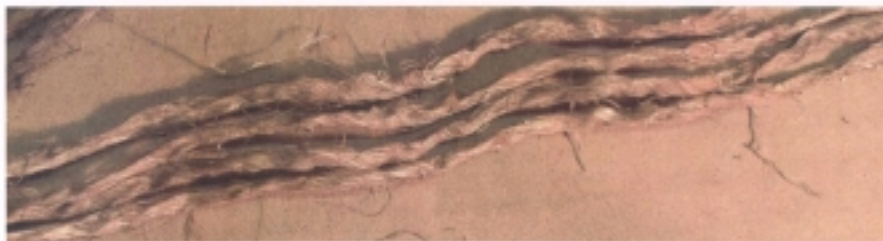
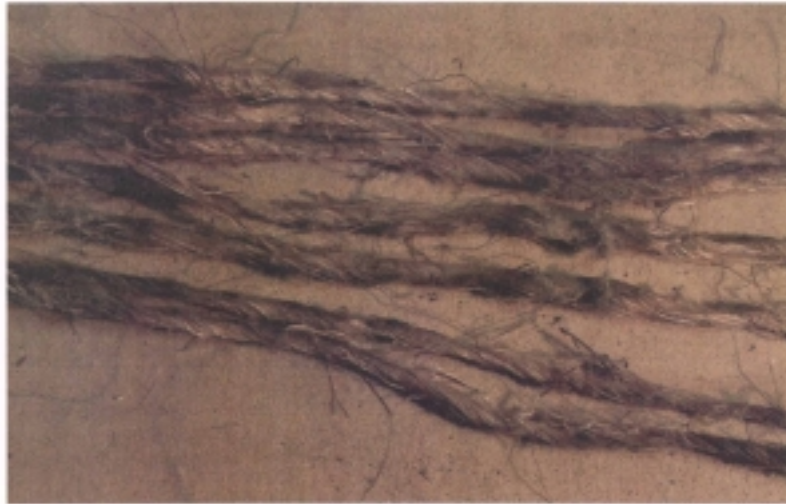
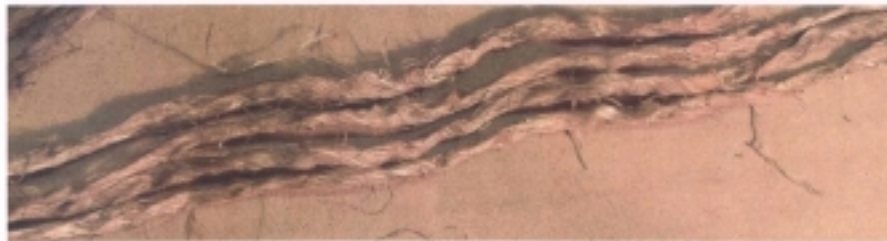
**Photo 17 Close up of outer yarns**

Damage to the outer yarns is again clearly seen, as is the relatively better condition of the inner yarns.

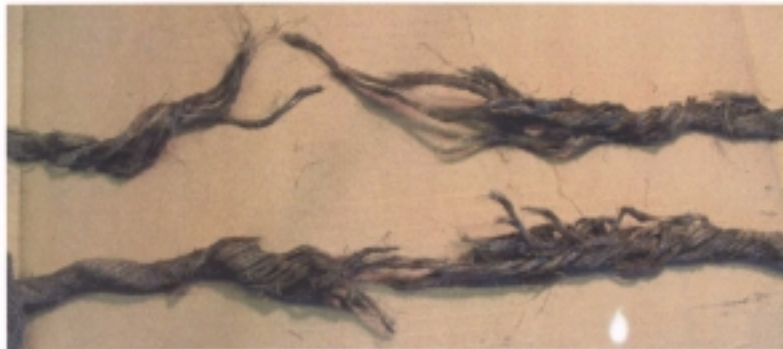
**Photo 19 Typical tensile failures of rope strands**

Basic statistics are also shown in Table 3, and it is seen that the Coefficient of Variability [Standard Deviation / Mean] is quite low. This is evidence that the location of the failures is not random and that there is likely to have been a very localised reduction in strength at these zones.

Photograph 19 shows an example of two tensile failed strands from securing rope Item A.

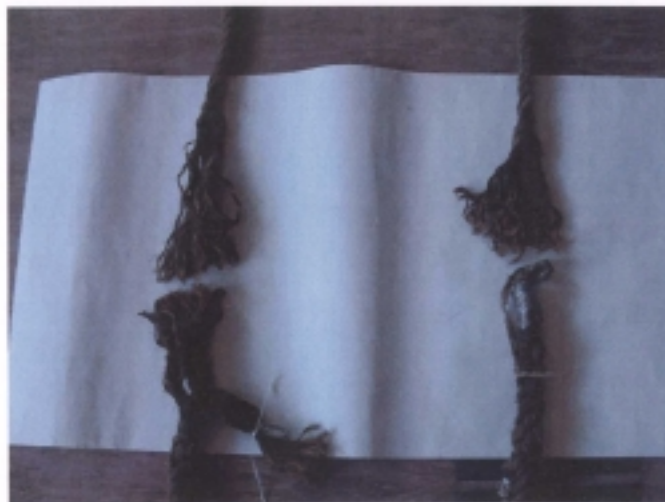
**Photo 20 Failure zones of the ladder**

Photo 20 is a reminder of the failure zones of the ladder, photo from DepCMNR

Whilst the conditions [under which the failures were generated ] were different, it is reasonable to note that the fail zones of the ladder show a greater degree of uniformity in terms of the positional distributon of the failed ends of the component rope yarns. There is no sign of the extened tails of rope yarn material as seen in Photo 19. This is another indication of a localised gross weakening of the rope structure at the fail zones. This will be discussed further in the next section.

The fact that the ladder failed close to both splices, and with a very uniform line of failed yarn ends across the rope, gives a strong indication that there was a very local deterioration of the tensile properties of both ropes in this area. Photograph 20 shows localised nature of the failures in each leg. Two common causes of this are flex fatigue and stress raising. TTI have seen failures of a similar nature in previous investigations and studies [Ref 1], and it is very possible that both effects played their part in this incident.

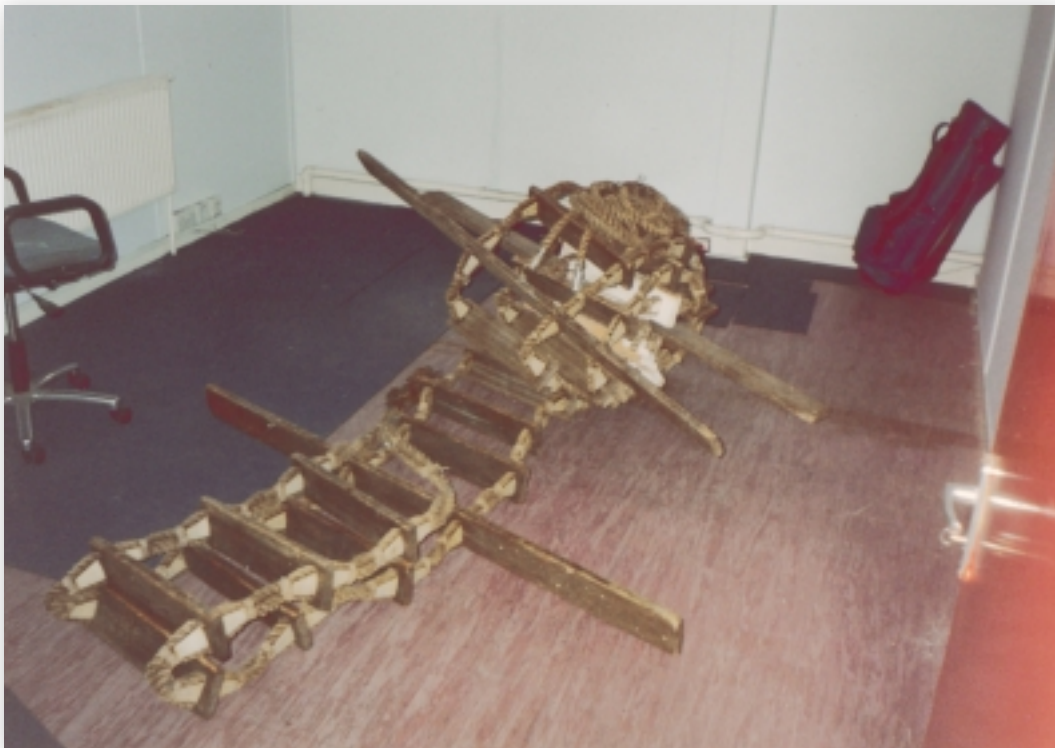
- 4.6 Then both rope sides of the ladder failed. (See Photograph No 7 at Appendix 8.4).
- 4.7 The pilot and the pilot ladder fell approx 27 feet onto the pilot cutter. (See Photograph No 6 at Appendix 8.4).

6. Section of pilot ladder from M/V "Alexia" that fell onto the pilot vessel.

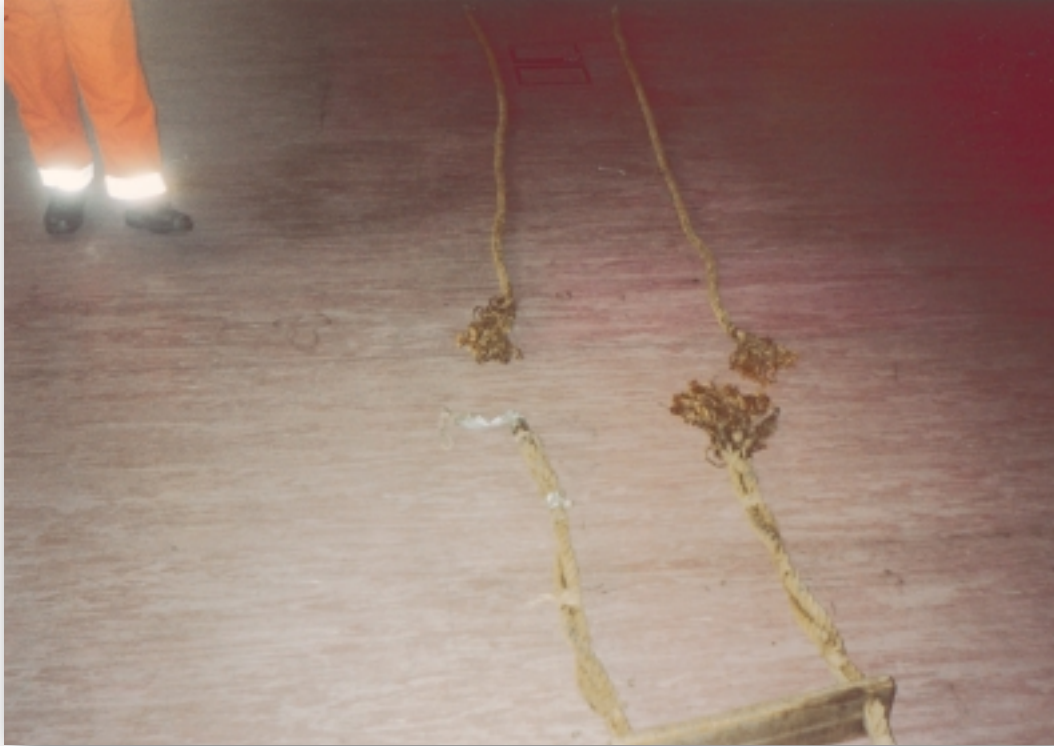
- 6.9 The instantaneous and complete failure of the rope supports of the pilot ladder was due to the deteriorated condition of the rope supports as per the report from Tension Technology International Ltd. The average breaking strength of the pilot ladder rope side supports was 0.76 Tonnef whilst the minimum breaking strength of new rope is 5.33 Tonnef.
- 6.10 The average residual strength was 14.2% of a new rope.
- 6.11 Additional factors involved in the parting of the pilot ladder rope side supports were the interaction with the pilot cutter placing a strain on the pilot ladder, and the relative movement of the pilot cutter with the vessel causing mis-alignment of the pilot ladder rope side supports.

7. Section of pilot ladder showing failure of both rope sections.

- 7.1 It is recommended that a report of the incident be sent to the Malta Government Marine Administration where the ship is registered.
- 7.2 A Marine Notice should be issued reminding owners and shipmasters of the requirement to provide safe means of pilot transfer, the proper stowage and regular inspection of pilot ladders as per SOLAS Chapter V, Regulation 23 2(2.1).
- 7.3 Pilot transfer arrangements and pilot ladders should be inspected during Port State Control inspections.
- 7.4 Pilot ladders should have a certificate stating their year of manufacture and compliance in line with IMO Resolution A.889 (21).
- 7.5 Port authorities should ensure that the boarding and landing of pilots is carried out as per Marine Notice number 26 of 1993 re The Boarding and Landing of Pilots by Pilot Boat Code of Practice. (See Appendix 8.5).
