**REPORT INTO THE INCIDENT ON  
BOARD THE "ARKLOW BROOK"  
ON 15TH JANUARY 2002  
WHERE A CREWMEMBER  
SUSTAINED SERIOUS INJURIES.**

The Marine Casualty Investigation Board was established on the 25<sup>th</sup> March, 2003 under The Merchant Shipping (Investigation of Marine Casualties) Act 2000

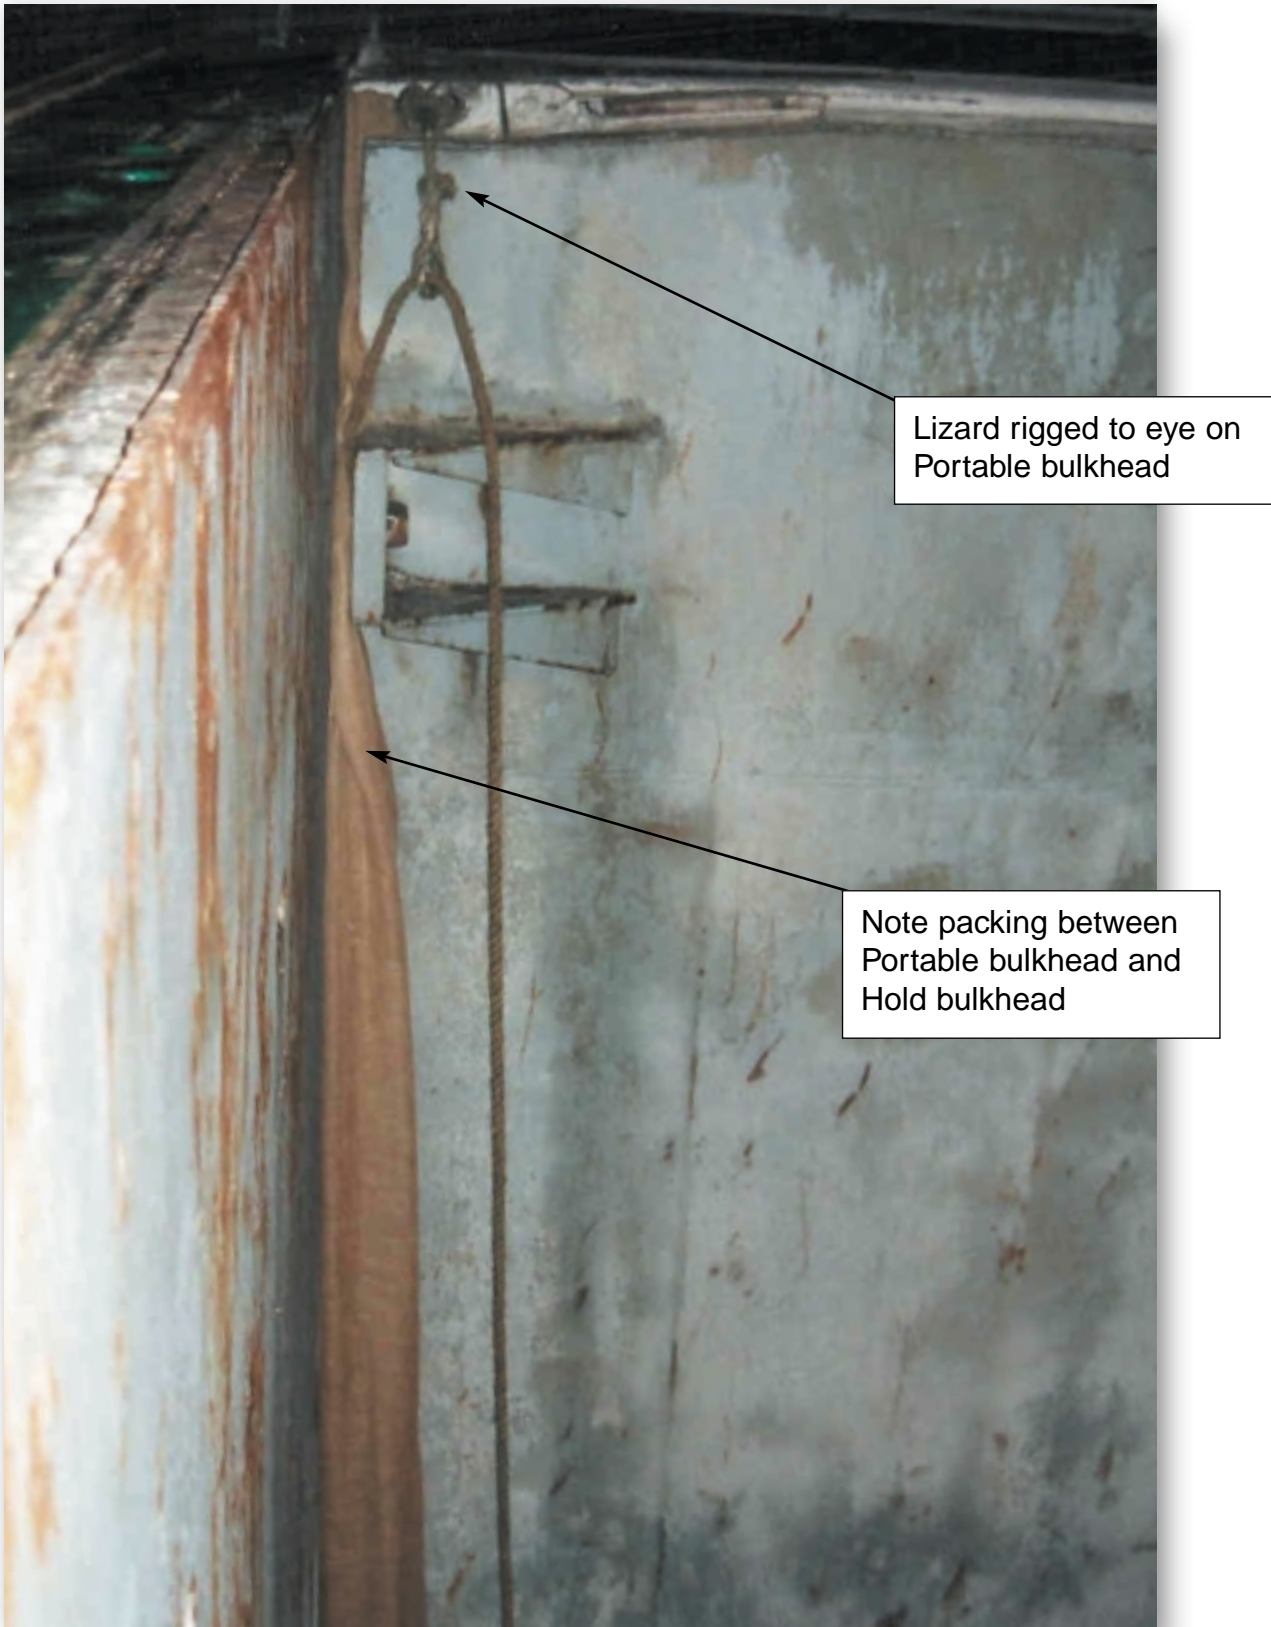
### Appendix 8.2

- 3.1 The MV "Arklow Brook" was on passage from Amsterdam to Hamburg. The vessel was due to load a cargo of fertilizer in Hamburg. It was the practice on this vessel to pack a gap between the portable bulkhead and the hold bulkhead with burlap (sack cloth) to prevent ingress of cargo into the space aft of the portable bulkhead.

Photograph showing packing between portable bulkhead and hold bulkhead.

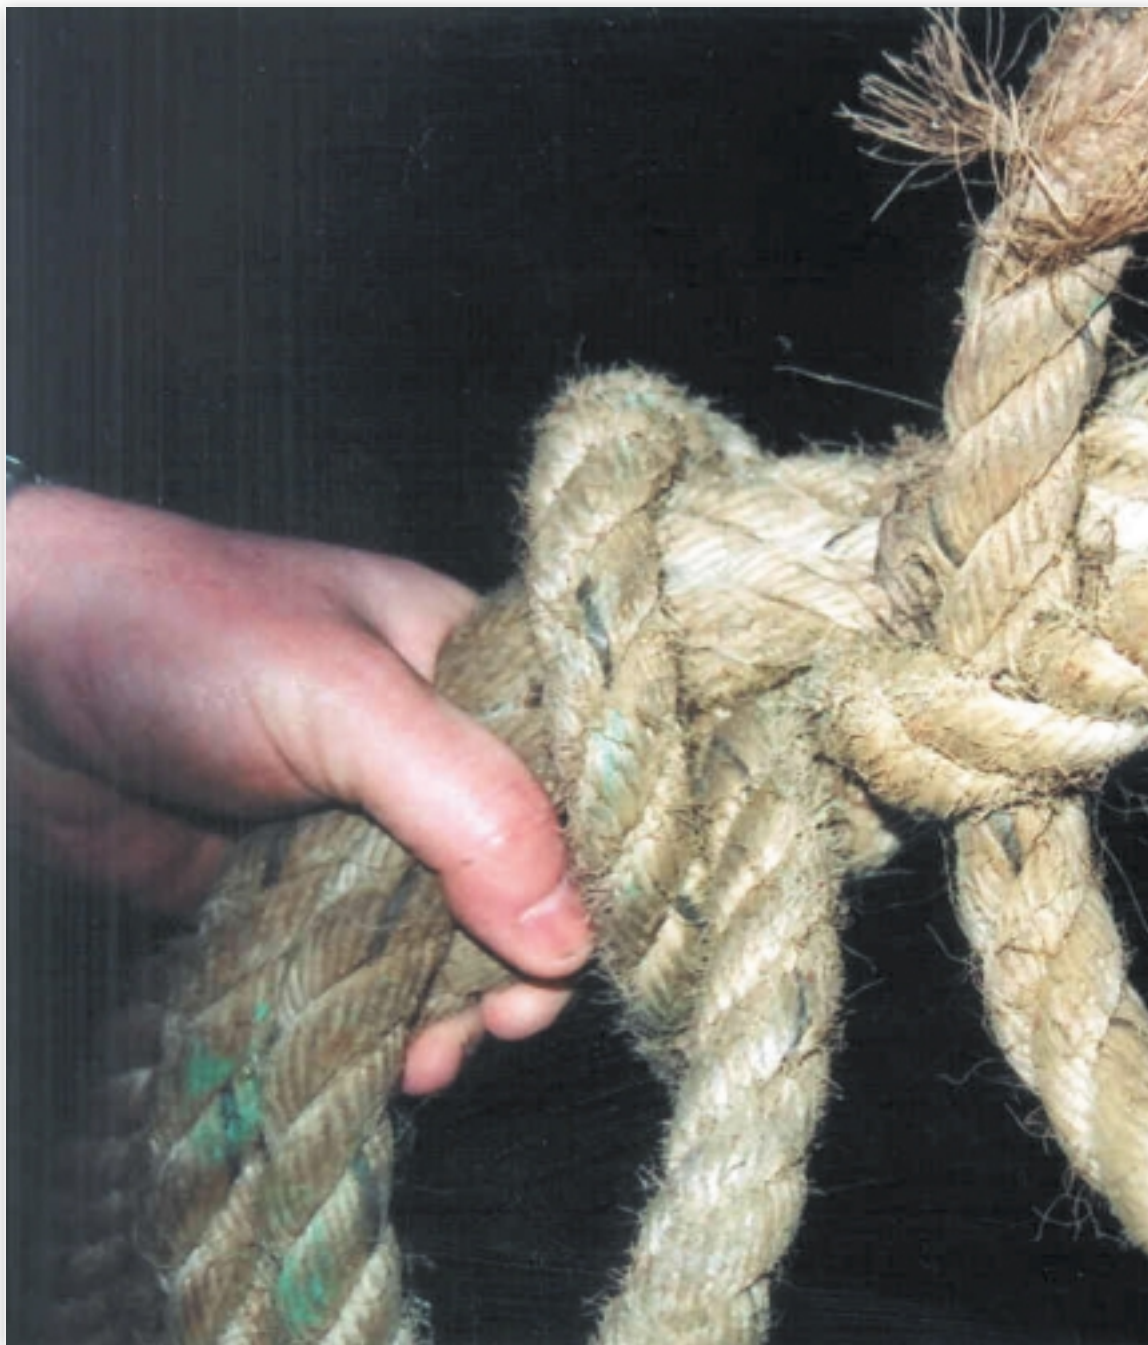
### Appendix 8.3

- (ii) See Appendices 8.3 and 8.4. It appears that when Mr. Lax sat into the chair that the chair was free to fall. The chair may have been rigged with only one end of the lowering rope fast to the chair and Mr. Lax was yet to make the standing part fast but lost his grip and fell to the deck below.

Photograph showing close up of rigging of chair.

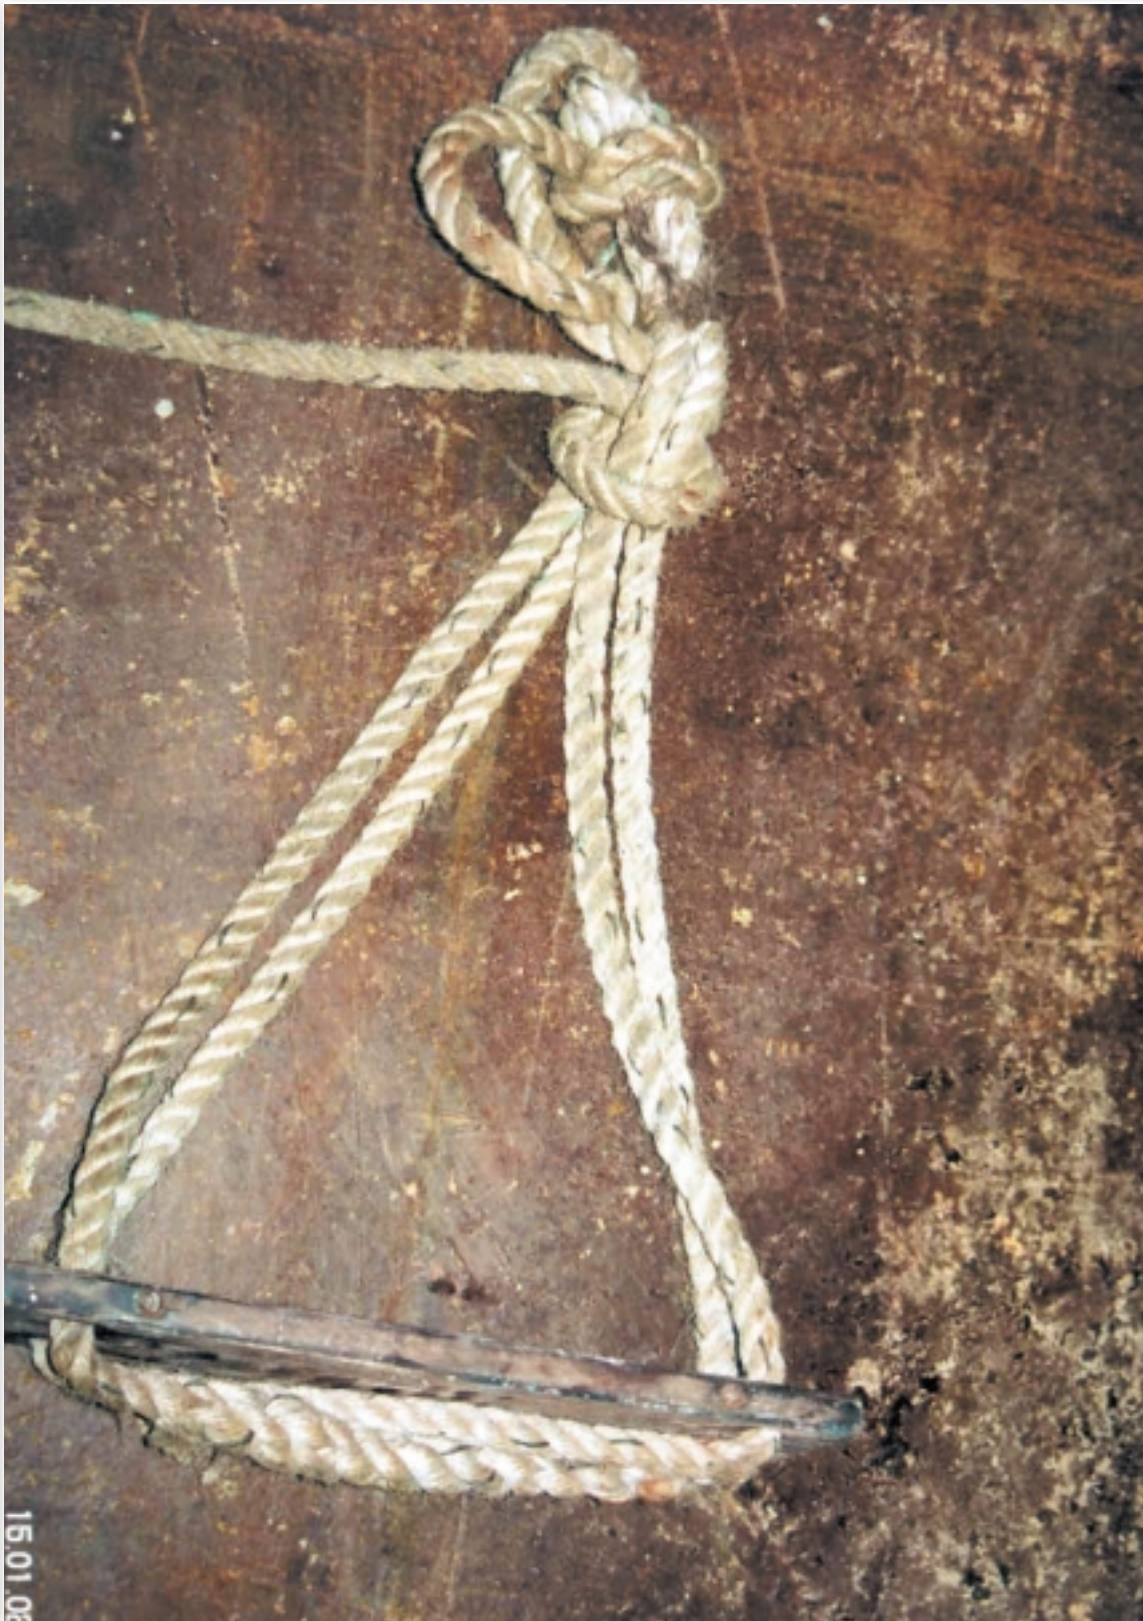
### Appendix 8.4

Photograph showing rigging of Bosun's chair.
