**REPORT OF THE
INVESTIGATION INTO THE
LOSS OF THE
BRIGANTINE SAILING SHIP
STV "ASGARD II"
ON THE
11th SEPTEMBER 2008**

**REPORT No. MCIB/161
(No. 10 of 2010)**

Report MCIB/161 published by The Marine Casualty Investigation Board
27th September 2010.

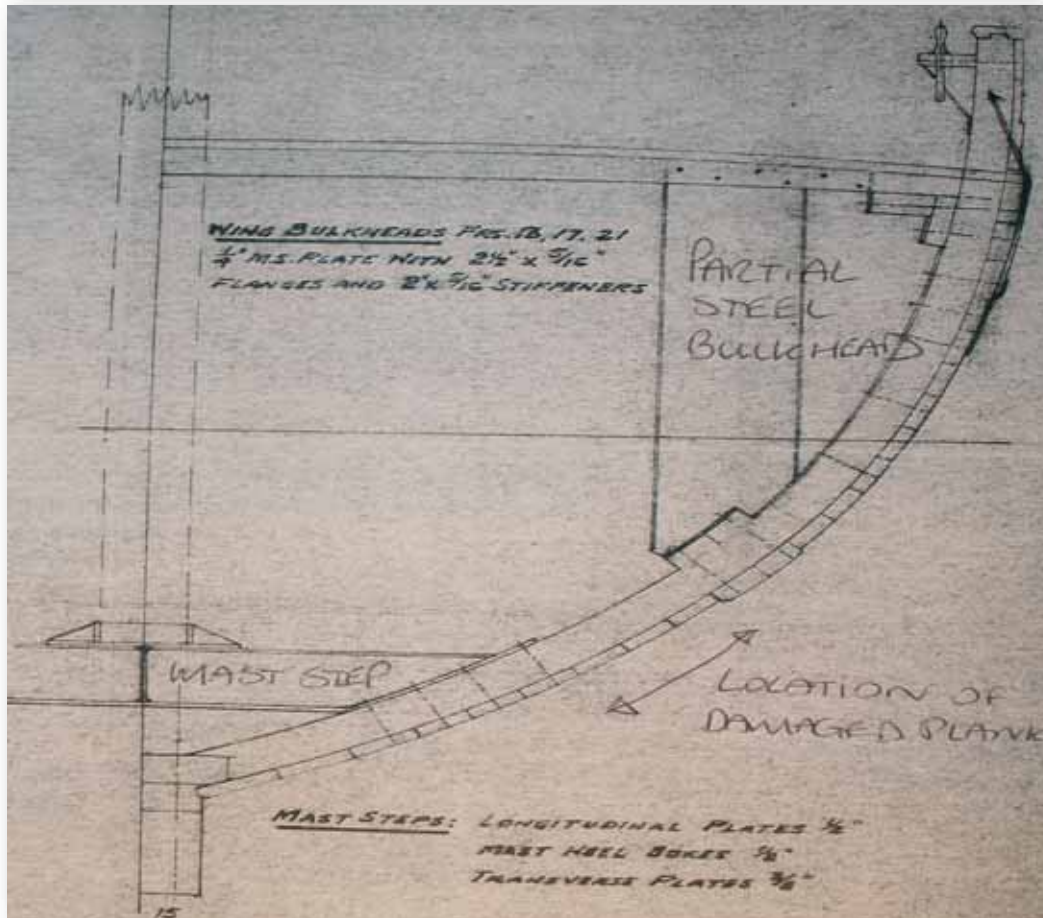
Fig 1 Construction Section in way of foremast (the heavier bilge plank is shown)

Examining the construction section, the three planks containing cracks on the starboard side are located between the toe of the partial steel bulkhead and the outboard toe of the mast step. A force applied to the underside of the keel would be transmitted through the hull framing and planking and possibly dislodging the plank on the starboard side and fracturing the plank on the portside.

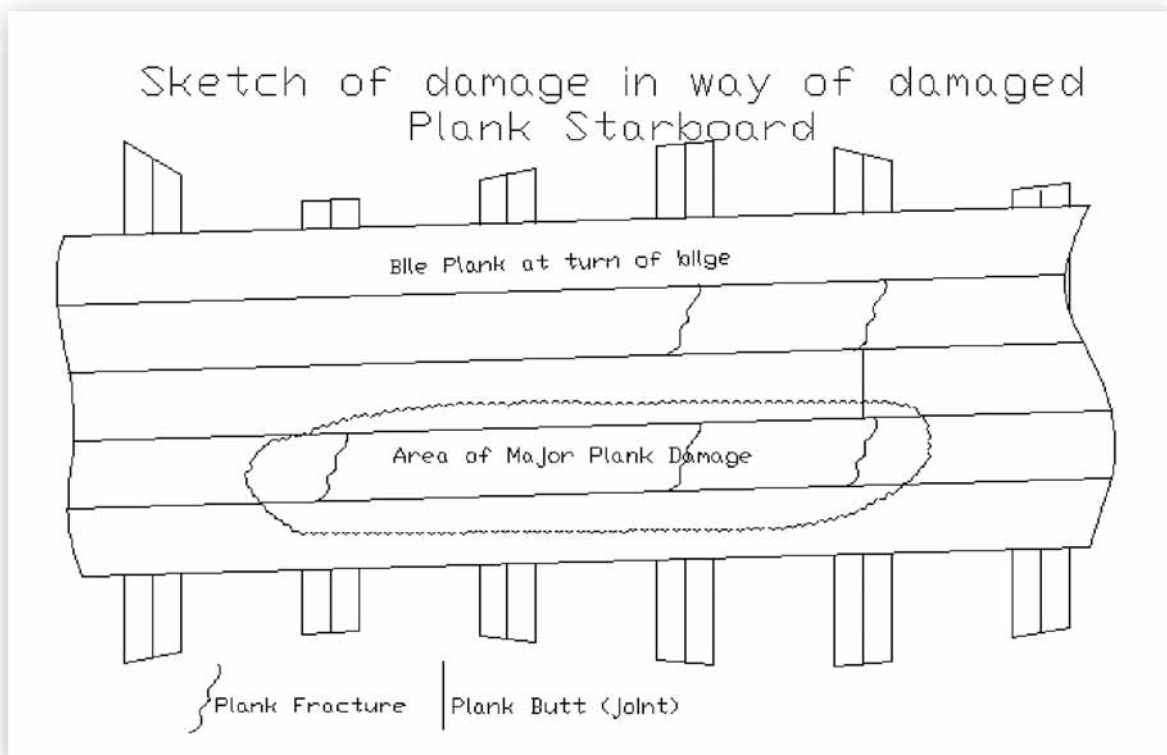
Diag. 1 - Sketch of the location of the damage.

During the course of the ROV survey significant plank damage was found in the third plank below the turn of bilge plank starboard side in way of the forward chainplates. Additional damage was found in the two planks located above the plank with significant damage. Diag. 1 contains a sketch of the location of the damage. Photo's 1 & 2 were obtained from the ROV video footage.

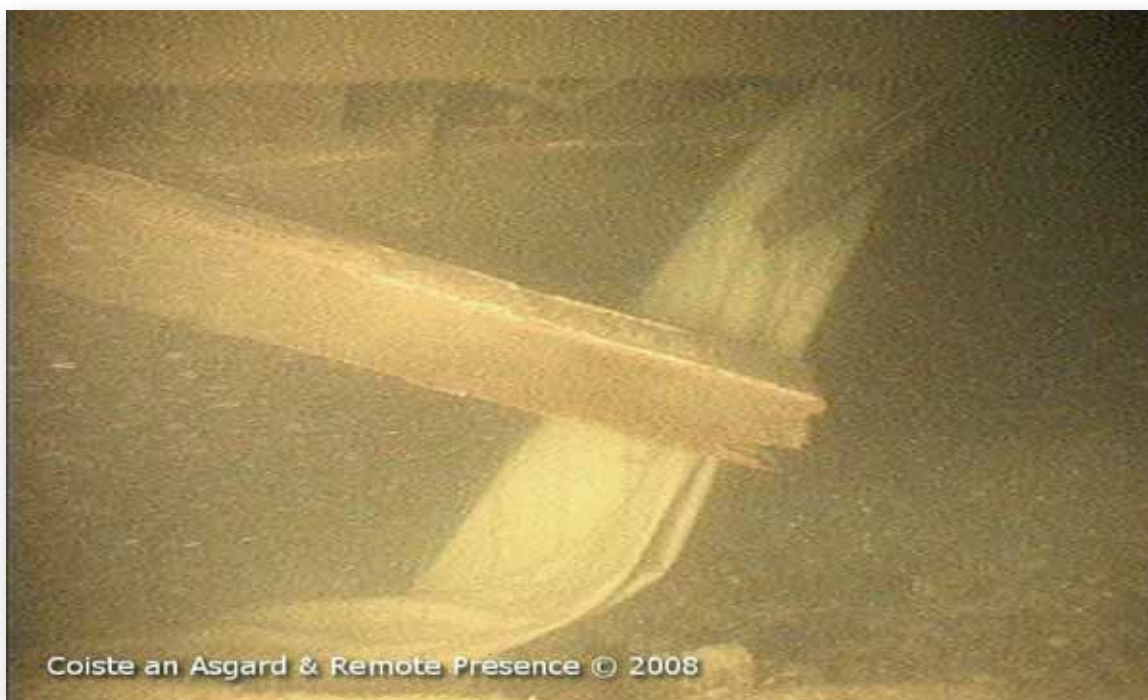
Photo 1 - Fractured Hull Plank (Starboard Side) in way of forward chainplates (the white item is a bed sheet).

“The break in the hull plank is rather brash (non-fibrous) and could be indicative of slight decay or more (likely) of the presence of “tension wood” in the timber, which I understand is of iroko and which species frequently contain small amounts of tension wood and has interlocked grain. It is not an indication of severe decay or of attack by marine borers.”

Based on the evidence flooding occurred as a result of the fractured plank (starboard) as no other significant plank damage was found and the TRIBON calculations indicate failure a 1¹/₂" seacock would not cause such rapid flooding.

Based on the findings it is probable the ship struck an underwater object causing the major planking failure on the starboard side.

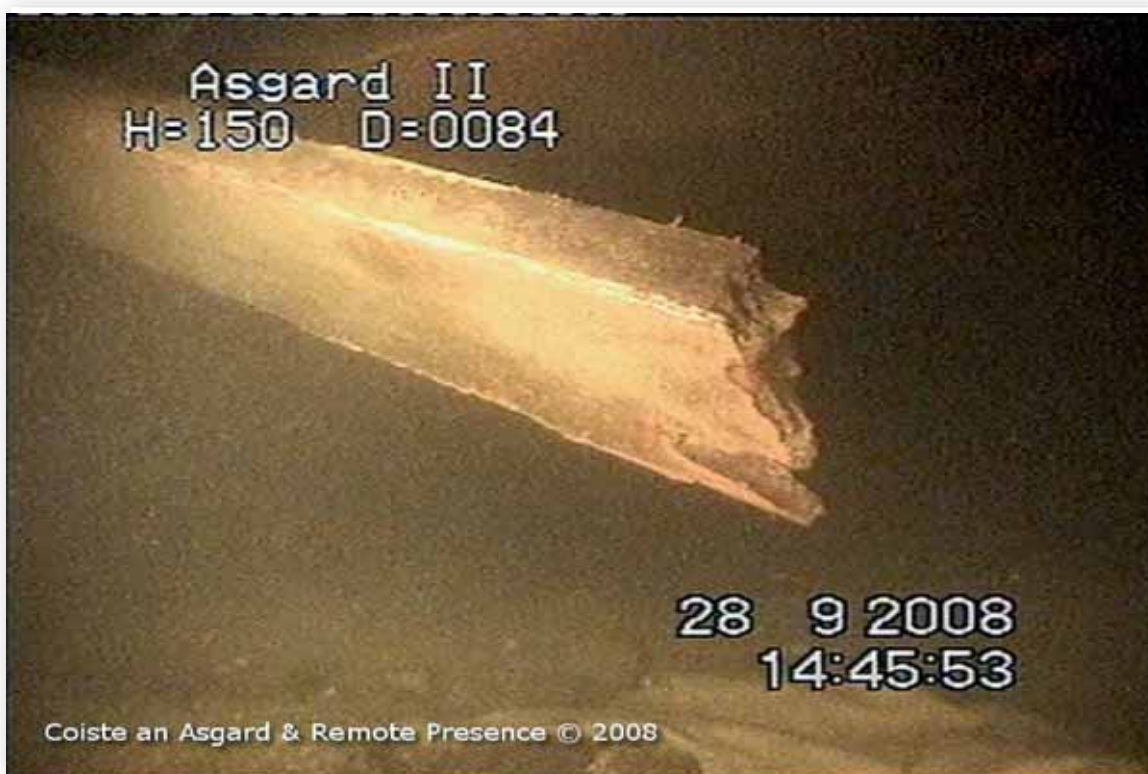
Photo 2 - Close up photograph of fractured Hull Plank (Starboard Side) in way of forward chainplates.¹³

Examining the fractured starboard plank it appears that the damaged plank occurs over approximately 3 frame spaces. Each frame space measures approximately 7½" x 7" (190.5 mm x 177.8 mm) giving a total area of (190.5 mm x 177.8 mm) x 3 = 0.1 m². This value is significantly larger than the area determined by the continuous flooding calculations (0.017 m²).

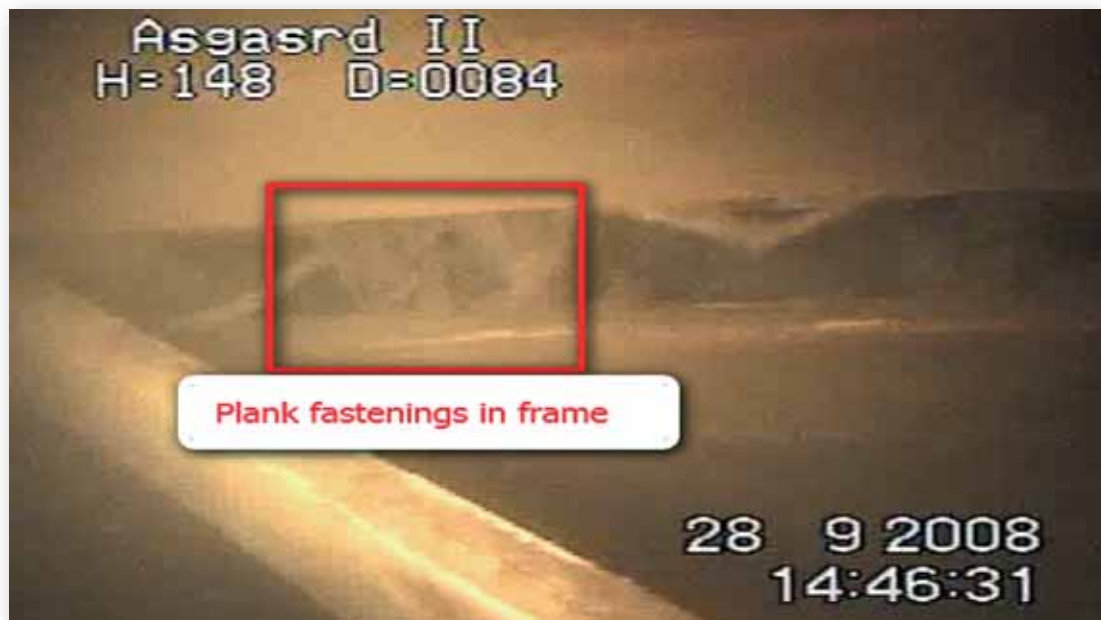
The ROV footage shows that the spikes remained in the oak frame in way of the plank fracture and one frame aft of the fractured plank. It was not possible to see if the spikes remained in the other frames in way of the fractured plank.

Photo 3 - Plank fastenings.

As outlined in the findings the spikes remained in place and the plank detached over the head of the spikes indicating the fastenings were secure in the oak framing. Reviewing the MSO files and Lloyd's Register Classification files no evidence of any issues relating to the presence of rot were found.

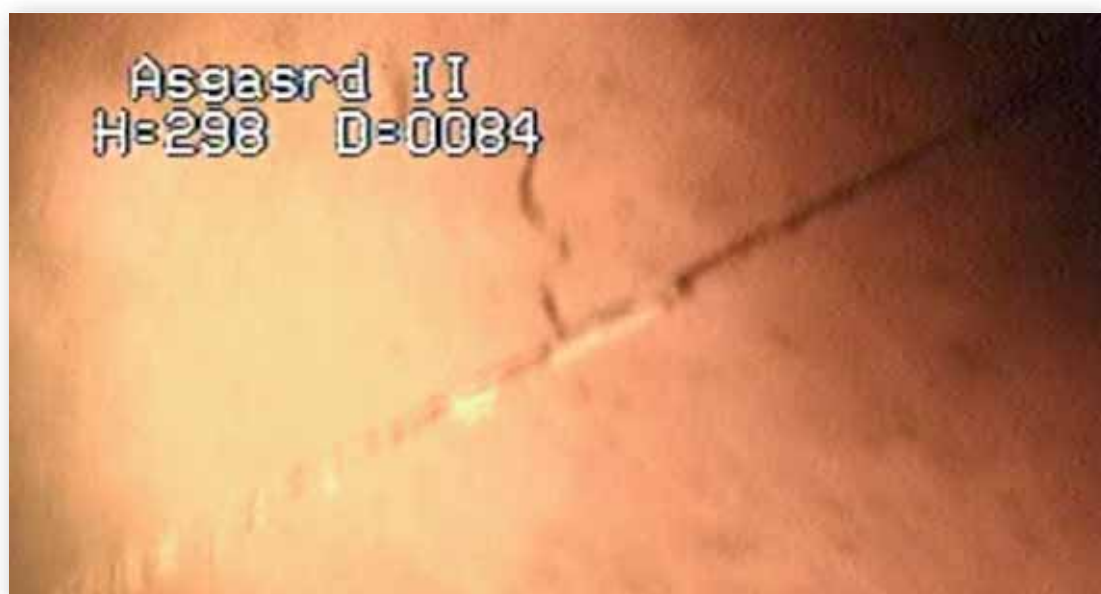
Following a detailed review of the ROV footage an additional cracked plank was found on the portside, see photo 4 below. The exact longitudinal location of the cracked plank could not be established. However, it was established to be in a similar location to the damaged starboard plank.

Photo 4 - Cracked Hull Plank (portside).

The presence of the cracked plank on the portside as reported in the findings is located in a similar longitudinal location to the fractured plank on the starboard side. It is considered unlikely for rot to be present in the same location port and starboard side.

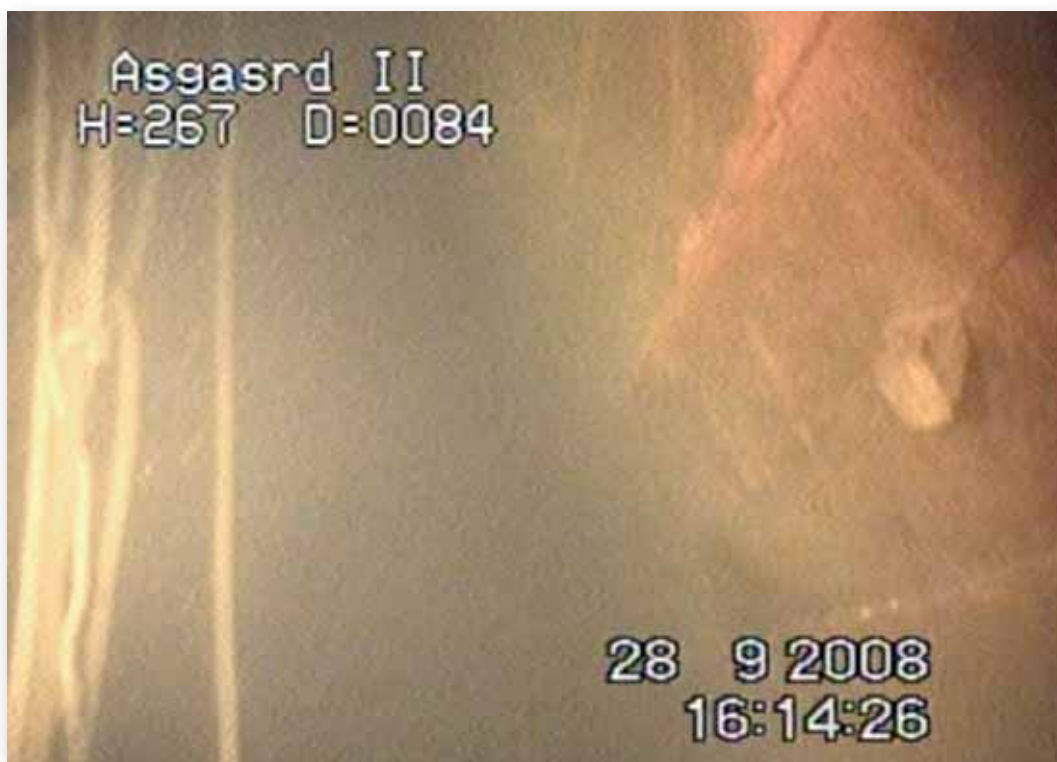
Slightly forward of this location an object was found which appears to be embedded in a plank seam, see photo 5 below.

Photo 5 - Embedded object in plank portside just forward of cracked plank (disturbed seams can be observed in this photograph).

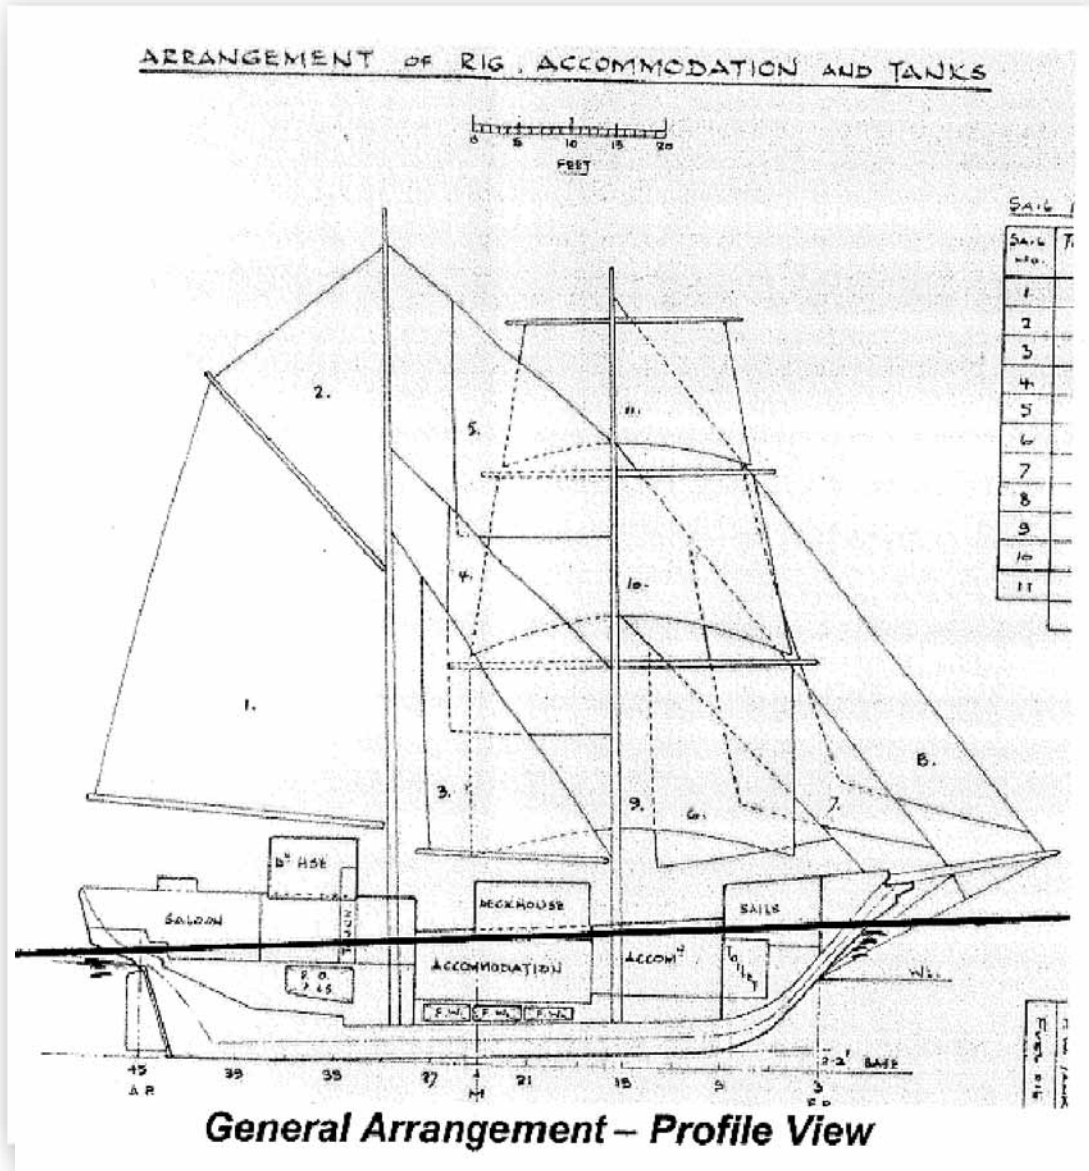
Diag. 2 - Showing the assumed waterline for initial calculations to be calculated.

By adjusting the permeability¹⁴ of the Trainee Mess with the space assumed to be flooded, at 80% permeability, the ship remains afloat at approximately the waterline shown in the above diagram. The required volume of floodwater can be estimated, as the gross volume of the space x 0.8 equals 110 tonnes.

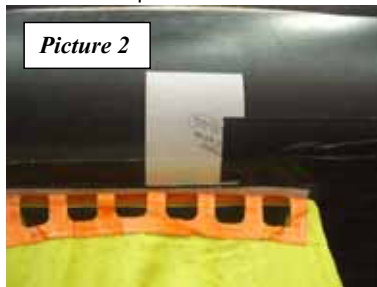
Picture 2

- A patch was placed on the floor seam to stop the floor peeling any further – See Picture 2.

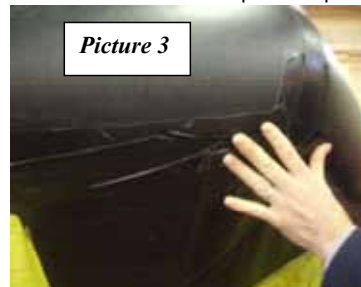
Picture 3

The detached part of the floor was stuck down with self adhesive tape -See picture 3.

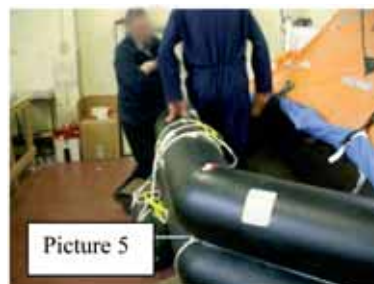
Picture 5

He then proceeded around the liferaft on foot applying his weight on the area of the intact floor attachment See picture 5. – No seam slippage or edge lifting was detected on the floor.

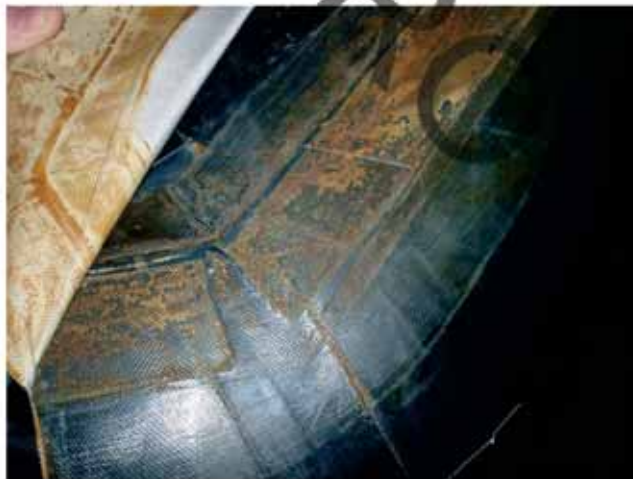
Degraded adhesive - dark brown shiny appearance
FIGURE 3

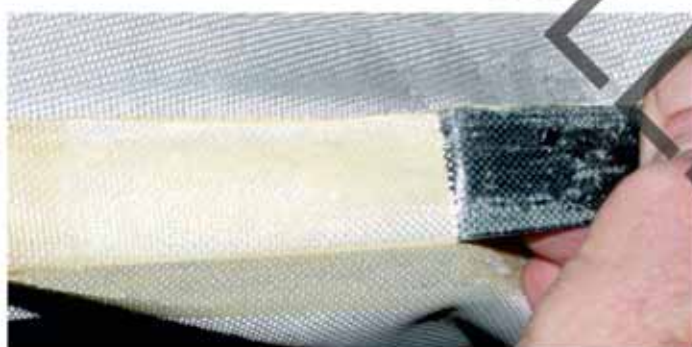
Adhesive which is in good condition, is beige in colour and feels rubber-like. Bonds which appear like this are difficult to separate and are resistant to peeling, (FIGURE 4).

**Adhesive in good condition - beige in colour
FIGURE 4**

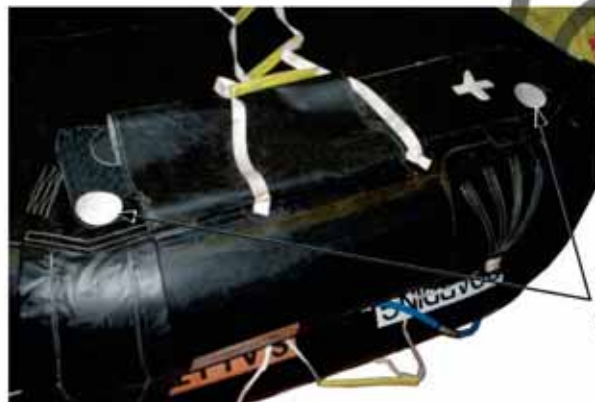
AREAS OBSERVED &
REPAIRED, MARKED WITH
50 mm DIAMETER PATCH

Repair patches applied
FIGURE 8
