**REPORT OF THE
INVESTIGATION INTO THE
INCIDENT ON BOARD
FV "ATLANTIC WEST" WITH
THE RESULTANT LOSS OF LIFE,
NORTH OF MAYO STAGS,
2nd JULY 2007**

REPORT No. MCIB/144

Report MCIB/144 published by The Marine Casualty Investigation Board
31st August 2009

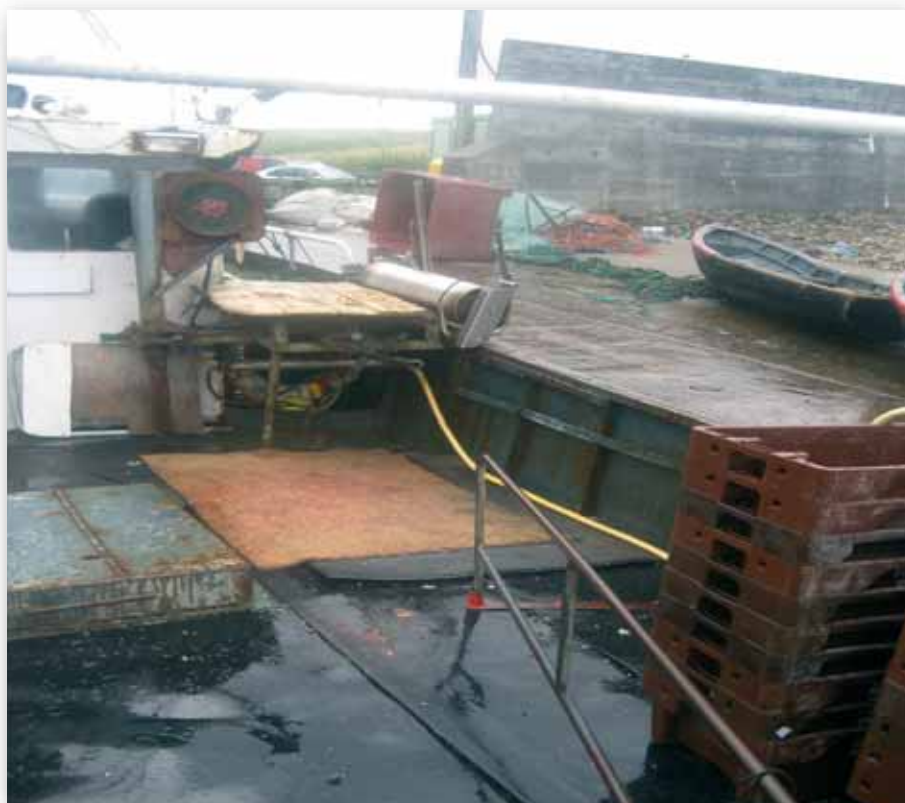
Figure 1. Hauling Area - Starboard amidships

- 4.4 The operation proceeded without event having hauled and shot a number of spirits (lines of pots) without incident.
- 4.5 At approximately 12.55 hrs. they had a spirit of pots ready, and shooting commenced. Mr. Juhas was standing by the pot hauler on the starboard side of vessel amidships. (See Appendix 8.1, Figure 1).

4. [Section 4.5, page 8] While Mr. Juhas was standing by the pot hauler he was standing against the gunwale and so well away from the departing ropes. This is a position that would be considered safe by experienced fishermen.

In relation to point 4, both paragraph 4.5 and 4.7 of our report make it clear that the fact that Mr. Juhas was caught by a rope coil clearly demonstrates that he could not have been standing in a safe position.

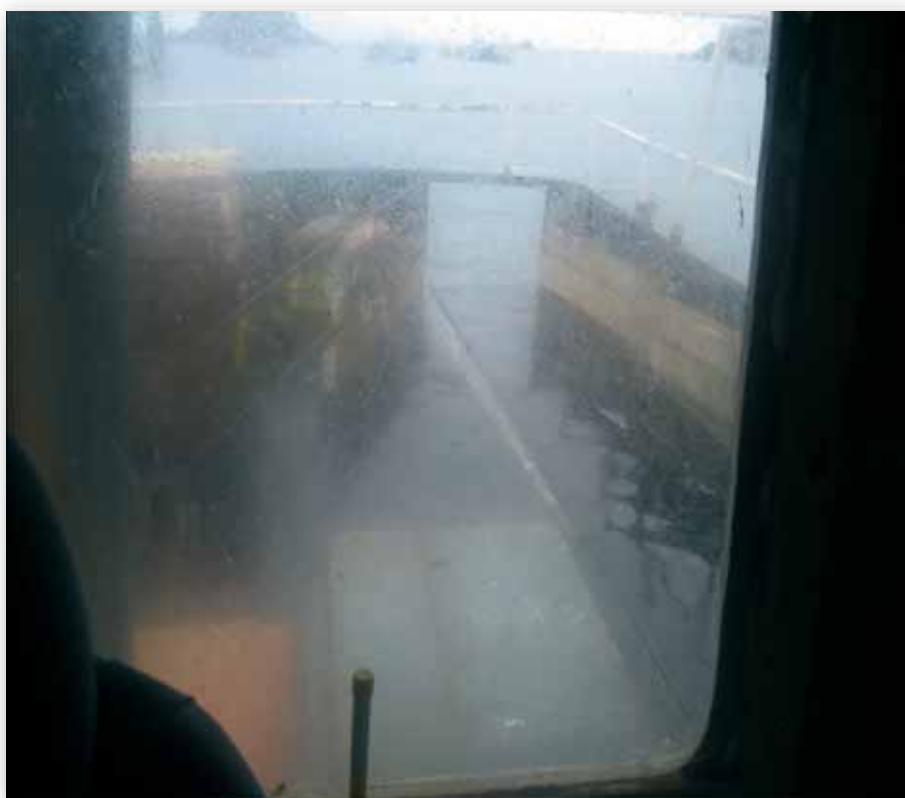
Figure 2. Skipper's view of after deck from wheelhouse

- 4.6 Mr. Juhas was visible to the Skipper from his position in the wheelhouse (See Appendix 8.1, Figure 2). Approximately 25 pots of the total were gone to sea at that point.

- 4.7 The Skipper observed Mr. Juhas being dragged along the deck by the departing rope toward the stern of the vessel and eventually overboard. The next pot in sequence had departed into the sea when the throttle was reduced and vessel was put astern in order to reduce pressure on the back rope to assist in the recovery of Mr. Juhas.
