**REPORT OF THE
INVESTIGATION INTO
THE SINKING OF THE FV
"CARRAIG AN IASC"
ON
20th JANUARY 2011**

**REPORT No. MCIB/197
(No.15 of 2011)**

Report MCIB/197 published by The Marine Casualty Investigation Board
22nd December 2011.

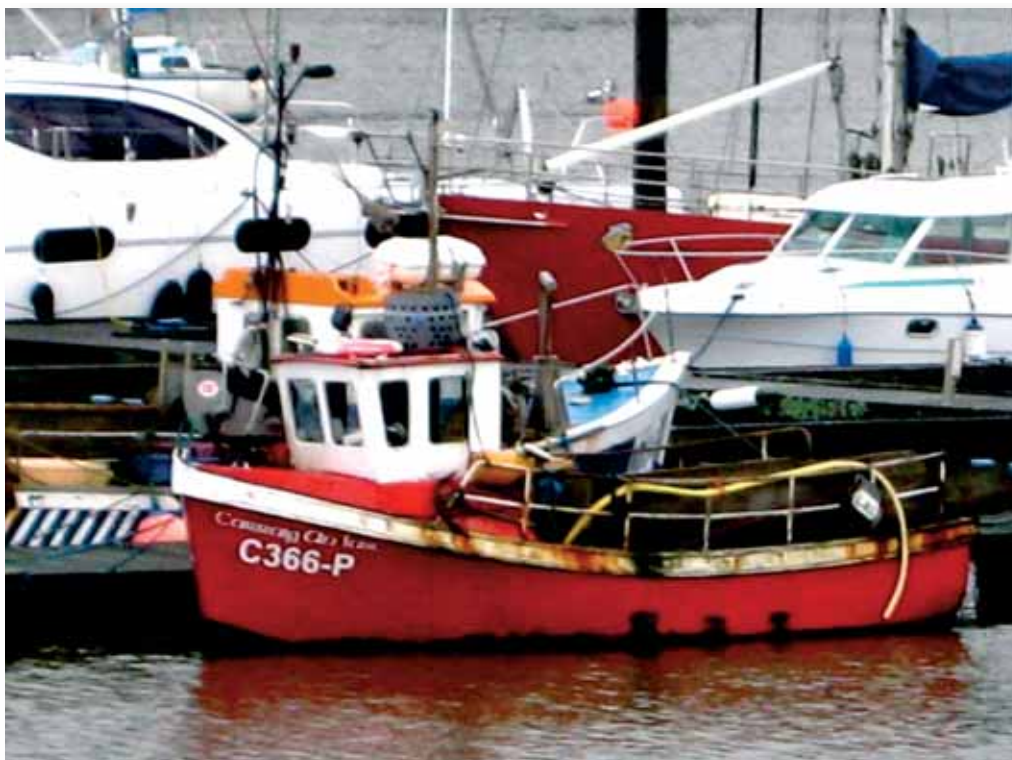
General View of Boat.

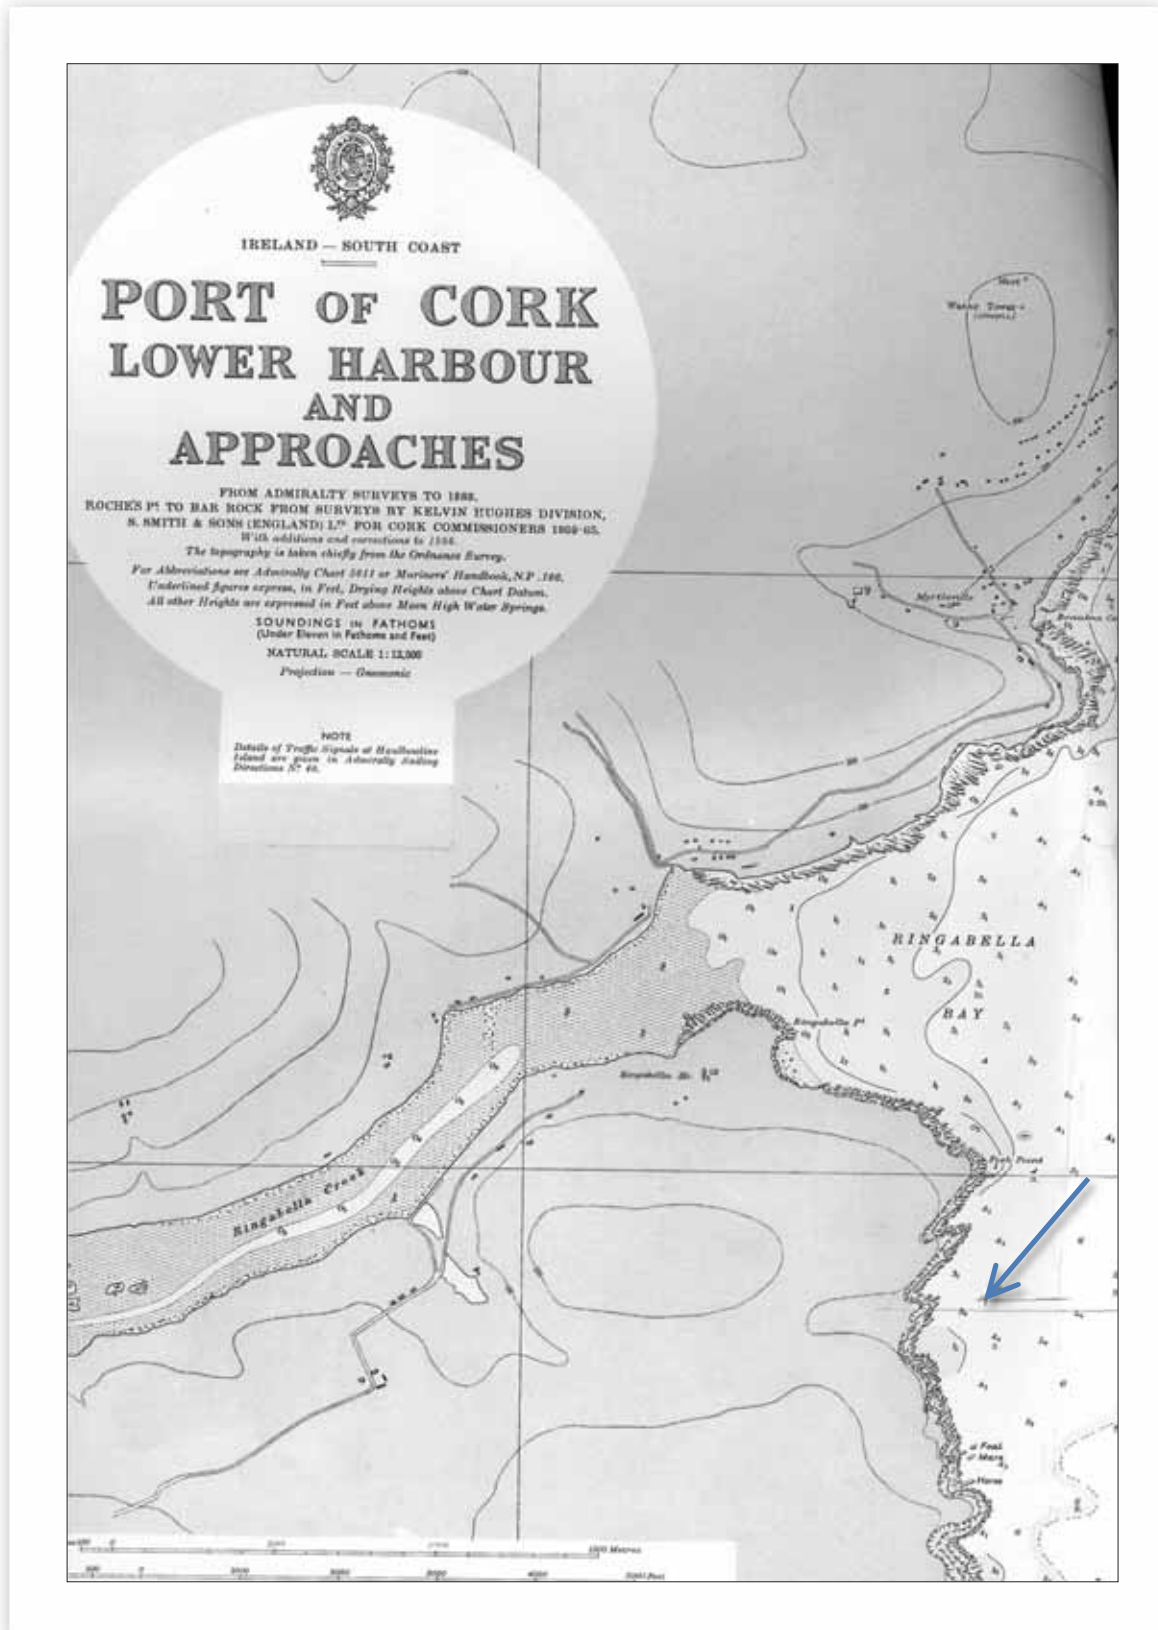
Appendix 8.1 Extract from Chartlet No. 1777 - location of incident.

Extract from Chart No. 1777, Showing Approximate Position of Sinking.
