**REPORT OF INVESTIGATION  
INTO THE MFV "CASSIE"  
AT INVER BAY, CO. DONEGAL  
ON 3rd DECEMBER 2007**

**REPORT No. MCIB/153**

Report MCIB/153 published by The Marine Casualty Investigation Board  
3rd July 2009

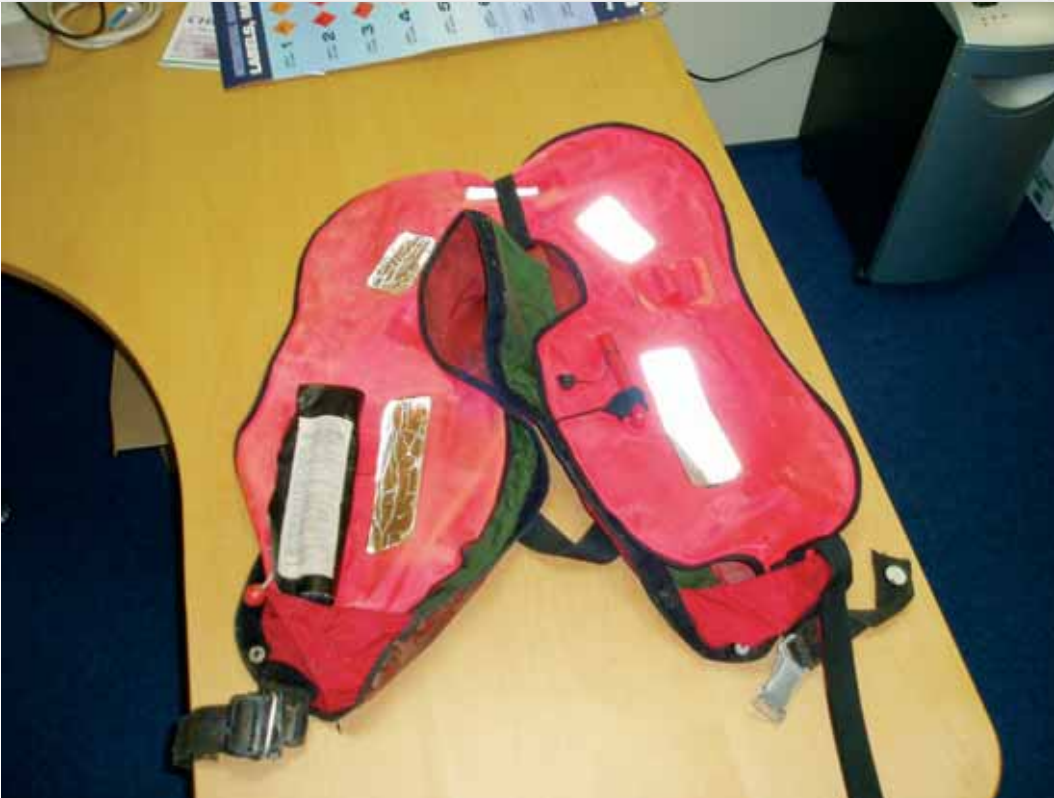
Personal Flotation Device worn by Mr. Conor Kennedy.

- 7.6 It was noted that during the investigation that the lifejacket had not been serviced. However, the PFD/lifejacket functioned correctly. The MCIB recommends that the Minister draws attention to Marine Notices No. 7 of 2002, No. 36 of 2005, No. 18 of 2006 and No. 23 of 2007 which give guidance on the selection and maintenance of Personal Flotation Devices on board Fishing Vessels and Pleasure Craft.

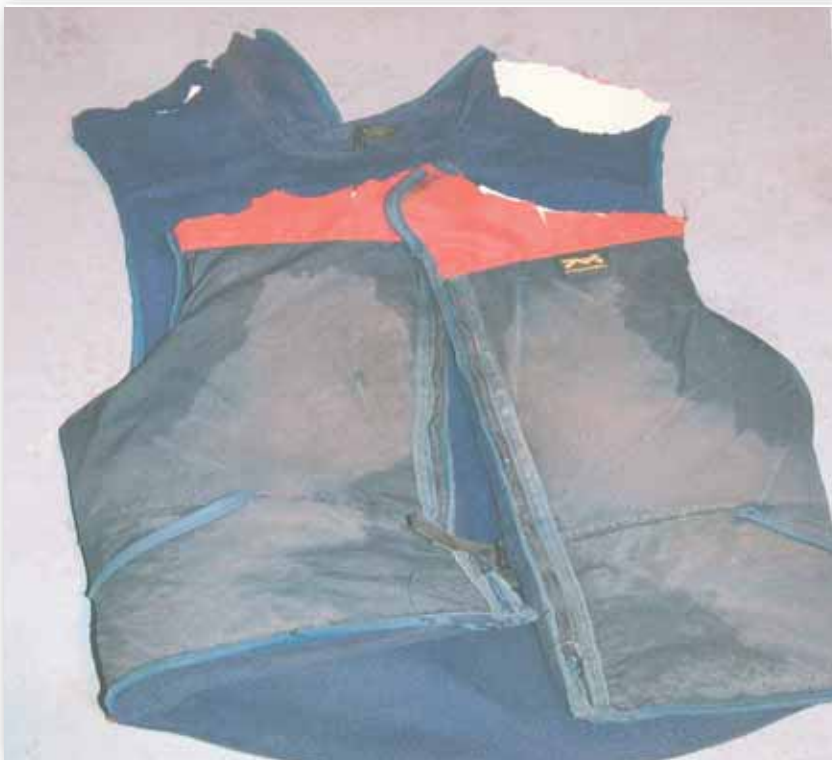
Buoyancy Aid Jacket worn by Mr. Liam Kennedy.

- 7.5 When going out on any fishing trip it is a requirement that Personal Flotation Devices are worn at all times and, in addition, SOLAS Lifejackets shall be carried for each person on board at all times. A buoyancy aid is not a lifejacket and does not support the head out of the water should the wearer lose consciousness. PFDs for offshore use should be a minimum of 150 Newton buoyancy (150 N) and should carry the CE mark and or the Marine Equipment Directive MED Approval Wheel Mark. Fitting straps should be made tight with preferably a crotch strap to help keep it in place. It is important that an approved dealer regularly services these every year. Ideally the PFD should be a SOLAS approved type with MED Approval Wheel Mark.

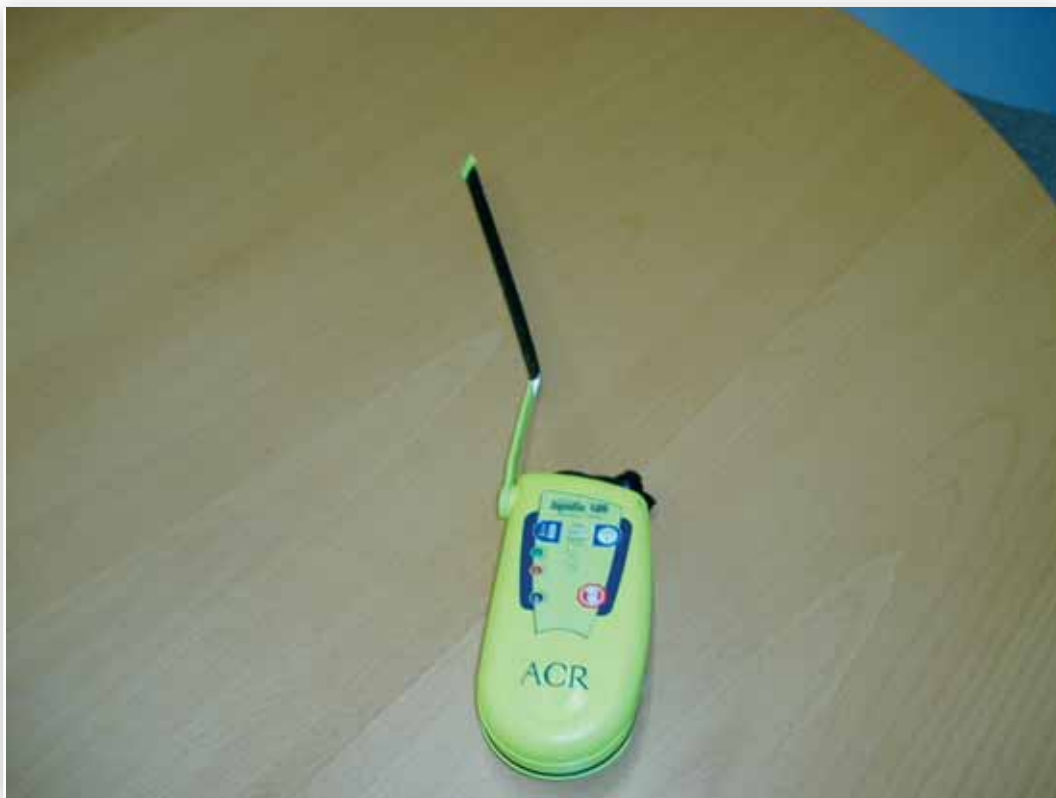
PLB Recovered from Incident.

The PLB Coded EI8093 is in good operational condition, the tests carried out have positive results. There are factors, which may have affected the beacon operation. The PLB indicates that the antenna must be extended for full signal emission. The human body can act to shield the PLB. This may block the signal from a satellite. The holster for the PLB was not recovered, this acts to prevent the PLB being inadvertently activated. The PLB having been removed from the holster may indicate that attempts were made to activate the PLB. If the beacon was active when the beacon holder was being winched into the helicopter this additional height would give very good propagation conditions for the 406 MHz. emission with a very high probability of a successful alert being picked up if the PLB had been activated. If the PLB had been activated the operation of the off button would have stopped battery drain.

- 7.11 The PLB carried by one casualty does not appear to have been activated, in that no distress alert was received. This is a manually operated device only. On test it worked and had good battery capacity. Other types of EPIRB can be operated either automatically or manually and for the fishing vessels over 12 metres length are required to be of the float free type achieved by automatic activation of a hydrostatic release unit and capable of either manual or automatic operation, that is operate when afloat after release. On an open boat difficulties arise as to where to locate a float free type but this could be overcome by fitting the unit on a mast. The hydrostatic release unit is designed to release within a depth of 4 metres. It has the advantage however, that it can be manually released from storage and of automatic activation when afloat. It is recommended that all EPIRBS fitted are of the float free type and capable of both manual and automatic operation.

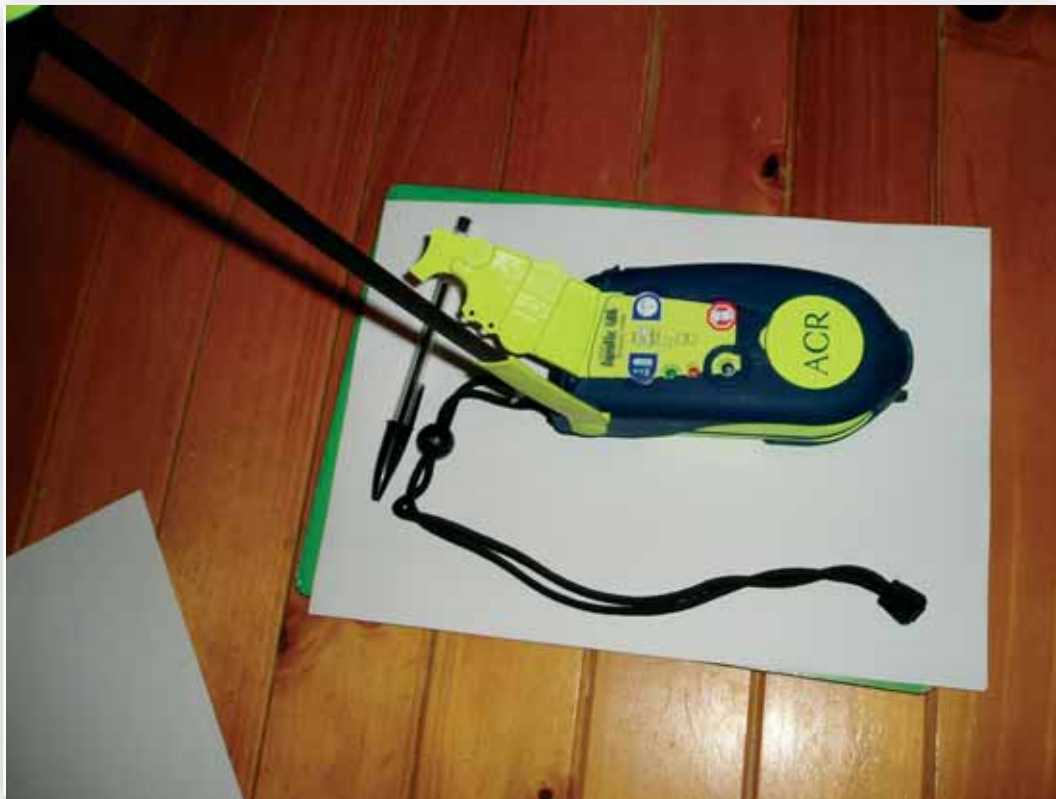
PLB with Flap open and aerial in extended position.
