**REPORT OF THE
INVESTIGATION INTO THE
SINKING OF THE IRISH FISHING
VESSEL "CHRIST MARIA" IN
GLANDORE HARBOUR, CO.
CORK ON 30 MARCH 2003.**

The Marine Casualty Investigation Board was established on the 23rd, May 2002 under The Merchant Shipping (Investigation of Marine Casualties) Act 2000

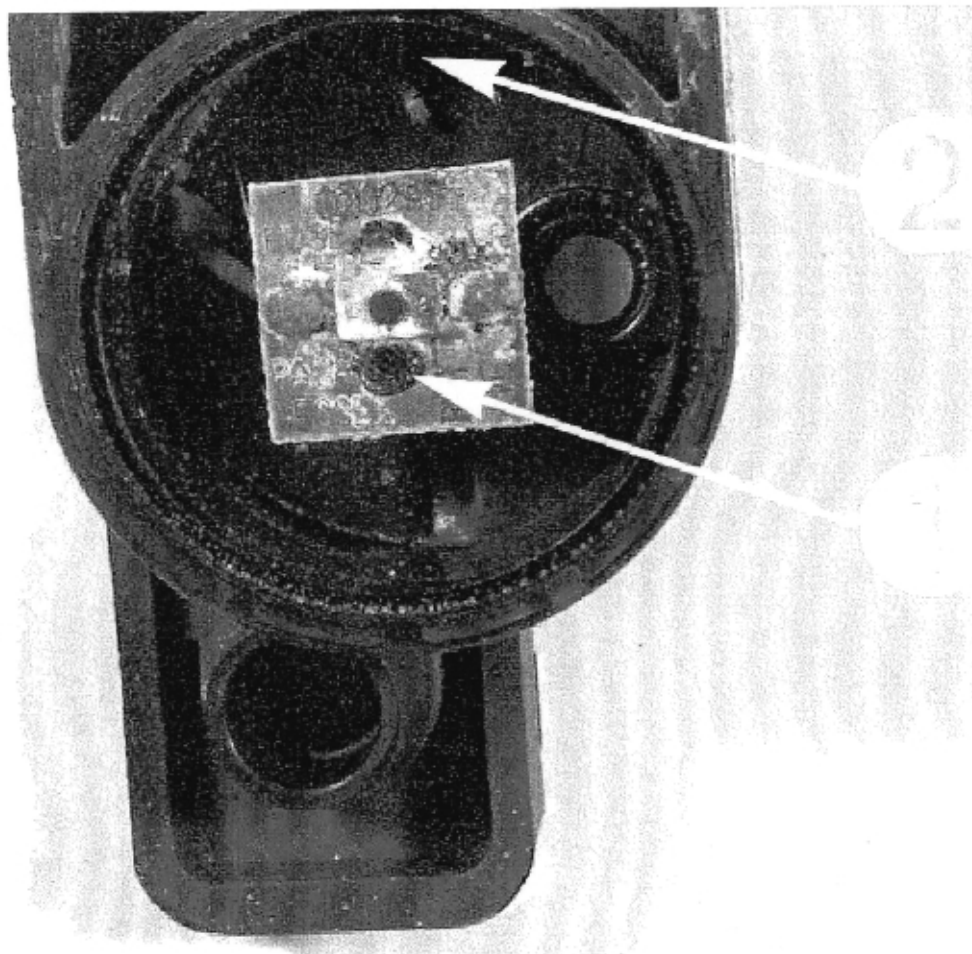
1. Illustrates the corrosion of the board,
2. Shows that the salt water was confined to the top of the unit due to the cle of the base of the unit.

In order for this level of galvanic action to take place the circuit board must be submerged in electrolyte (salt water). This could only happen if the HRU was mounted up side down.

- 7.2 The hydrostatic release unit manufacturers instructions should be strictly adhered to, with regard to the expiry date, not painting and using the correct fitting instructions. Marine Notice No. 6 of 2000 deals with the Stowage and Float Free arrangements for Inflatable Liferafts and is reproduced in Appendix 8.8.

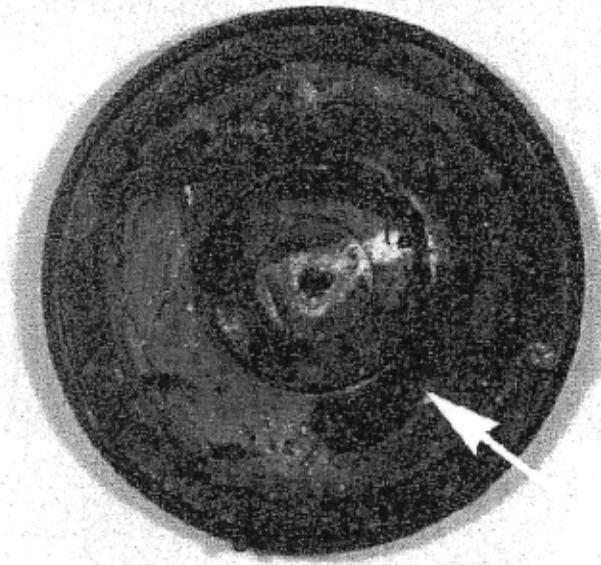
4. The view below is the internal surface of the diaphragm, which is mounted on top of the circuit board. This shows the build up of residue from the salt water, again verifying that there was evidence of water in the chamber under the diaphragm
