**REPORT OF THE
INVESTIGATION INTO THE
COLLISION INVOLVING THE
F.V. “*CLARA*” AND THE CARGO
VESSEL “*CORAL ANTILLARUM*”
OFF THE COAST OF CO.
WICKLOW ON 24TH AUGUST
2000.**

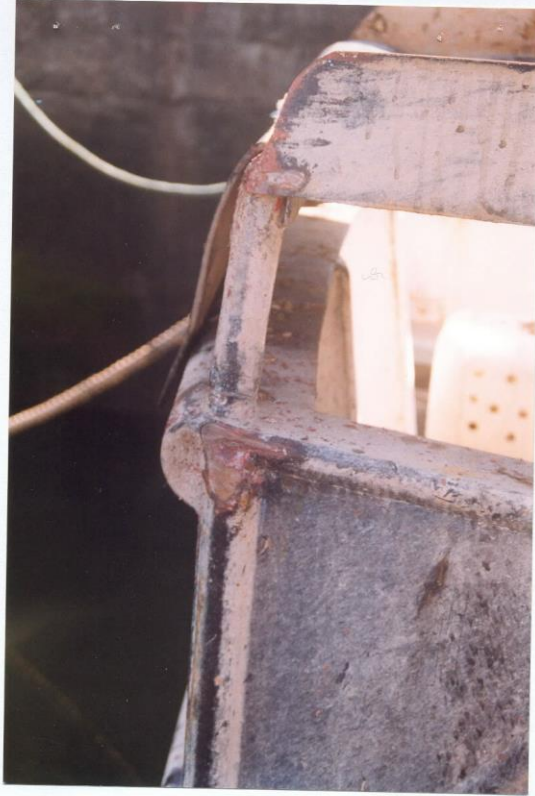
APPENDIX 8.9

- 5.1 The crew of the “Clara” checked the integrity of the hull and headed back to Wicklow harbour (See Appendix 8.9). As a precautionary step they transferred diesel out of the starboard side tank to port side tank.

- 8.9 Photograph showing the starboard aft corner of the “Clara” which was impacted by the “Coral Antillarum”.
- 8.10 This photograph shows a closer view of the side ramp where the paint chippings from the “Coral Antillarum” landed and were retained by the Investigator.

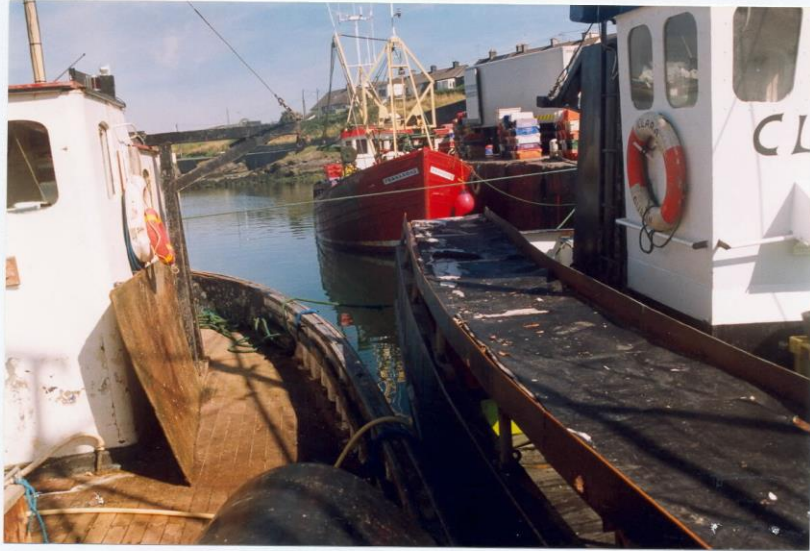
APPENDIX 8.10

- 5.6 The Skipper of the “Clara” was interviewed at the home port of Wicklow and his vessel inspected between 15.05 hours and 16.20 hours on 24th August, the afternoon of the collision. Some paint scrapings that had been deposited onto the side ramp of the fishing vessel from the hull of the unidentified colliding vessel were taken and placed in an envelope and retained by the Investigator (See Appendix 8.10).

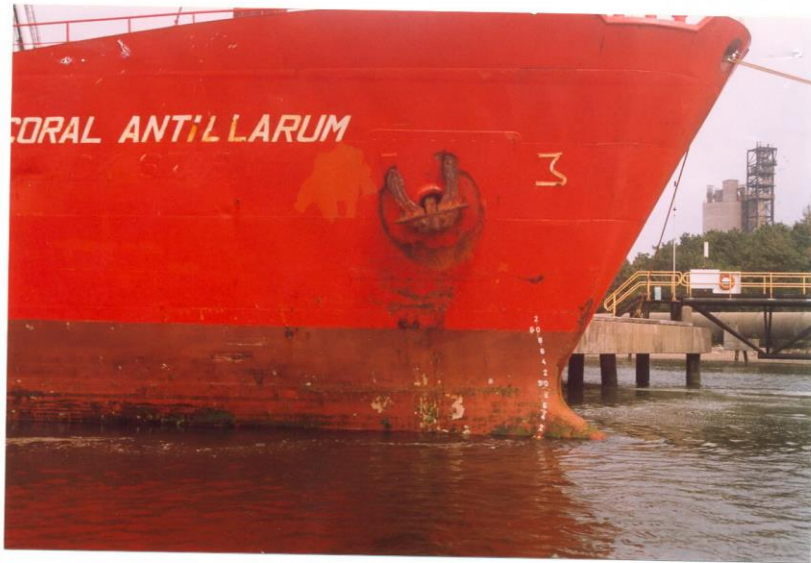
APPENDIX 8.11

- 5.8.4 Scuffmarks and paint markings that match the navy blue paint from the fishing vessel the “*Clara*” was noted. There were also scrapings, indentations to the steel with some missing layers of paint chippings consistent with recent contact damage. (See Appendices 8.11 and 8.12)

- 8.11 Photograph showing a closer view of the “Coral Antillarum” where the indentations may be seen below and aft of the anchor and just below the top line of the boot topping.

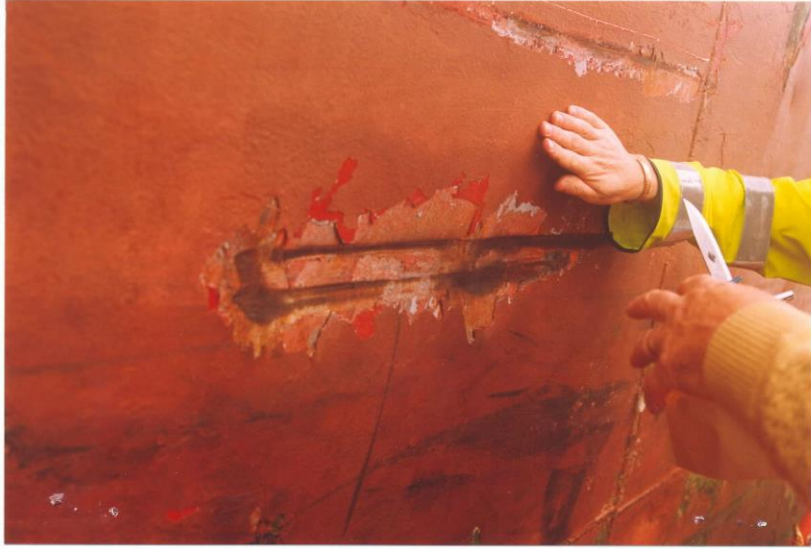
APPENDIX 8.12

- 8.12 This photograph shows a close up of the collision area and samples being taken. Retained by the Investigator and are on file.
- 8.13 Company Standing Order (1 page, page 5 of 12).

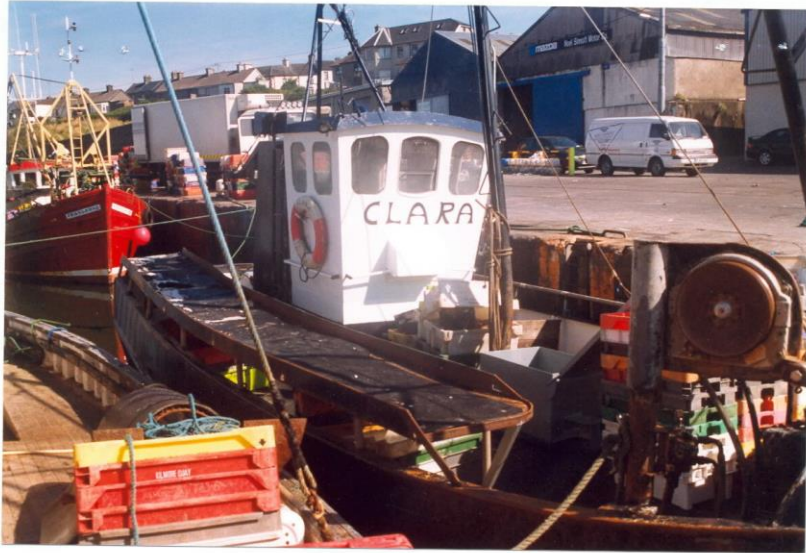
APPENDIX 8.3

- 8.1 Chartlet of area Dublin to Waterford.
- 8.2 Larger scale Chartlet of area Dublin to Arklow
- 8.3 This is a photograph of the “Clara” alongside Wicklow 24th August 2000. The side ramp for landing and re-baiting pots is seen on the starboard side.

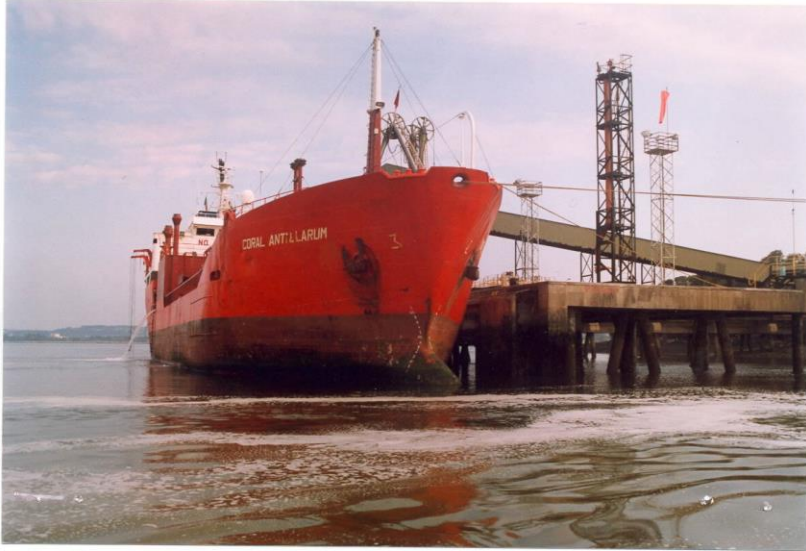
APPENDIX 8.4

- 8.4 Photograph showing the “Coral Antillarum” alongside IFI, Marino Point, Cork
25th August 2000.
- 8.5 Weather Report from Met Eireann for 24th August 2000.
