REPORT OF INVESTIGATION
INTO FATAL INCIDENT AT
CULLENSTOWN,
CO. WEXFORD
ON
7th SEPTEMBER 2010.

REPORT No. MCIB/190 (No.10 of 2011)

Report MCIB/190 published by The Marine Casualty Investigation Board Published 26th August 2011.

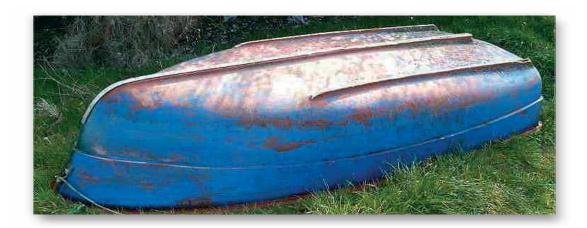
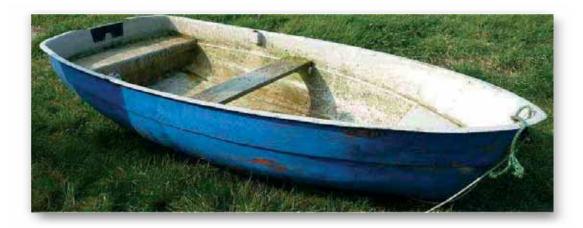
2.1 Description of Vessel

The boat was a small GRP (Glass Reinforced Plastic) punt with buoyancy built in forward and aft. A single seat was fitted close to midship. The boat was not a registered fishing vessel.
