**REPORT OF THE
INVESTIGATION INTO THE
COLLISION BETWEEN
THE YACHT "DEBONAIR" AND
CARGO VESSEL "BLUEBIRD"
IN DUBLIN BAY ON
20TH MAY 2001.**

Published by The Marine Casualty Investigation Board
11th February 2005

1. SYNOPSIS

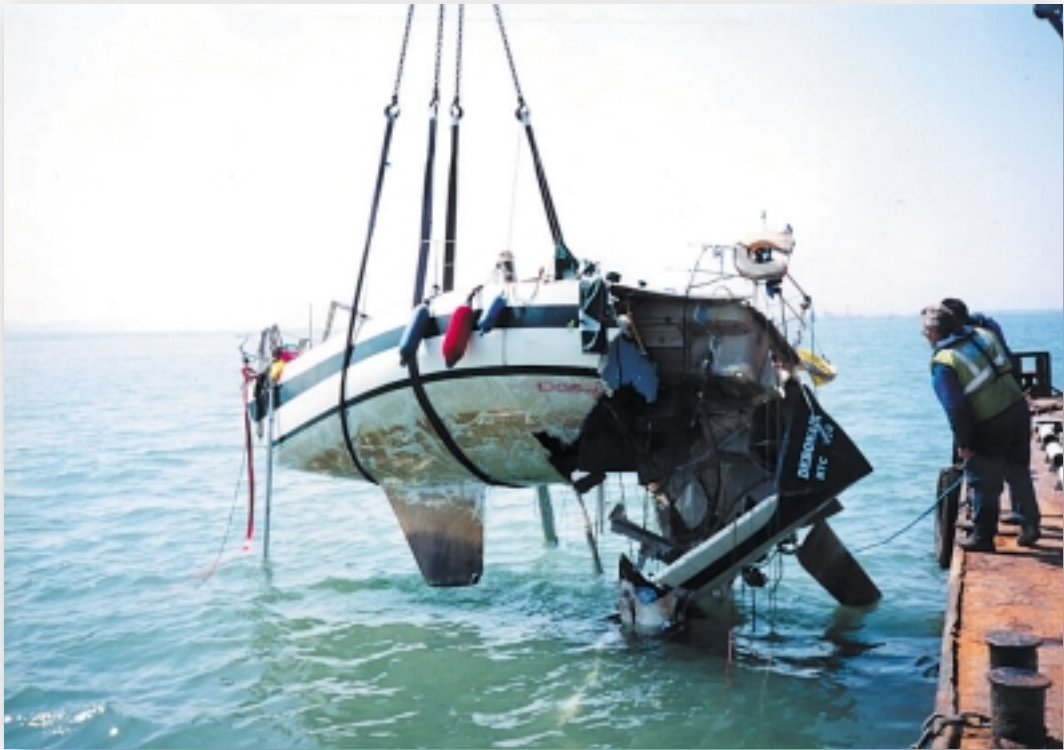
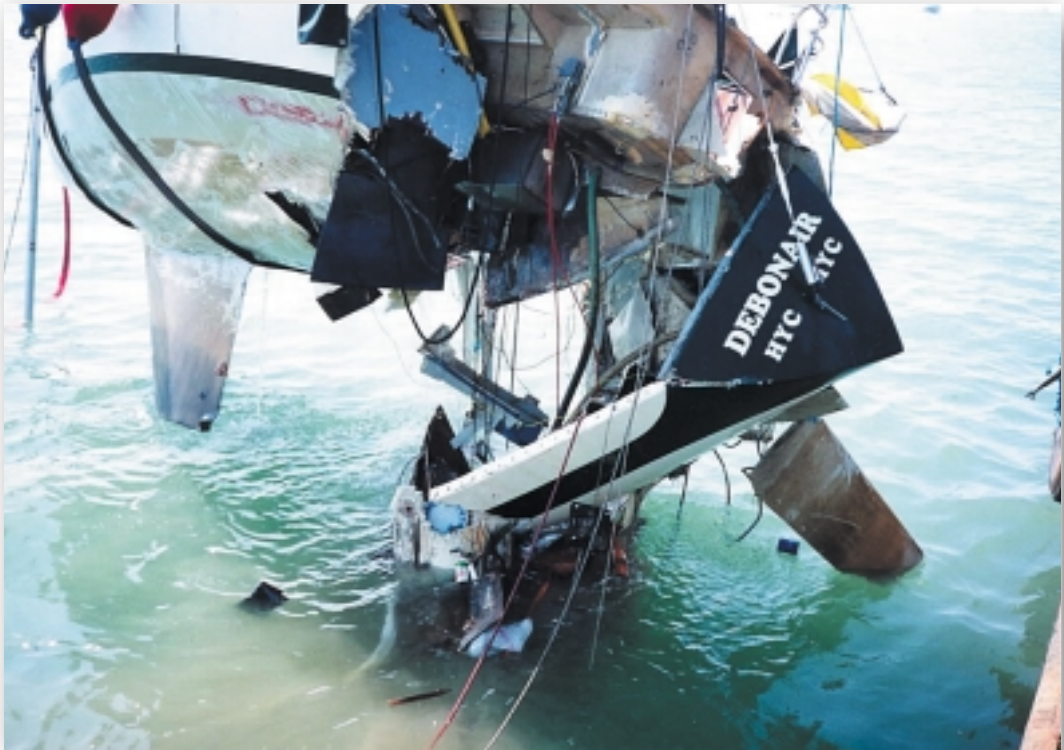
Appendix 12.6

- 7.2 The hull of the yacht, which was of GRP construction, was broken right across from the starboard side to the port side, just aft of midship. From the paint markings on the hull of the yacht it would appear that contact was initially made on the starboard side of the yacht just aft of midship. Also, the mast of the yacht made contact with the bulwark forward on the forecastle head of the "Bluebird".

- 7.4 At this point it would appear that the hull of the "Debonair" was already broken, as there is evidence of red paint on the broken GRP of the yacht. As there are also red paint markings on the port side of the yacht it would appear that the yacht was then pushed totally over before finally sinking.

- 7.6 Examination of the impact damage to the hull, propeller shaft and other items of equipment would indicate that the severing of the control cables was consistent with the collision damage and probably occurred at the time of collision.

Photographs showing damaged yacht "Debonair"

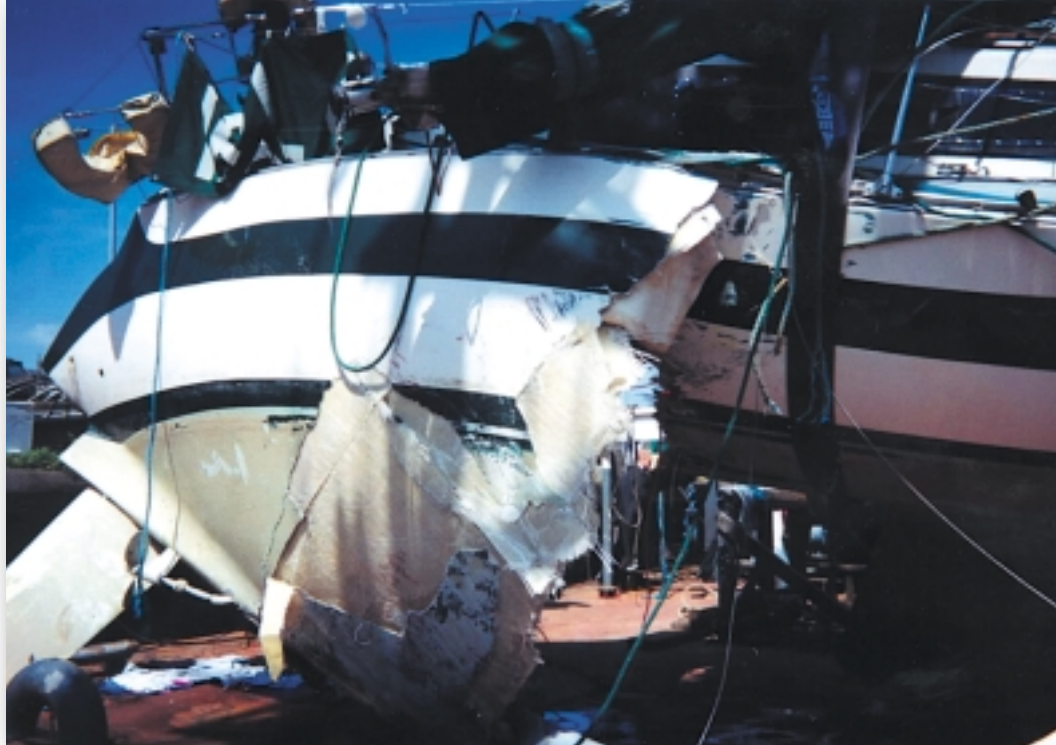
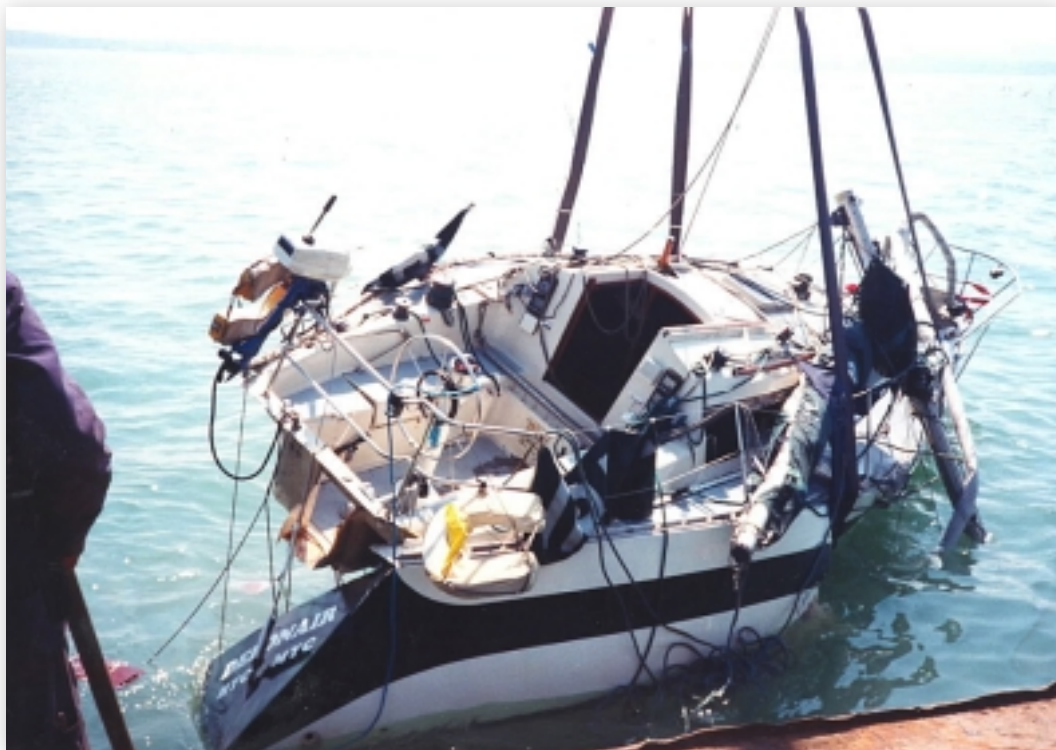
Appendix 12.6

- 7.8 The steering gear on the "Debonair" was also examined. Modifications were carried out to the original design but there was no reason to believe from the inspection that the steering malfunctioned. There was damage to the steering but again this was consistent with the collision damage and probably occurred at the time of the collision.

Photographs showing damaged yacht "Debonair"
