**REPORT OF INVESTIGATION
INTO "DUGGIE'S PRIDE" OFF
GREENORE POINT,
ROSSLARE, CO. WEXFORD
ON
15th MAY 2010**

**REPORT No. MCIB/184
(No. 2 of 2011)**

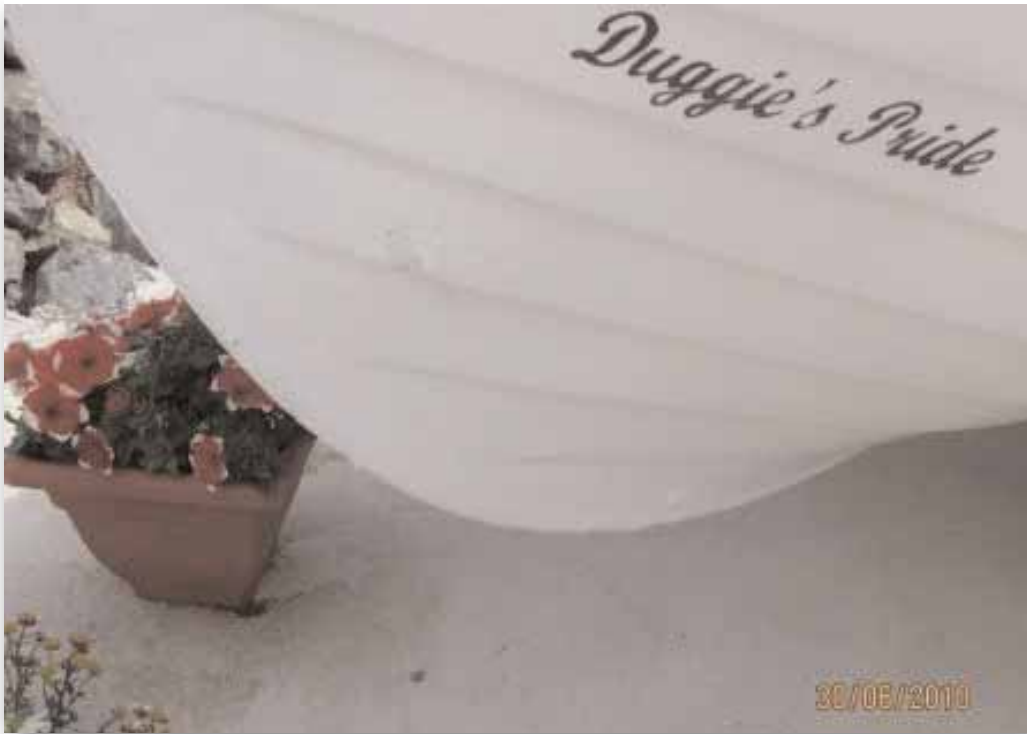
- 6.1 The vessel was viewed at the head of the area referred to as the lagoon. It was on shore and in an area cordoned off by railings and rope. There was evidence of minor repairs to the hull, particularly towards the port side of the fore foot (see appendix 8.1(a). This had no bearing on the casualty. The only significant openings were the transom well drain holes at 0.57 m above the base of the keel, and a slight reduction of transom height at the engine mounting point (see appendix 8.1(b). This was considered important when later it was advised that the vessel was floating at two strokes above the water, which allowed water to enter through the hull. The transom well drain holes were at the same level.

(a) Repair at port bow

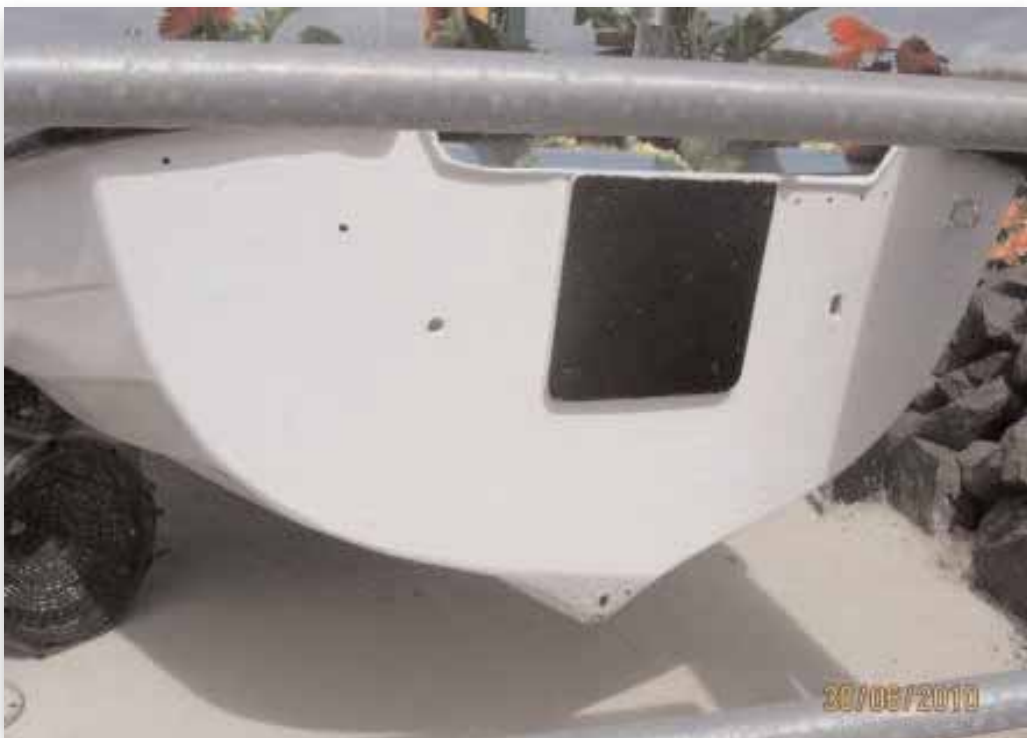
(b) Transom drain holes almost at same level as second strake from gunwhale.
