**REPORT OF
THE INVESTIGATION
INTO THE GROUNDING AND
FLOODING OF AN
EMERALD STAR
HIRE CRUISER
ON LOUGH DERG
ON 1ST JULY 2006**

REPORT No. MCIB/127

Report MCIB/127 published by The Marine Casualty Investigation Board
18th March 2008

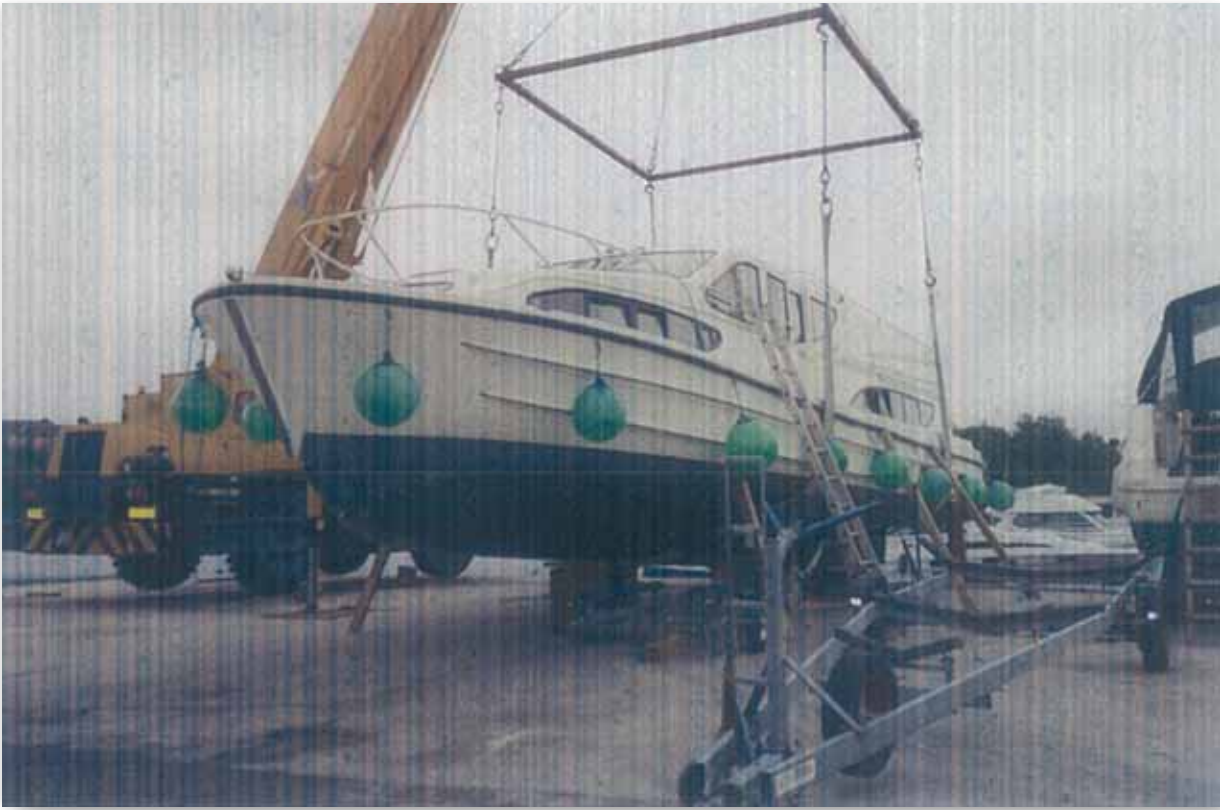
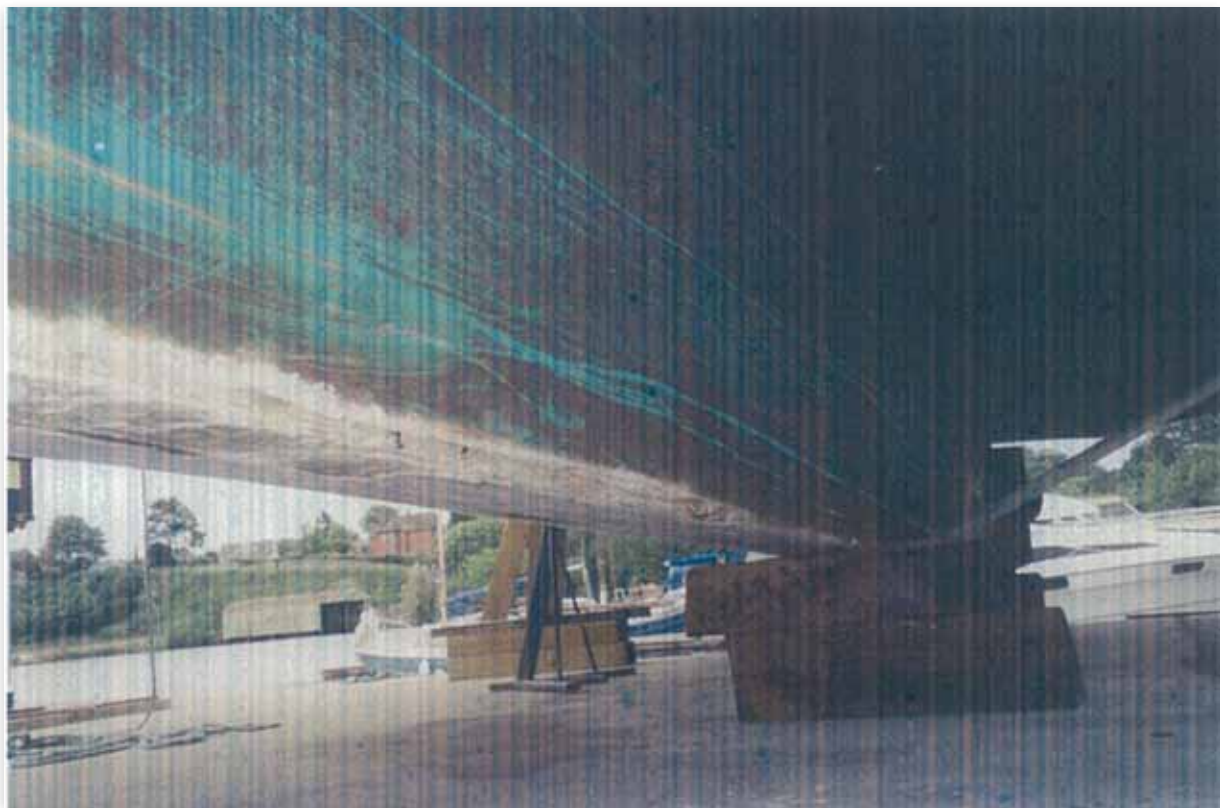
Appendix 7.1 Photographs

The vessel was inspected afloat prior to repairs being carried out. Damage was noted to the skeg extending over approximately 1m in length at approximately mid length of the vessel. (See photographs at Appendix 8.1). The damage found was consistent with the reported grounding incident.
