**REPORT OF THE
INVESTIGATION INTO THE
COLLISION BETWEEN IRISH
REGISTERED TRAWLER
"PRINCESS GRAINNE" AND
PLEASURE CRAFT
"TOUCH - N - GO"**

The Marine Casualty Investigation Board was established on the 25th March, 2003 under The Merchant Shipping (Investigation of Marine Casualties) Act 2000

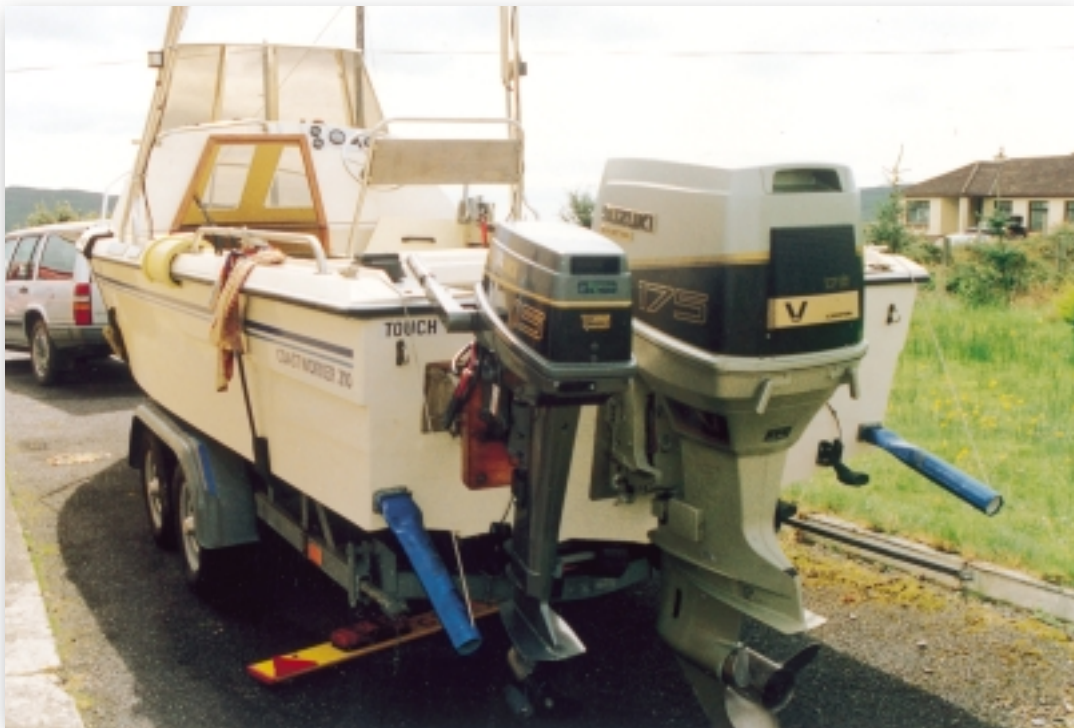
'Touch-n-Go' at the cottage base 17/8/98. The smaller outboard was said to be in the cabin at the time of the incident.

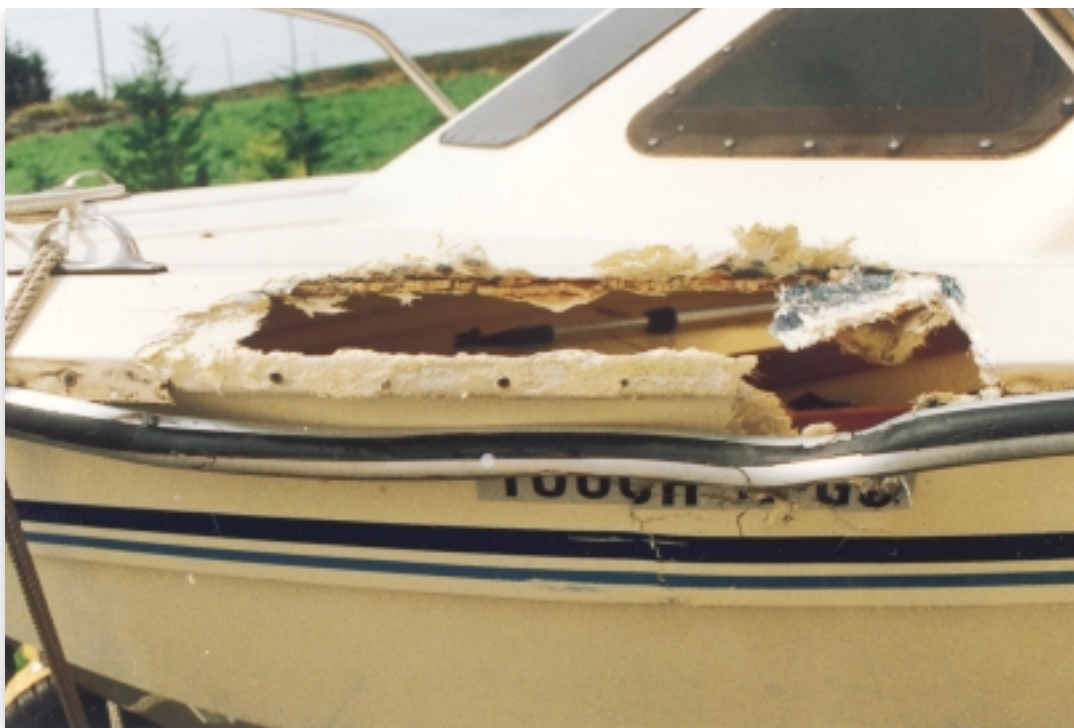
- 4.3 "Touch-n-Go" was forced back by the impact from the trawler and holed on the port side in a position well above the water line. It was stated that the boat was taking water over the stern while the boat was being pushed either sideways and/or astern into the water. (Refer to Photographs in Appendix 8.9).

Damage sustained to port side of 'Touch-n-Go'.

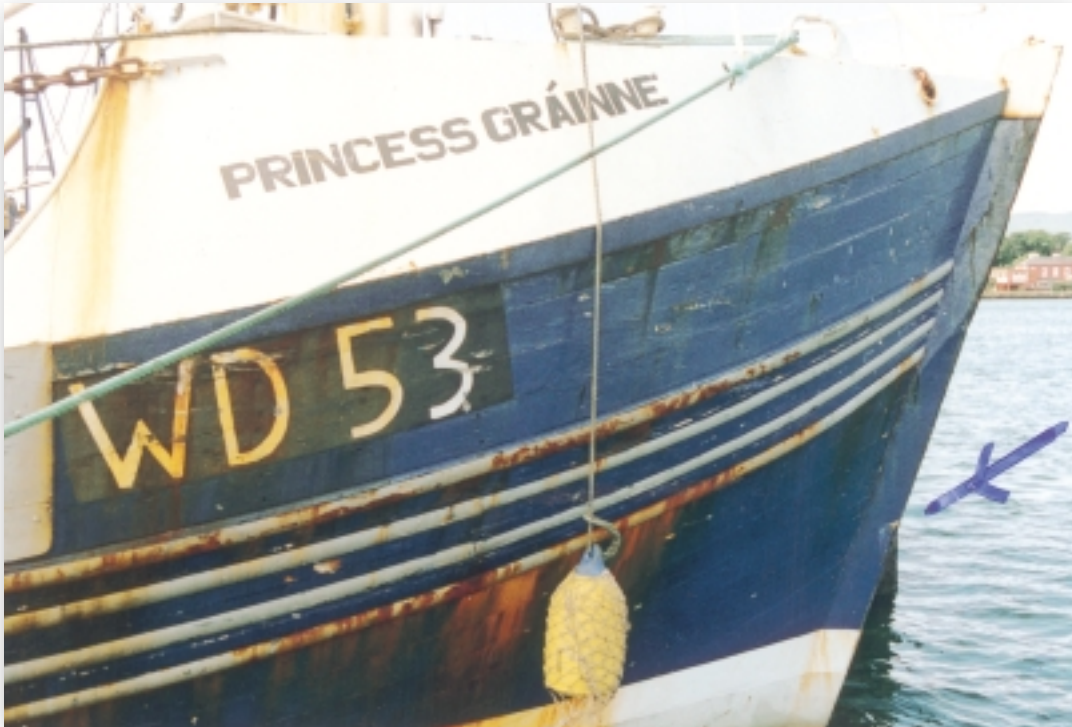
Arrow points to impact scuff marks where 'Princess Grainne' made contact with 'Touch-n-Go'.

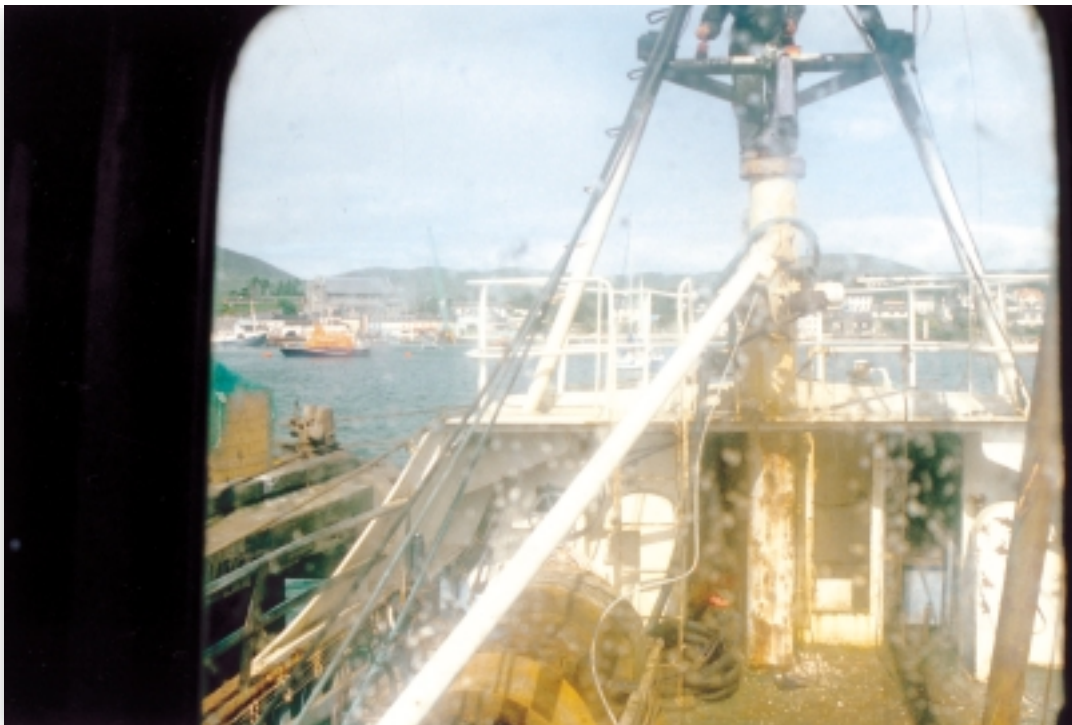
Visibility through forward facing window to the port side of wheelhouse 'Princess Grainne'.
