**REPORT OF THE INVESTIGATION  
INTO THE GROUNDING OF  
MV “HUELIN DISPATCH”  
ON PIERRE AU VRAIC  
21st SEPTEMBER 2012**

**REPORT No. MCIB/226  
(No.14 of 2013)**

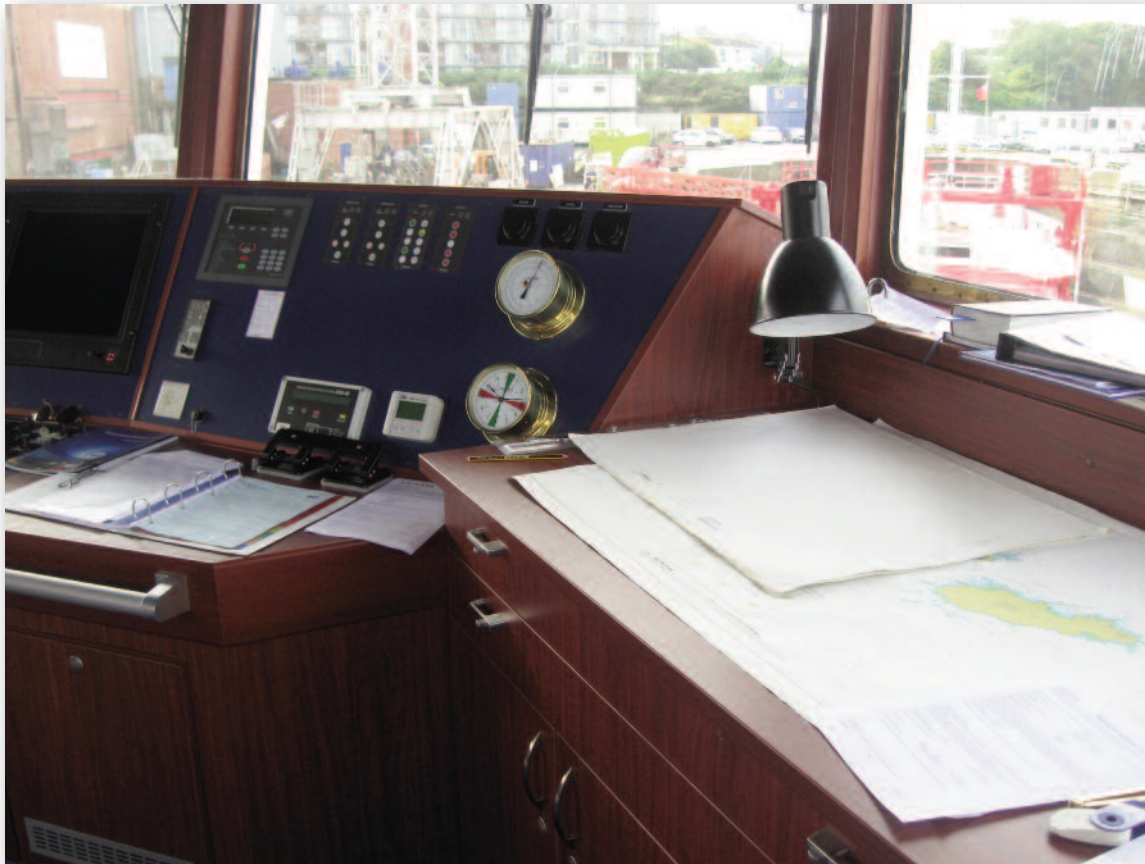
Appendix 7.2 Photograph of chart table on bridge, faces forward.

3.12 The vessel was being conned from the starboard side of the bridge, using the starboard radar unit and a chart set out beside him on a chart table set against the fore part of the wheelhouse (see Appendix 7.10).

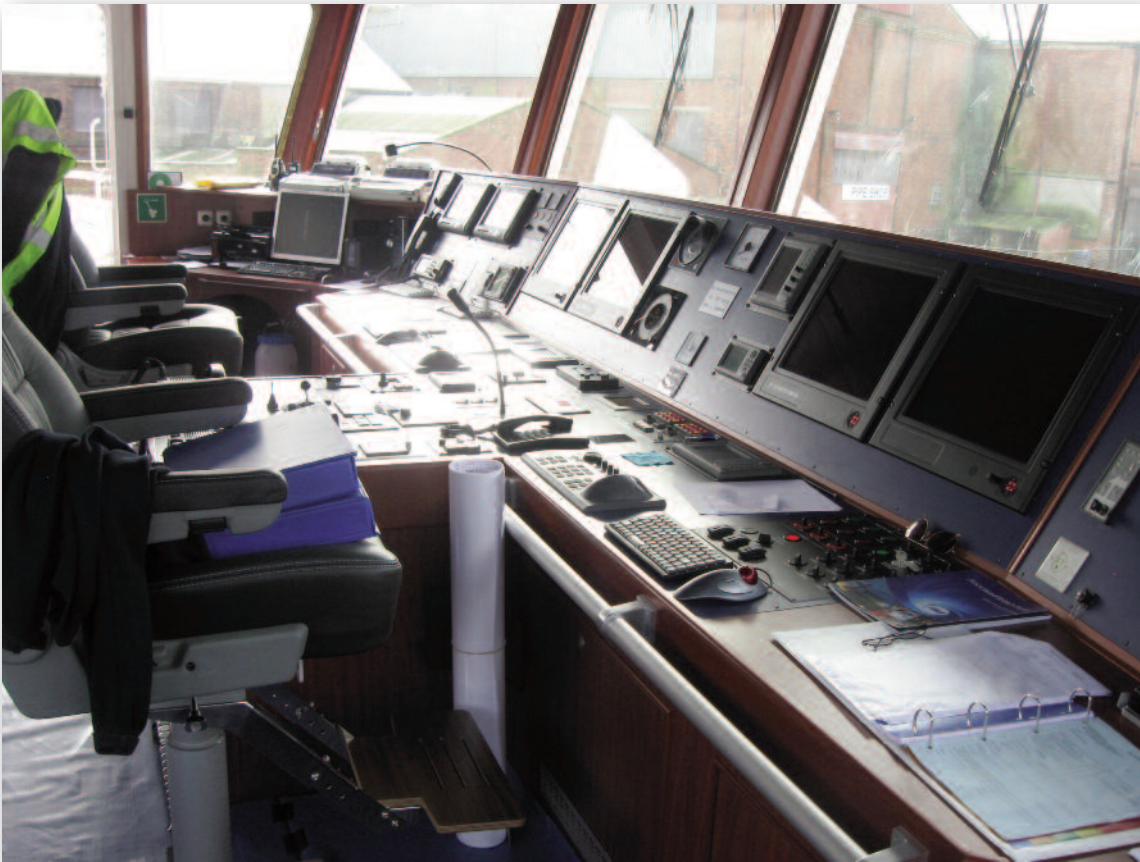
Appendix 7.3 Photograph of control console section being used by Master.

3.11 The vessel’s ECDIS was not performing correctly and the Mate/Relief Master was attempting to rectify the problem. Positions were plotted by transposing data from the GPS display to the chart. No secondary checks such as radar observations, or visual bearings were used.

- 6.1 The bridge team for the MV *“Huelin Dispatch”* should receive bridge resource management training and training in the use of ECDIS.

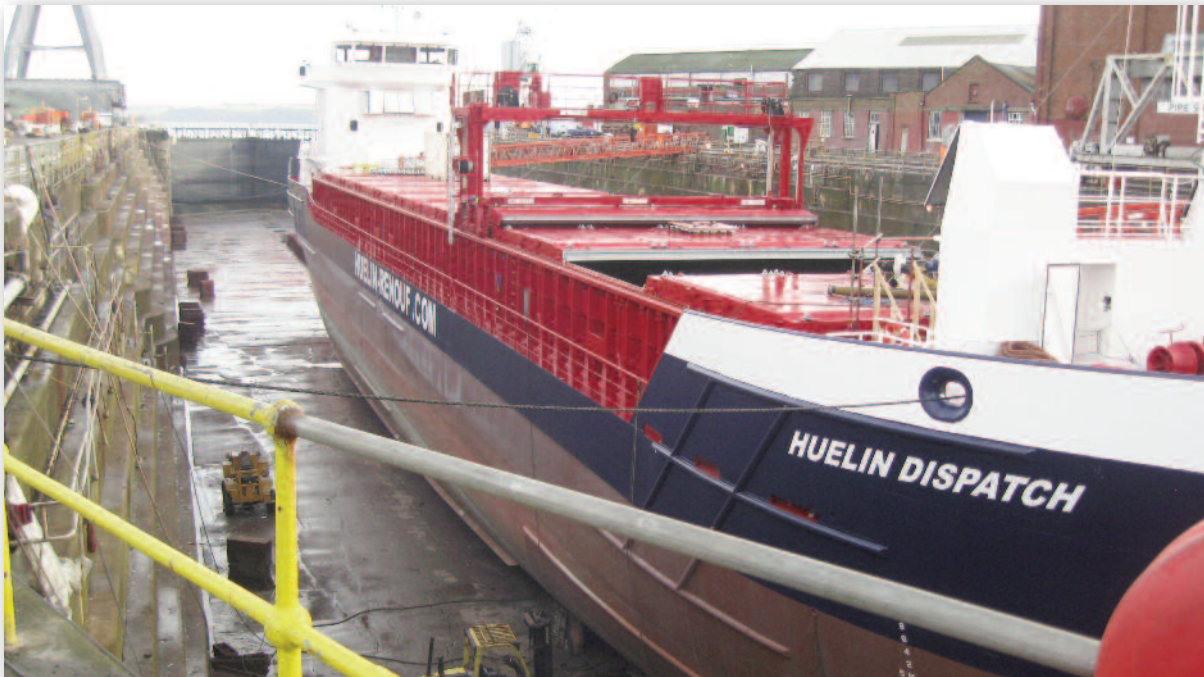
Appendix 7.5 Photograph of vessel in drydock, Flamouth.

3.13 The vessel suffered structural damage in way of the no. 1 ballast tank (Forepeak) and the bow thruster compartment. It is understood that approximately 10 tonnes of steel had to be replaced.

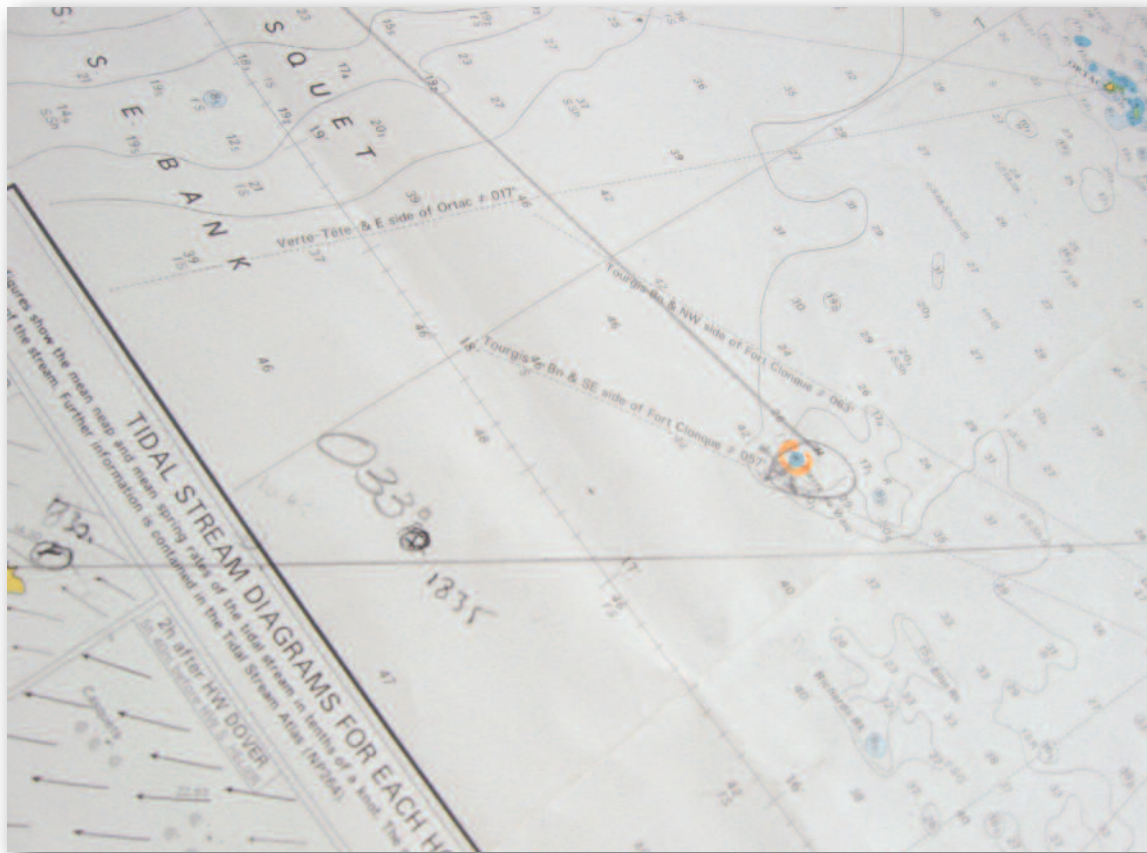
Appendix 7.6 Photograph of chart BA 60, showing course line and last two positions of vessel before incident.

“*Huelin Dispatch*”. The paper charts in use were British Admiralty Charts nos. BA 3653 and BA 60. The charts were corrected to date. The rock was clearly marked on the chart and that it dries at 1.2 metres above chart datum. The height of the tide at the time of the incident was about 1.67m and there was less than 0.6m of water over the top of the rock. In addition, the rock was encircled in pencil on the chart and was highlighted. Courses were marked permanently on the charts (see Appendices 7.6, 7.7 and 7.8).

- 5.1 The incident occurred due to an error in navigating the vessel. In considering the causes the investigator has noted:
  - 5.1.1 Operational pressures on the Master, the owner of a new vessel, a new crew and planning a first voyage.
  - 5.1.2 There was an electrical failure that used part of the Master's rest period in St. Helier.
  - 5.1.3 There was an electronic failure of the vessel's ECDIS system.
- 5.2 For a vessel that is not familiar with the waters it would be better to approach the Island from the eastern side, as there is more open water.
- 5.3 Insufficient consideration was given to the effect of set and drift in an area where it is known that there are strong tidal currents.
- 5.4 The change from one chart to another prevented a long term assessment of the course made good. The last three positions plotted were to the west of the course line.

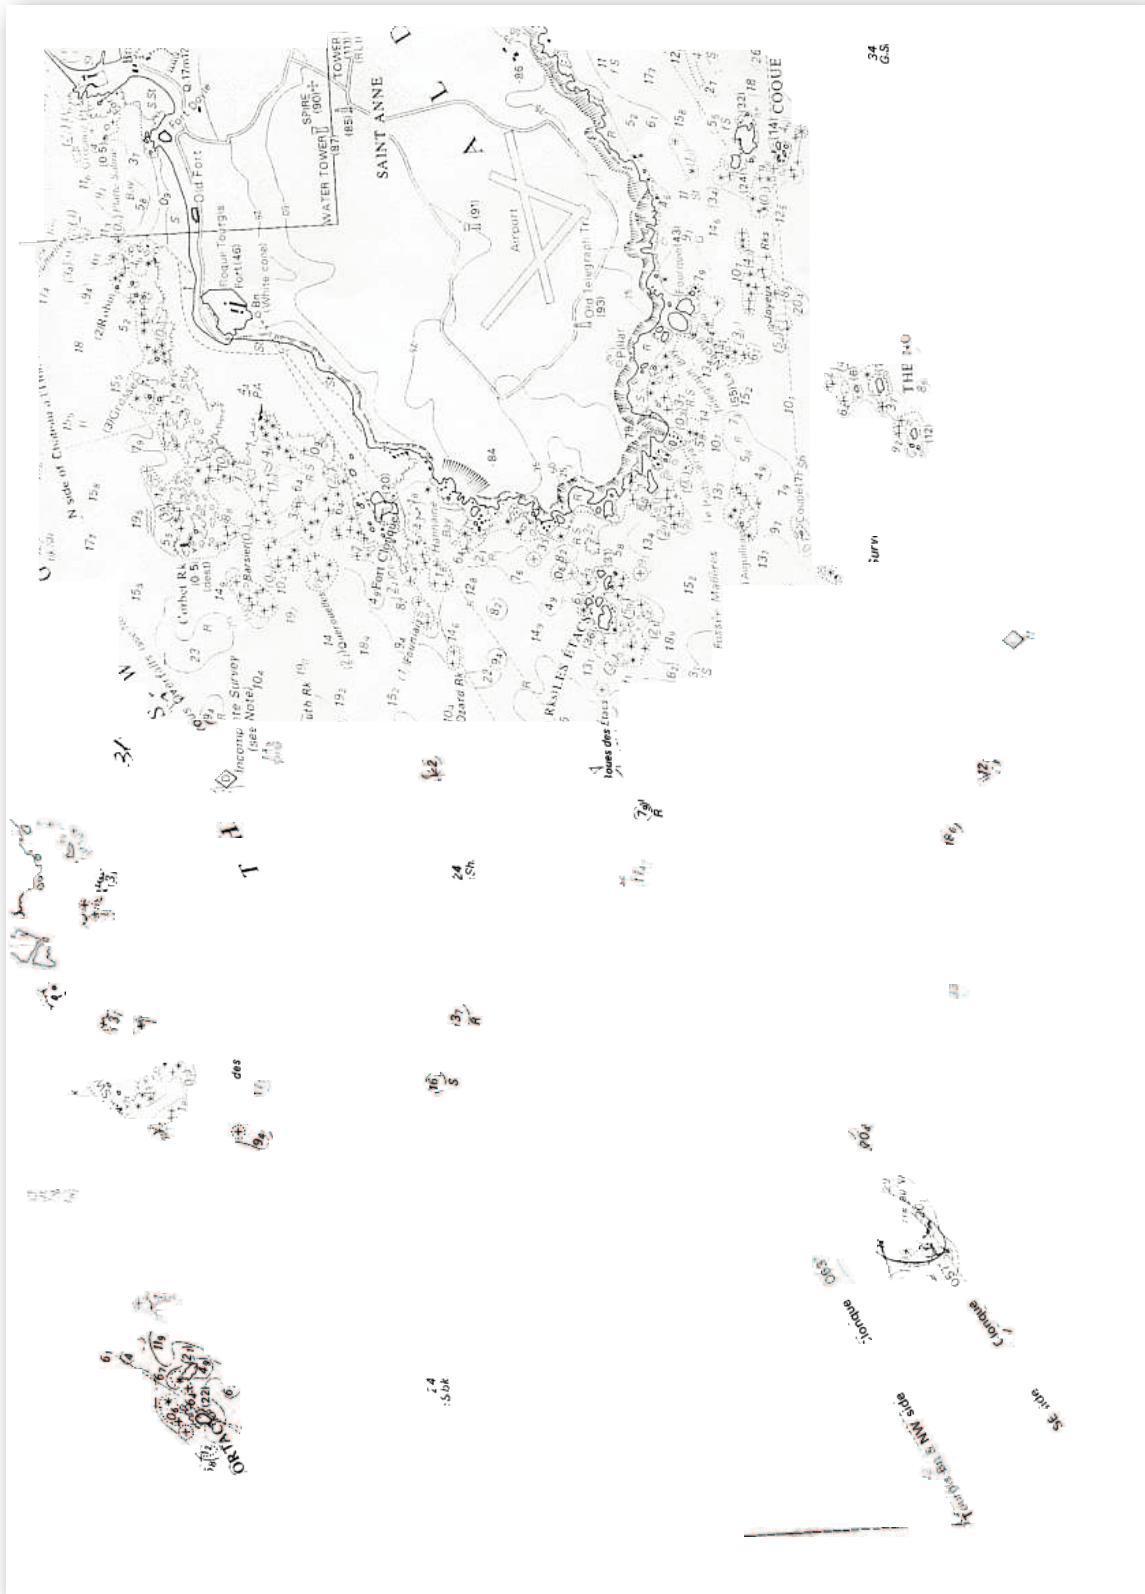
Appendix 7.10 Photocopy of chart in use, taken on board vessel.

The course marked permanently on the charts onboard the vessel was some 6 cables west of this recommended safe approach line.
