**REPORT INTO A FIRE  
ON BOARD THE  
IRISH REGISTERED VESSEL  
MV "INISHFREE"  
ON 21 FEBRUARY, 1997.**

The Marine Casualty Investigation Board was established on the 5<sup>th</sup>, June 2002 under The Merchant Shipping (Investigation of Marine Casualties) Act 2000

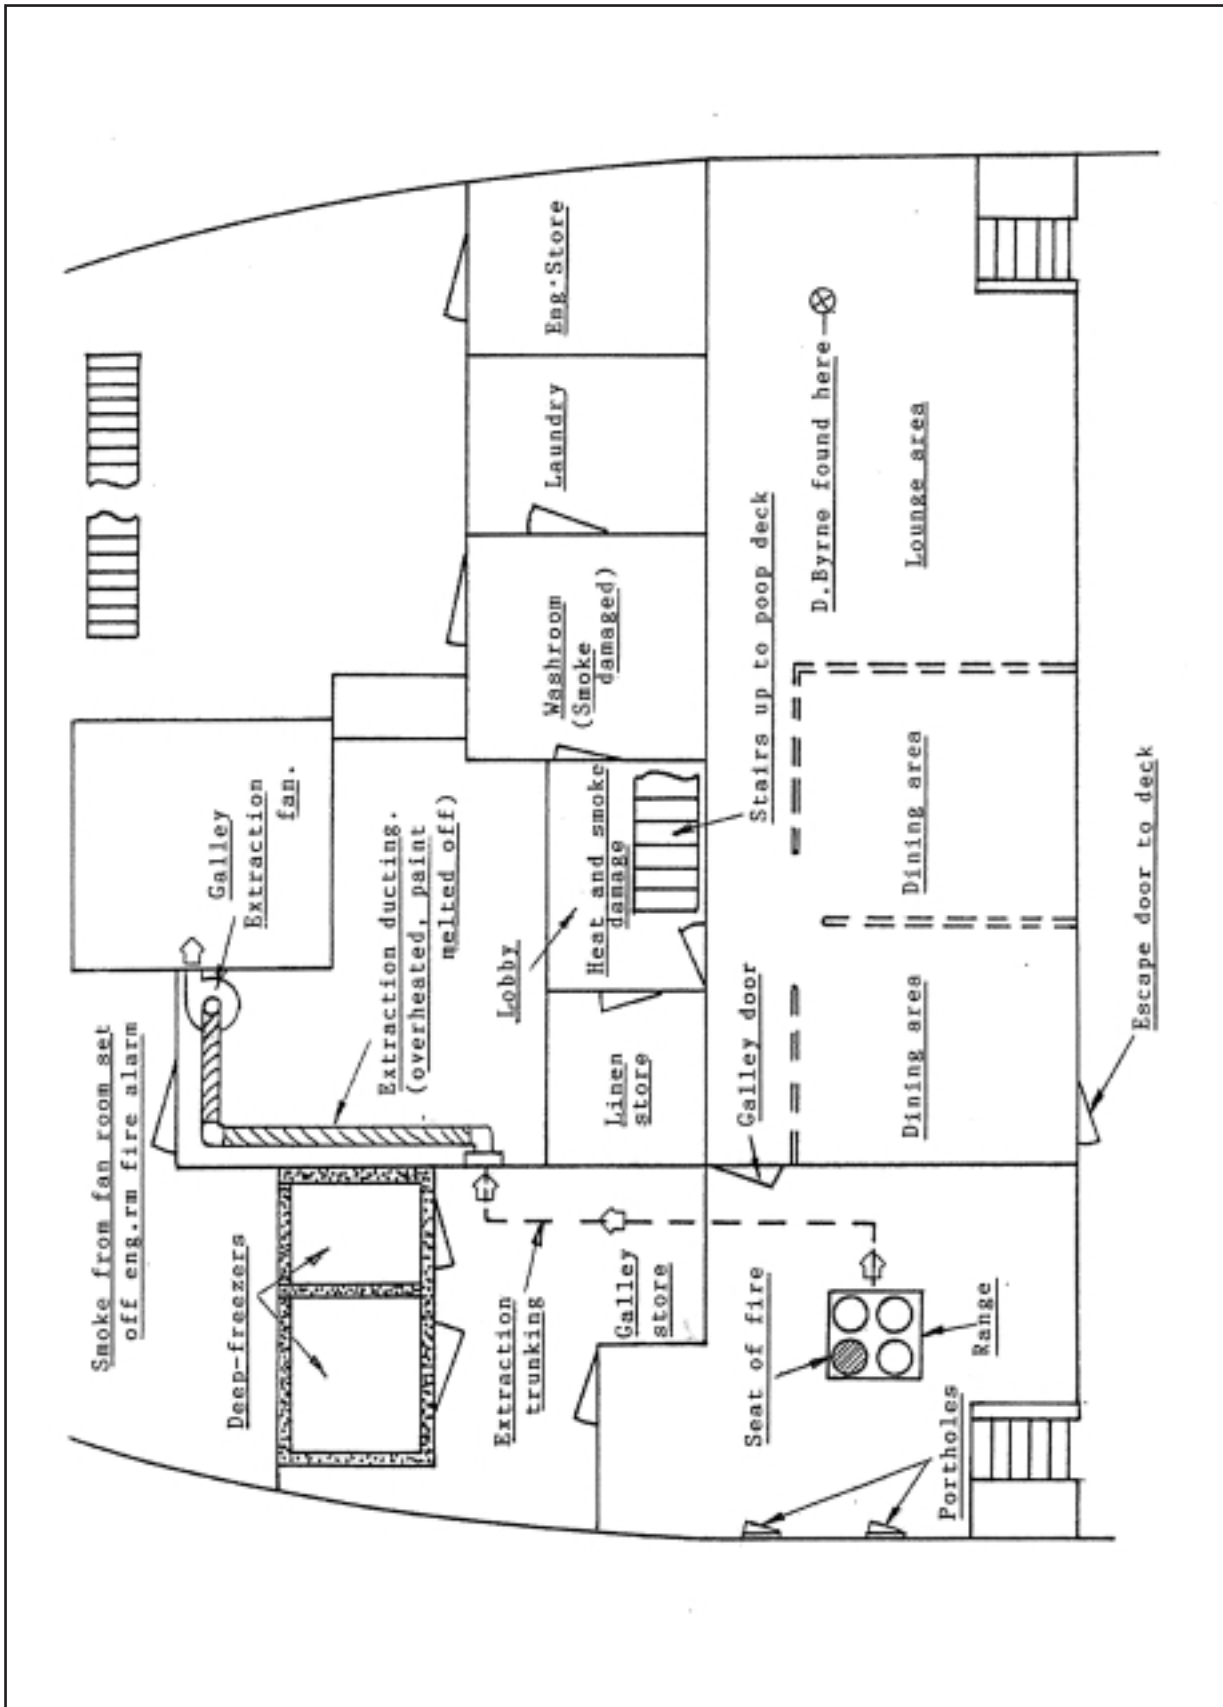
- A 2.5 In addition, the galley was fitted with a dedicated extraction system to serve the area over the range in order that cooking odours and vapours would be extracted directly. An extraction unit was fitted in the deckhead (ceiling), over the range, which incorporated wire mesh filters, which would act as traps for oil vapours, which would condense on the mesh and accordingly, would not be carried into the ventilation trunking where they would pose a serious fire hazard. This extraction unit was connected via galvanised steel trunking to the bulkhead between the adjacent stores area and the fan room. The ducting then changed into a fabricated steel structure as it passed through the bulkhead into the fan room. Within the fan room, the ducting reverted to galvanised steel trunking (300mm round section) which passed to the aft, inboard side of the fan room to the extraction fan itself and was attached to the fan with a short flexible fabric transition piece. The fan was attached to another steel "box" which connected it to the funnel casing and to atmosphere. (See Appendix 6).

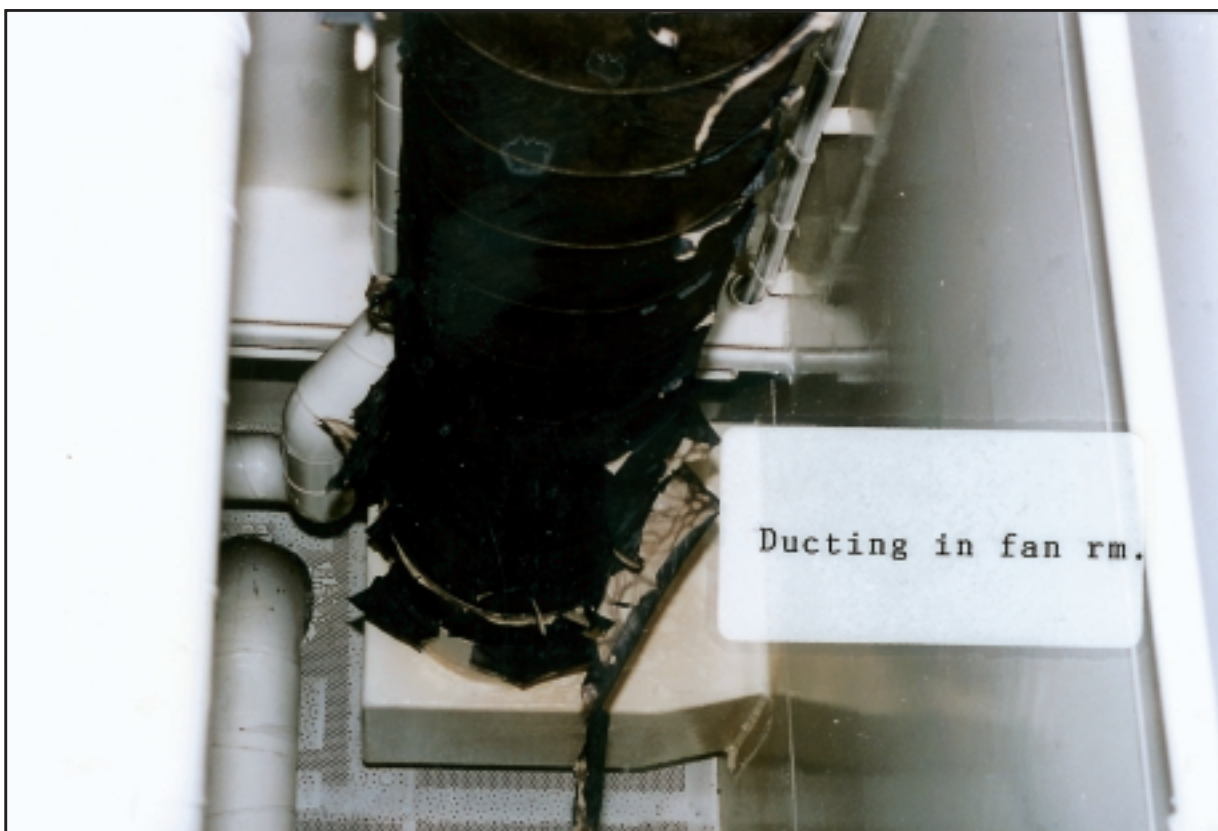
- 5.3 The galley ventilation trunking was examined in the fan room and showed evidence that it had been subjected to considerable heat internally. The trunking was blackened with all of the paint melted off and lying on the deck in strips. (see photographs at Appendix 7)

Ducting in fan rm.

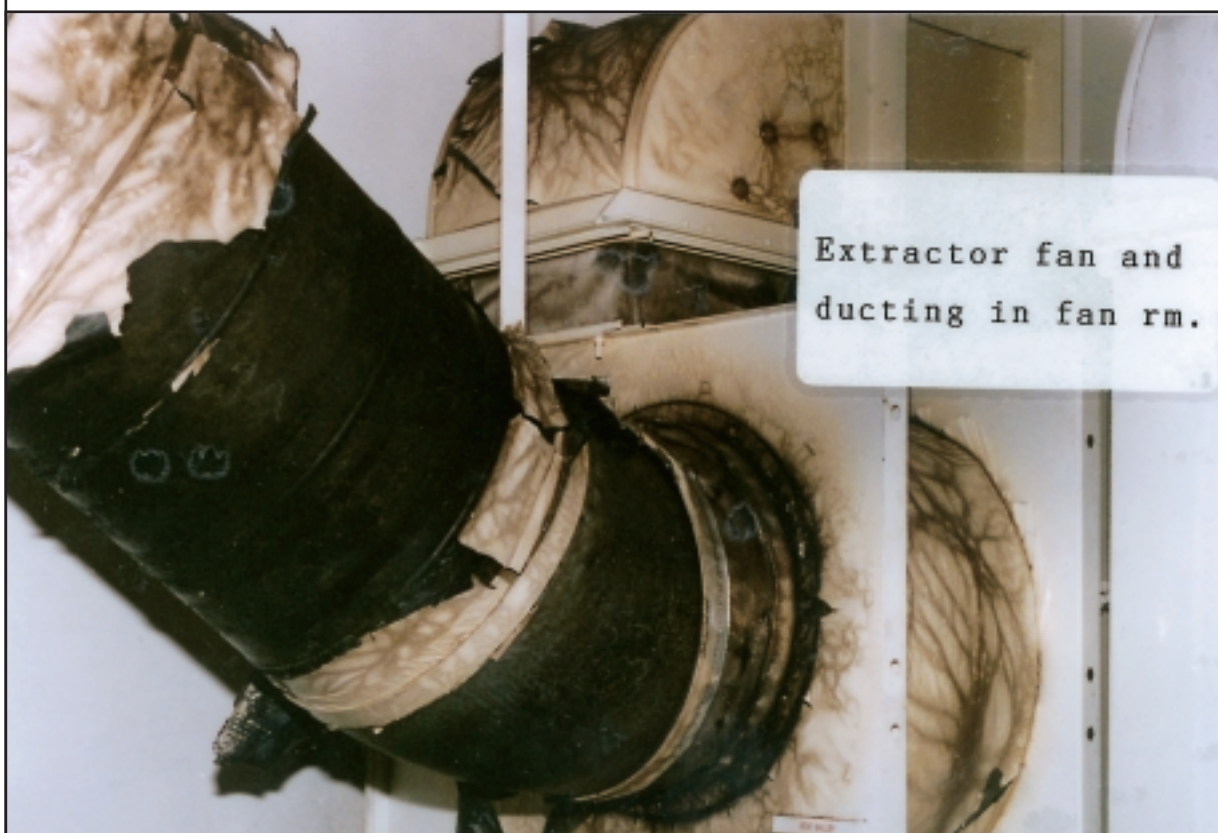
Extractor fan and ducting in fan rm.
