**REPORT OF INVESTIGATION  
INTO  
THE LOSS OF A CREWMEMBER  
OVERBOARD MFV 'JANIREH'  
ON  
13th FEBRUARY 2010**

**REPORT No. MCIB/179  
(No.5 of 2011)**

Report MCIB/179 published by The Marine Casualty Investigation Board  
Published 2nd June 2011.

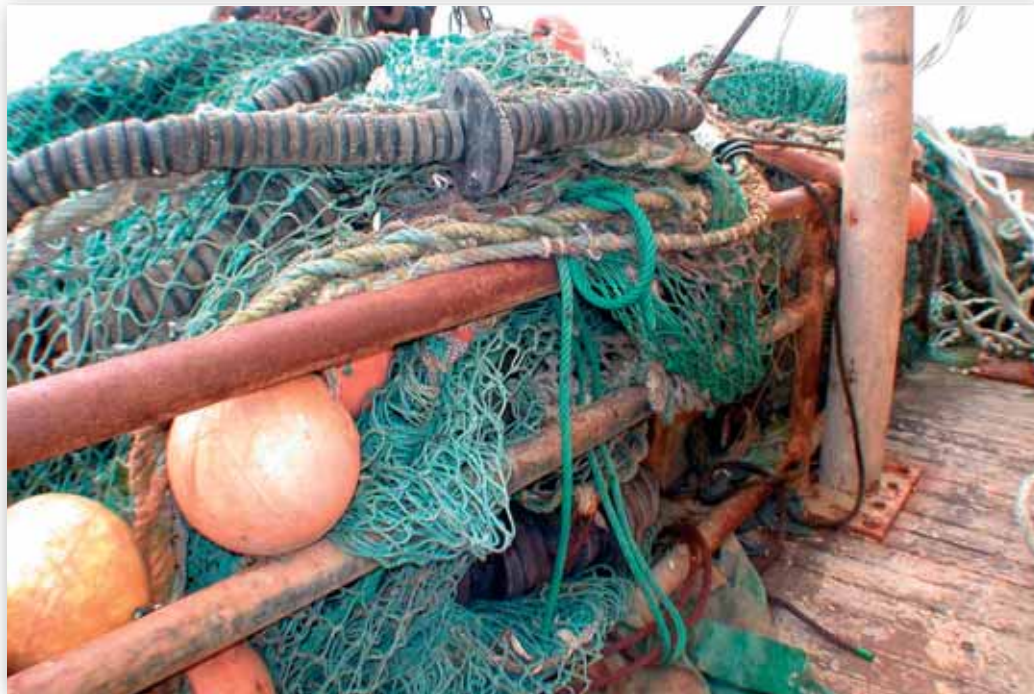
- 3.6 With the gear ready to heave forward the clump backstrap became fouled in the centre warp preventing its forward movement. The Skipper climbed up on to the starboard side of the net bin and stood on the stowed spare nets while he attempted to release the fouled elements (see photos 1 and 2).

Photo 1 - Net bin arrangements viewed to port with position of clump visible aft.

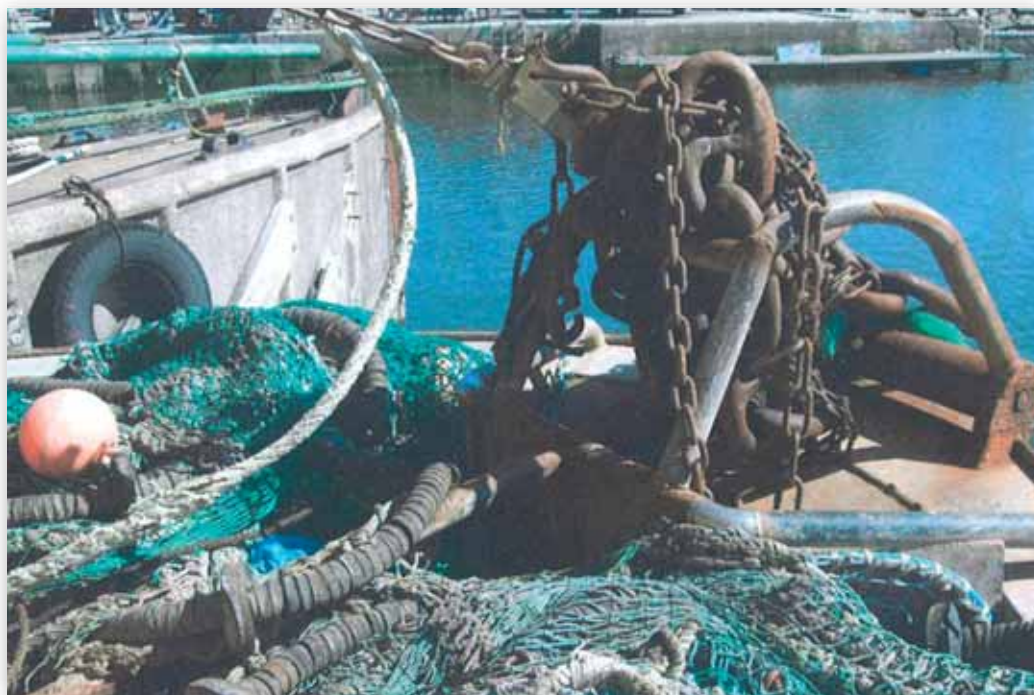
Photo 2 - View to starboard over net bin with clump secured in its cage on bulwark rail and securing senhouse slip in place.

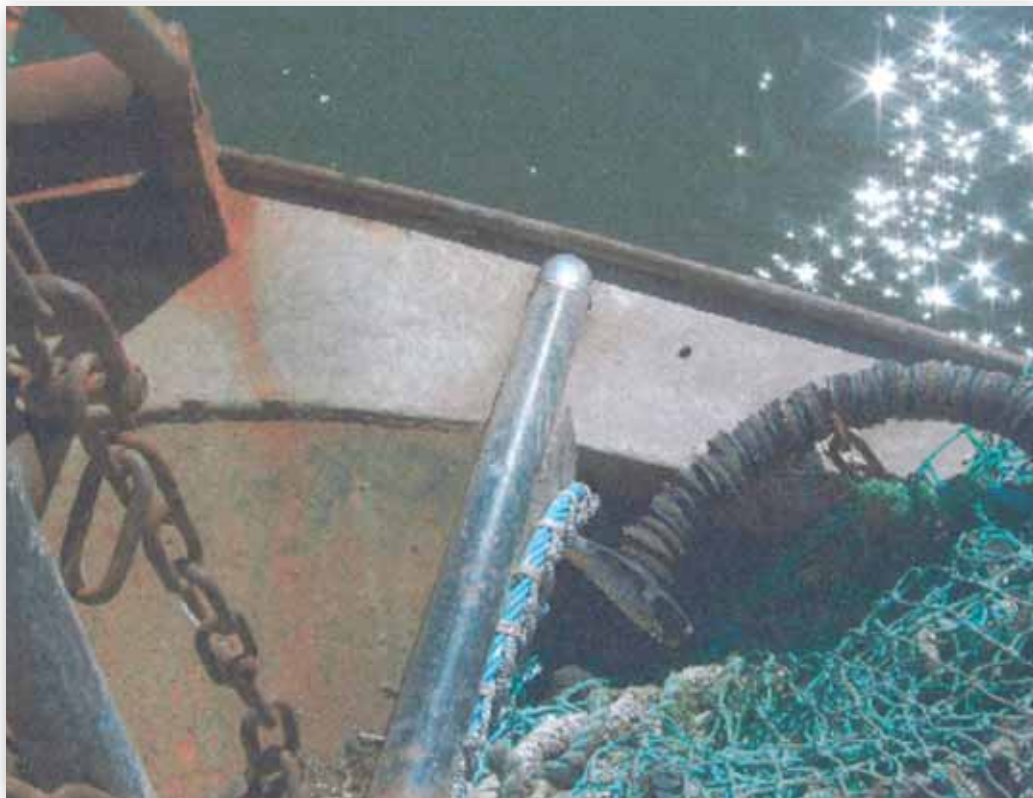
- 3.7 Mr. Sehsaah climbed up onto the portside to assist the Skipper, standing with one foot on the stowed spare nets in the net bin and the other on the bulwark rail with his back to the rail (see photo 3).

Photo 3 - View of the portside aft area of bulwark rail capping arrangements.

- 6.1 Mr. Sehsaah is most likely to have overbalanced while standing on nets stowed in the port net bin with his foot supported by the rail while attempting to release fouled elements of the trawl gear. His body was not recovered.
- 6.2 Mr. Sehsaah was not wearing a PFD.
- 6.3 Weather was not a factor.
- 6.4 The Board notes that this vessel comes within the scope of S.I. No. 640 of 2007 and is within the last tranche of vessels to comply with these new rules.

- 7.1 There is an onus on the fishing industry including the representative organisations, vessel owners, skippers and crews amongst others to take responsibility for the safety of the industry and they should work to improve the safety culture within the fishing industry. For this reason the Board recommends the implementation of an appropriate Safety Management System for such vessels, in particular the wearing of lifejackets/PFDs by crew at all times.
