**REPORT OF INVESTIGATION
INTO DUAL FATALITY OFF
SKERRIES,
NORTH COUNTY DUBLIN
ON
1st APRIL 2011**

**REPORT No. MCIB/200
(No.4 of 2012)**

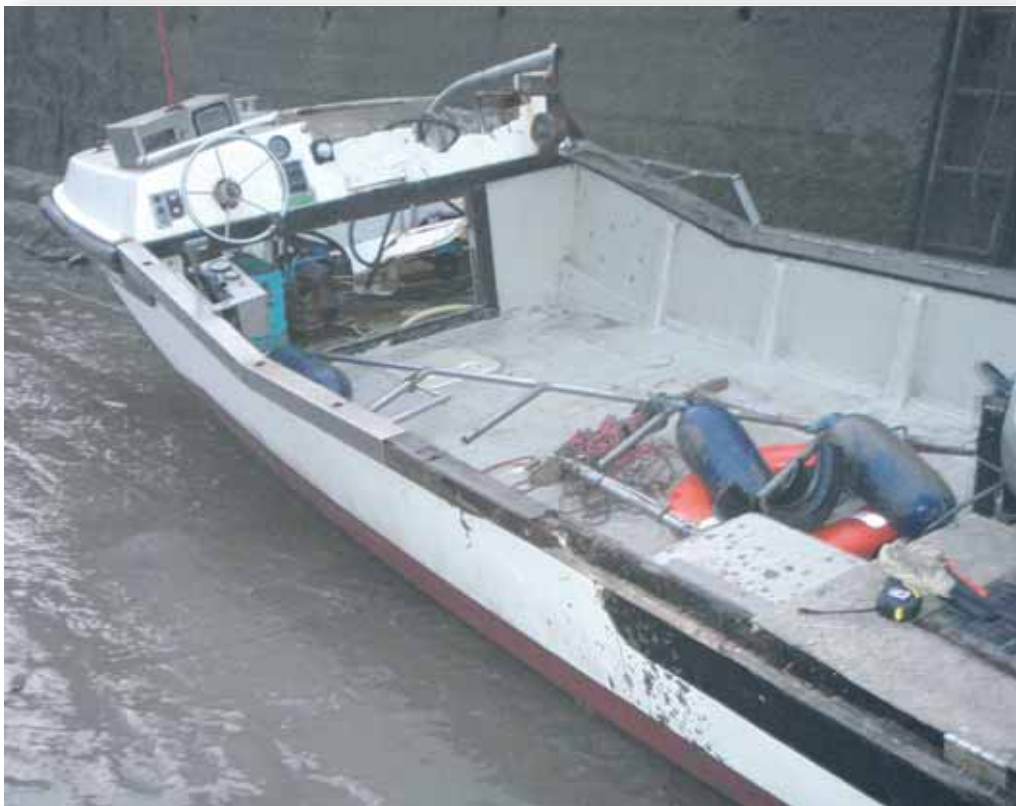
Photograph A

Taken by MCIB inspector, of the forward part of the vessel at Clogher Head after the vessel was turned upright on the evening of 5th April 2011.

- 5.7 The vessel had been moored upside-down at the slipway from the time it was brought to the harbour and had suffered major damage as a result. The forward deck in way of the pot hauler had been torn apart and the gantry mounted at the after part of the vessel had been destroyed.

- 5.9 The fender at the bow was parted in places.

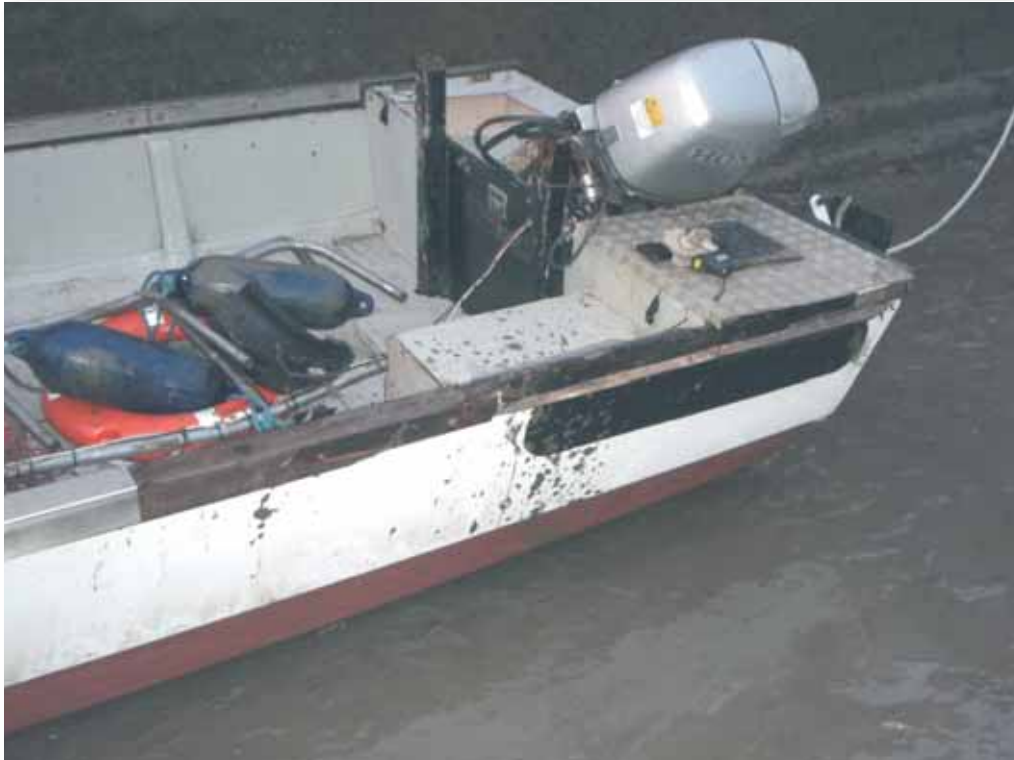
Photograph B

Taken by MCIB inspector, of the after part of the vessel at Clogher Head after the vessel was turned upright on the evening of 5th April 2011.

- 5.10 There was some mechanical damage to the gunwale area at the Starboard stern quarter.
- 5.11 The Starboard stainless steel hand rail was missing. This rail slotted into holes in the Starboard gunwale and may have fallen out when the vessel turned upside-down. This rail was not found in the course of the diving operations to-date.
- 5.12 The engine controls (No. 407753) were found to be in the “engine-on” position and the joystick was found to be in the full-ahead position. Please see photograph E below taken by MCIB inspector showing the engine control before the vessel was turned upright on the evening of 5th April 2011.

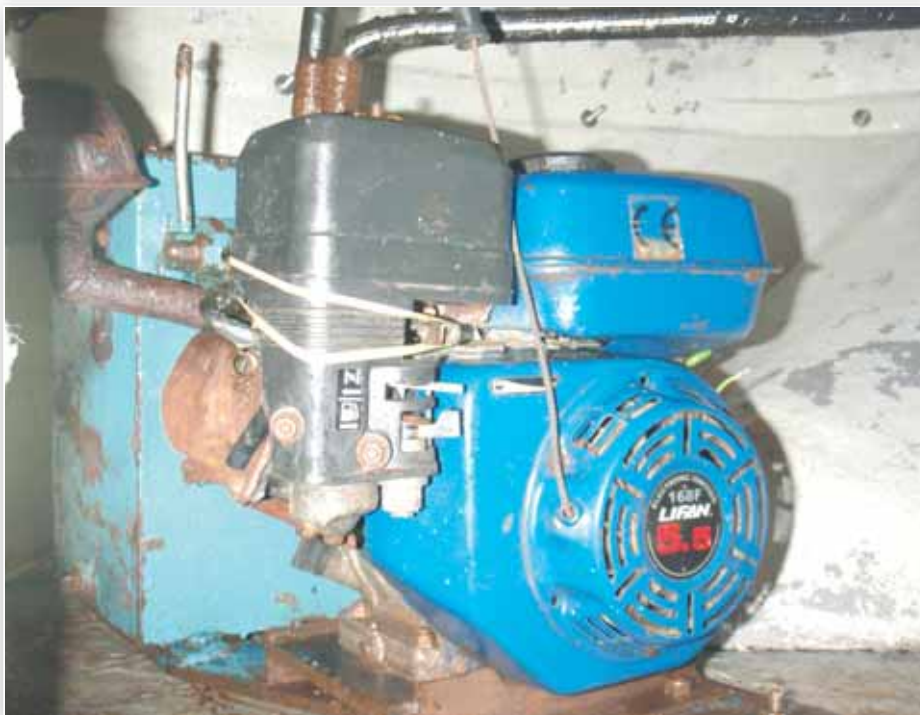
Photograph C

Taken by MCIB inspector, of the donkey engine before the vessel was turned upright on the evening of 5th April 2011.

- 5.13 The emergency cut-out protection cord for the engine was found to be attached to the ignition key.
- 5.14 The petrol tank (dimensions 500mm x 300mm x 275mm) for the engine was found to be in good order and approximately 1/2-full.
- 5.15 The throttle control for the donkey engine was found to be in the full throttle position and held in place with a rubber band, please see photo C on page 6.
- 5.16 One life belt was lashed to the remains of the rear gantry.
- 5.17 The emergency equipment, flares, hand held manual EPIRB, etc., were found in a yellow flare box with the top cut-off located in the forward water tight compartment under the deck. The compartment hatch was closed with the two dogs in the closed position.
- 5.18 No personal floatation devices were found on the vessel.
