**REPORT OF THE  
INVESTIGATION INTO THE LOSS  
OF THE FISHING VESSEL  
"LISA SELINA"  
IN LOUGHROS MORE BAY,  
CO. DONEGAL ON  
31ST OCTOBER 1998**

The Marine Casualty Investigation Board was established on the 25<sup>th</sup> March, 2003 under The Merchant Shipping (Investigation of Marine Casualties) Act 2000

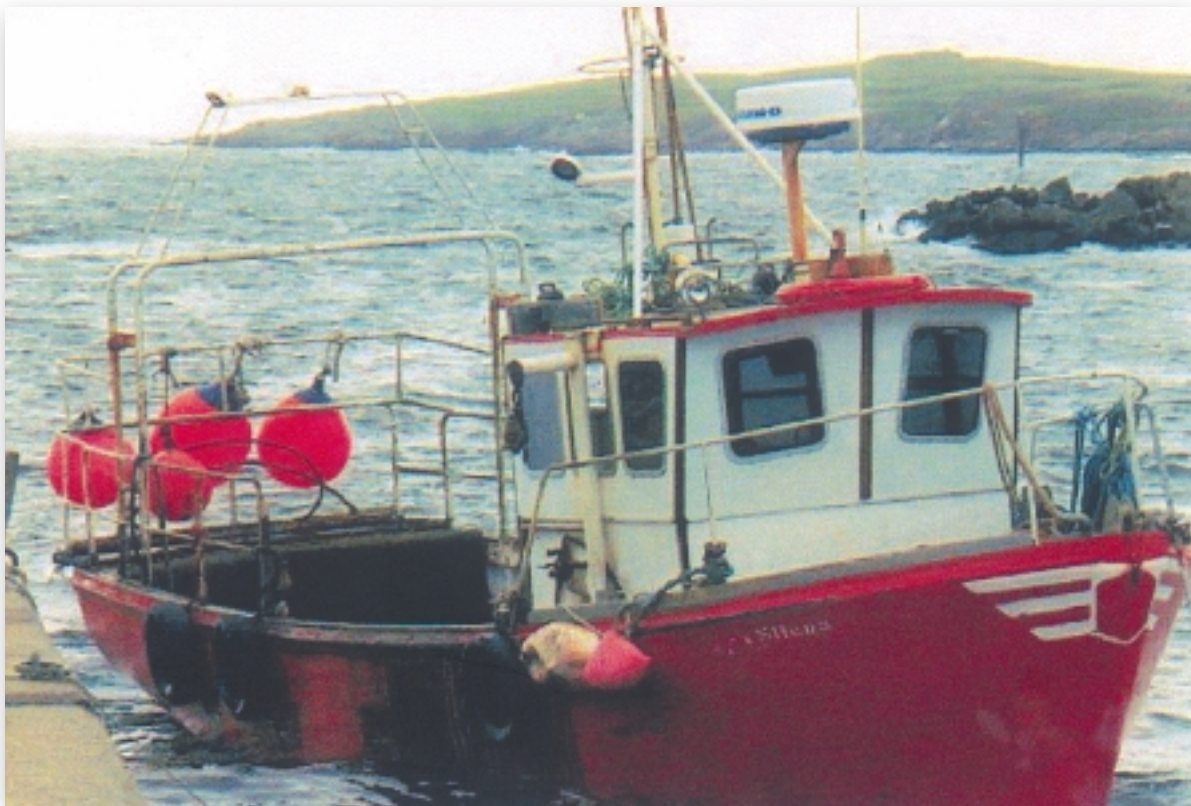
### Appendix 10.1

**Description of vessel:** Carvel built, wooden constructed fishing vessel with a transom stern. The vessel had no watertight bulkheads fitted. The "Lisa Selina" was used for fishing of crabs and lobsters using patent steel pots. (see Appendix 10.1).

Photograph of fishing vessel "Lisa Selina".

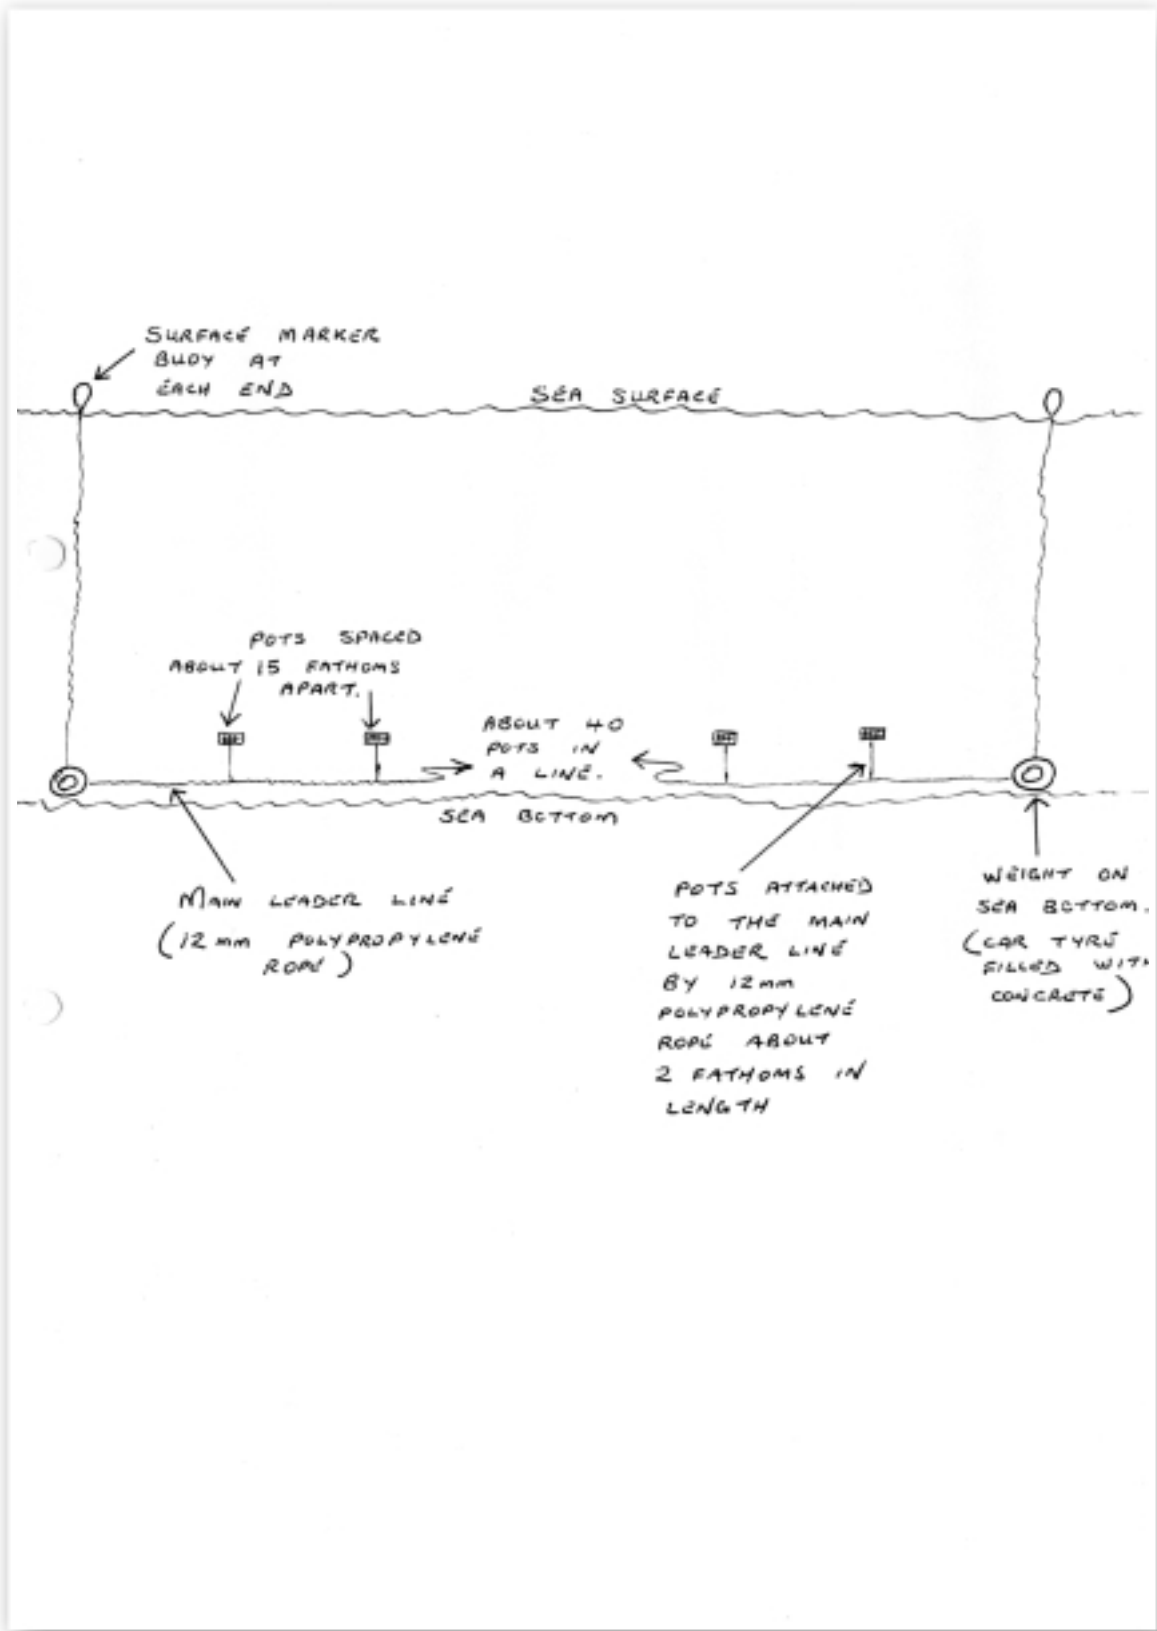
Appendix 10.2

- 3.2 Approximately 320 crab pots had been deployed about 6 weeks previously in the Loughros More Bay and Dawros Head area. The pots were laid approximately 40 to a line with a surface marker at each end. The pots were spaced about 15 fathoms apart along the main leader line and were attached to it by a line about 2 fathoms long. Each end of the leader line was attached to a tyre filled with concrete, which was also attached to the surface marker. Both the main leader line and the line attached to the pots were of 12mm polypropylene rope. (see sketch in Appendix 10.2).

Arrangement of pots and lines.

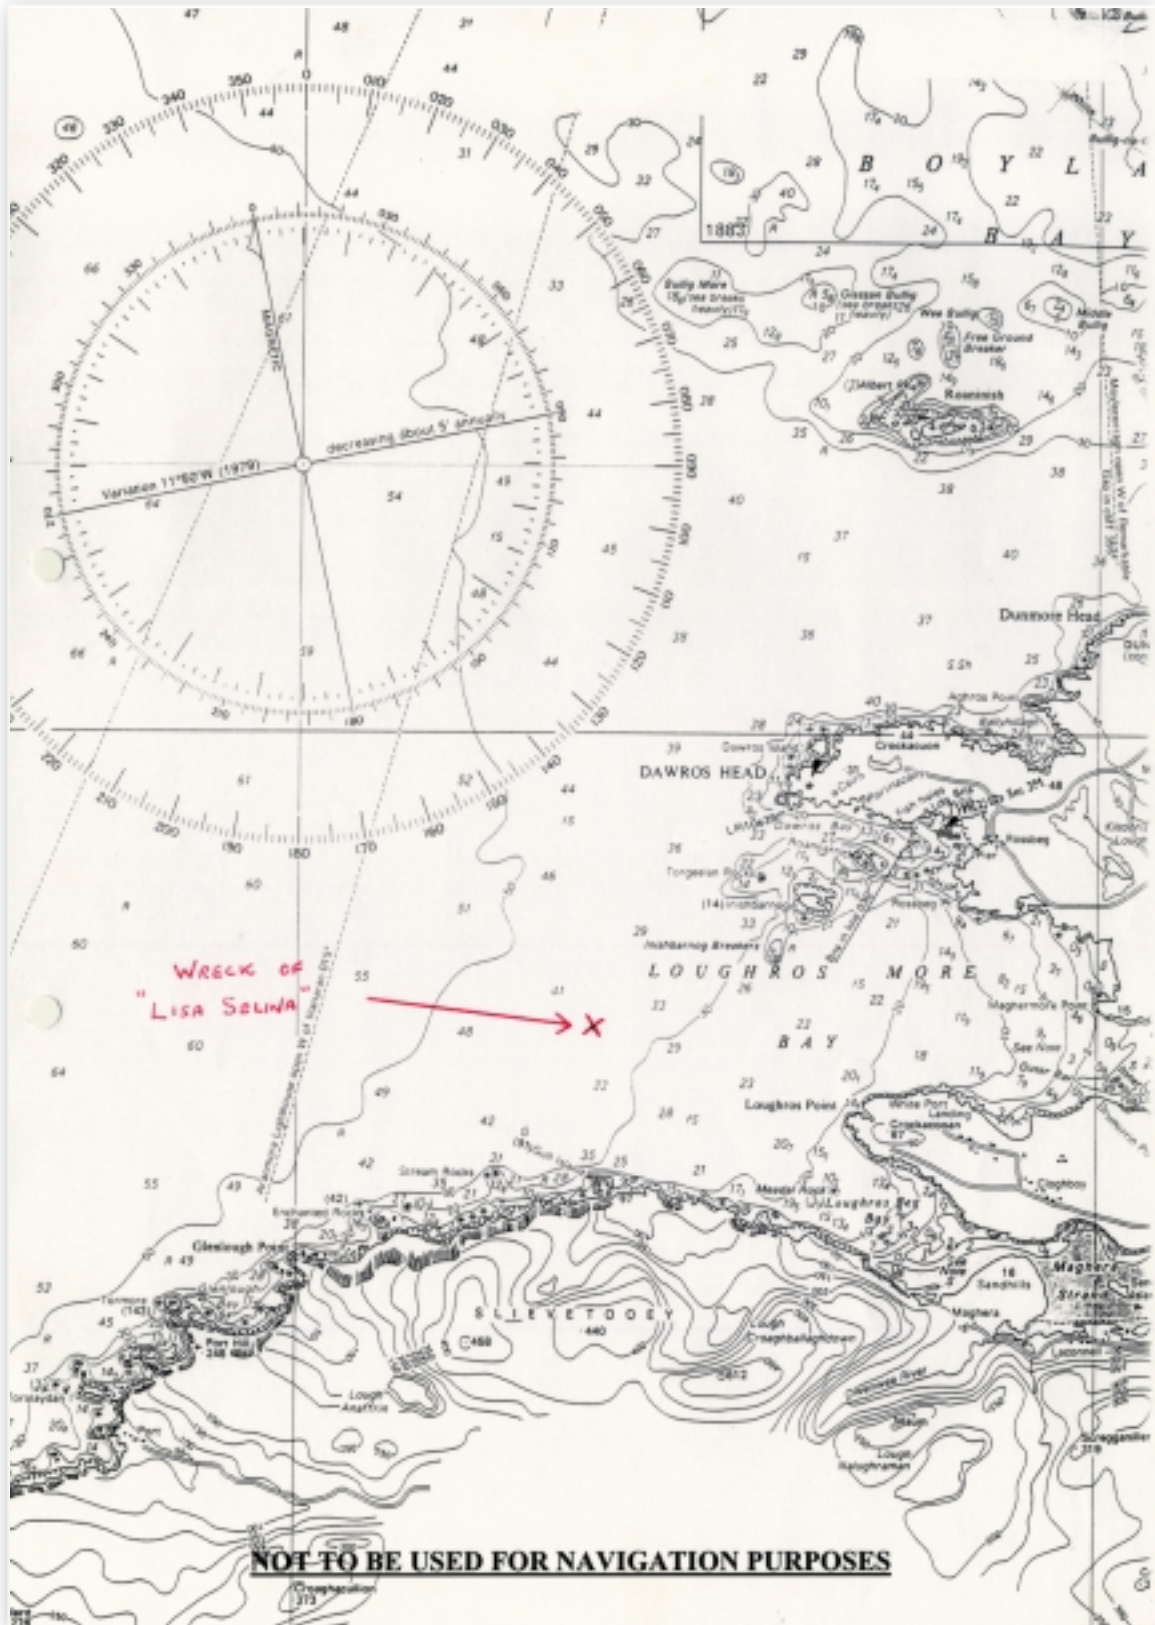
Appendix 10.4

- 4.6 The "Lisa Selina" was located in position 54° 47.90N 008° 36.38'W in 42 metres of water at 1501 hours. (see Appendix 10.4).
- 4.7 At 1807 hours Glenhead Radio broadcast a PAN message on Channel 16 giving the position of the wreck of the "Lisa Selina".

Position of wreck of "Lisa Selina".

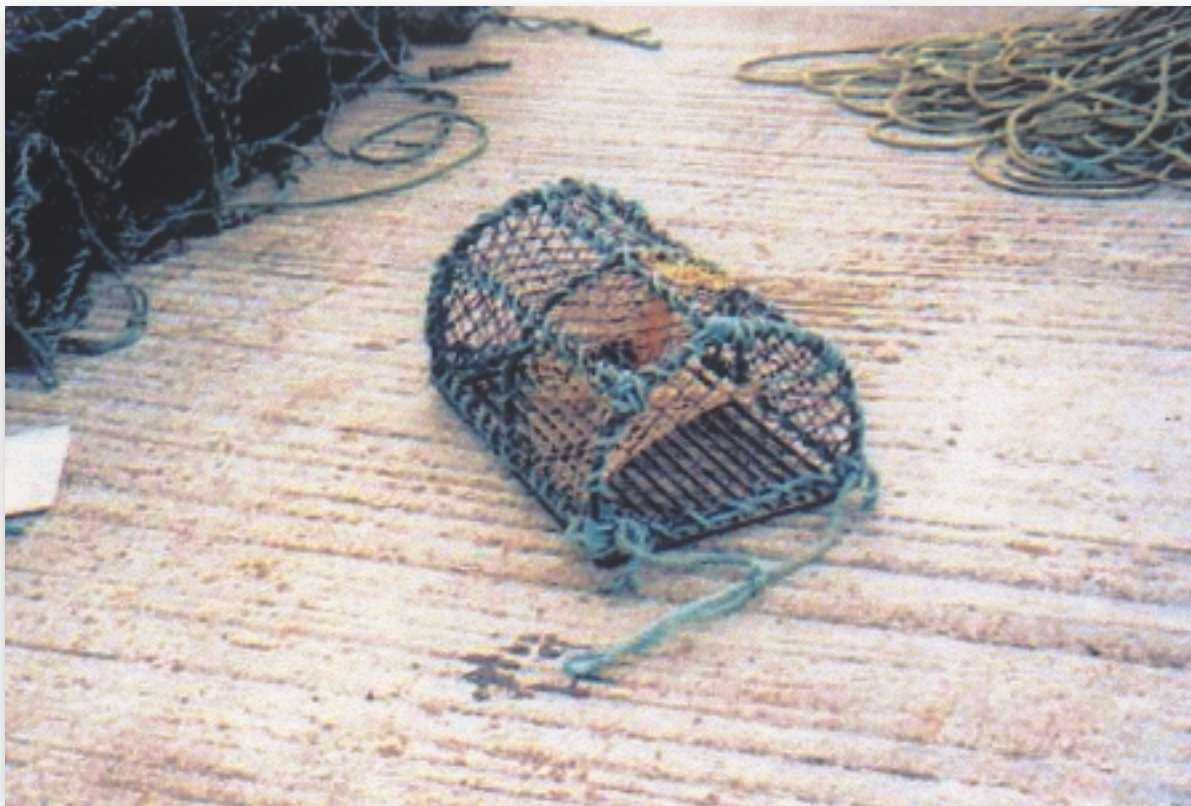
### Appendix 10.5

- Normally the pots would be hauled, emptied and re-laid every two days.
- 7.3 The weight of a crab pot is approximately 9 kgs. (see Appendix 10.5).
- 7.4 The weight of a tyre filled with concrete, which is used at the end of the leader line and to which is attached the surface marker, is approximately 65 kgs. (see Appendix 10.6).

Steel Crab Pot.

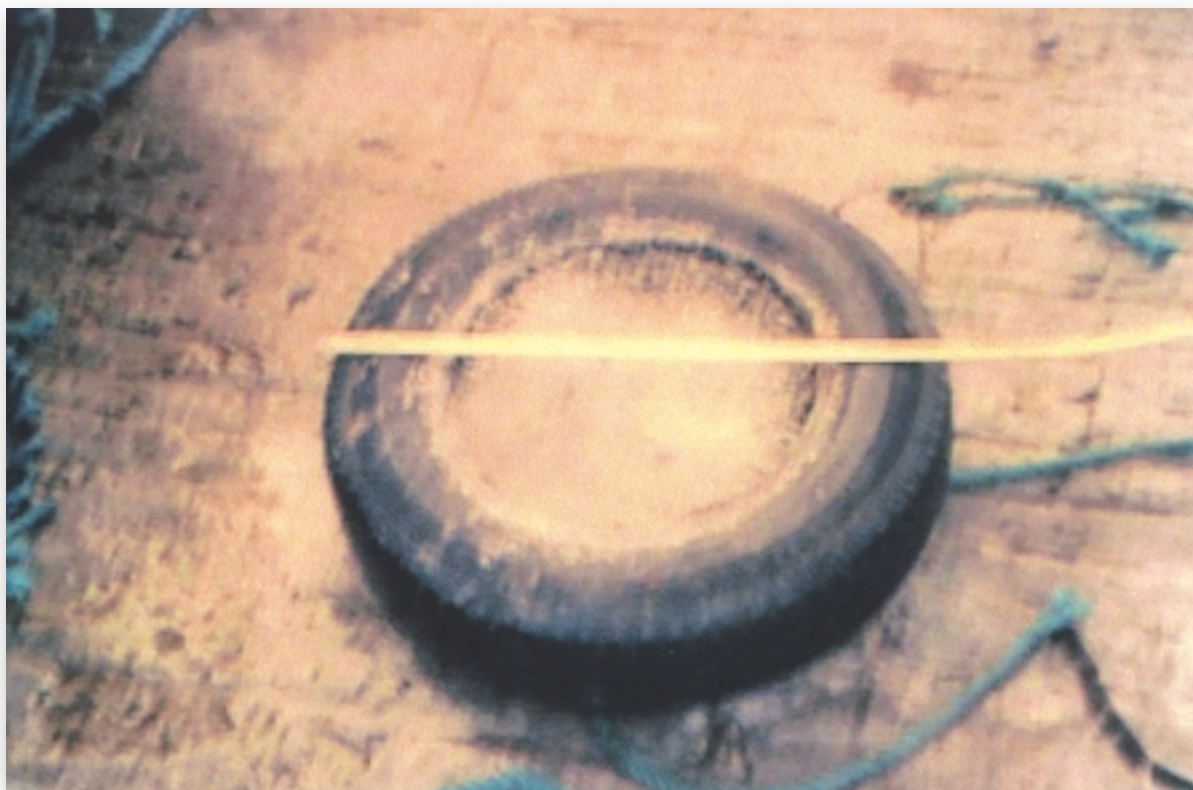
## Appendix 10.6

- 5.4 One tyre filled with concrete was found on the deck of the vessel.
- 5.5 No fish boxes were found on board either on deck or in the hold.
- 5.6 The hold was open with the lid found alongside on the deck.

Tyre filled with concrete.
