Marine Casualty Investigation Board

**REPORT
OF THE INVESTIGATION
INTO THE GROUNDING OF THE
MV "LOCATOR"
OFF SAINT MACDARA'S
ISLAND, OFF THE COAST OF
GALWAY
ON 31st MARCH 2007**

REPORT No. MCIB/139

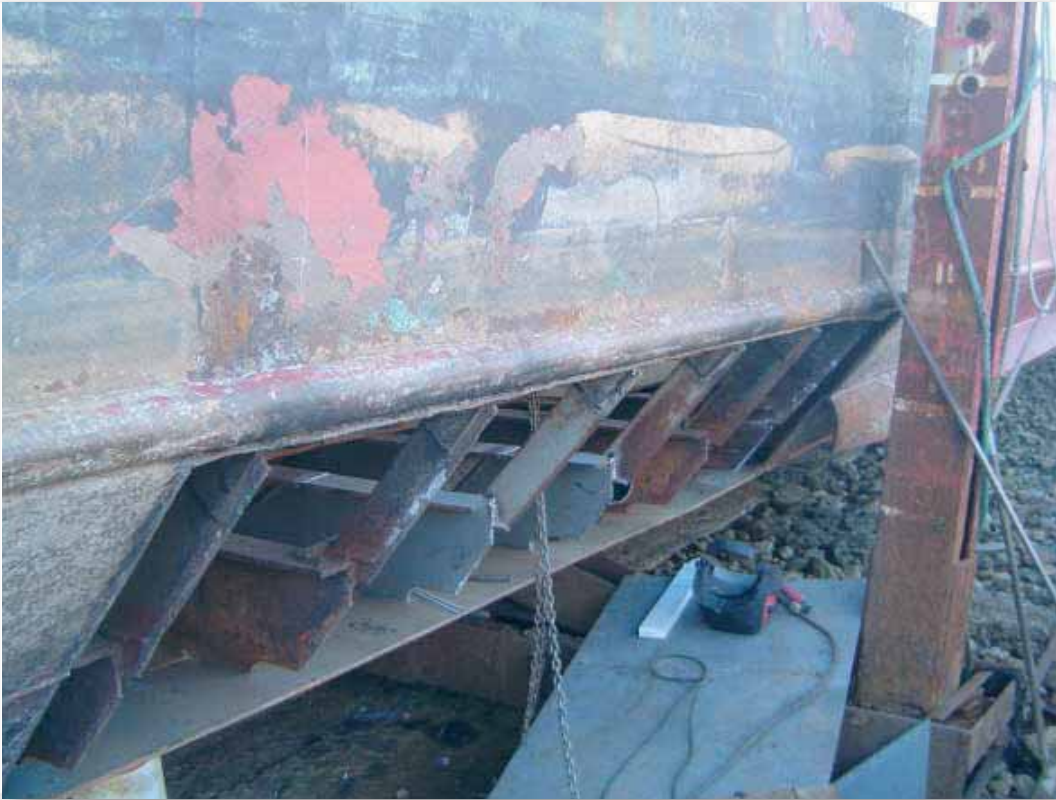
APPENDIX 8.3

Appendix 8.3 Photograph showing section of hull with damaged plate cropped.

- 6.1 The vessel was later inspected at Glynsk, Co. Galway and approximately 4 metres x 1 metre of bottom plating was renewed. The vessel was detained for safety reasons by the Department of Transport on the 2nd April 2007 on account of 1) the Masters Certificate not as required and 2) as a result of a grounding incident.

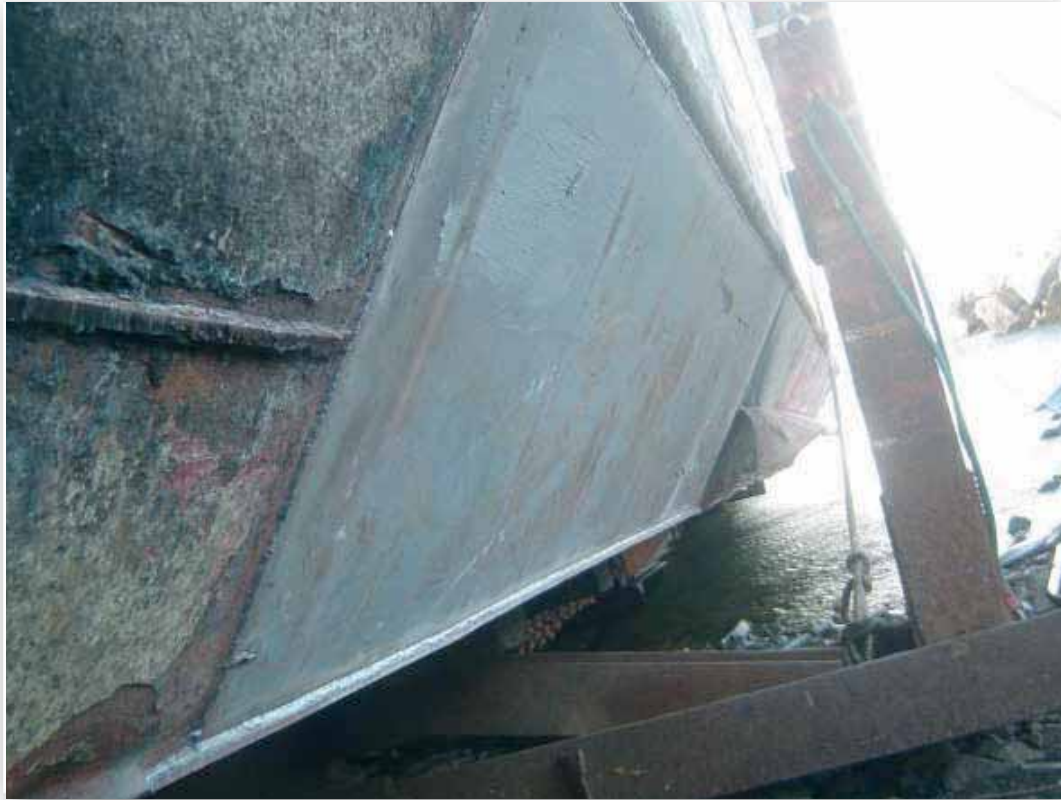
Appendix 8.4 Photograph showing new plate after repair.
