**REPORT OF THE  
INVESTIGATION INTO  
THE DROWNING ON  
THE LOUGH MASK  
ON THE 3RD MAY, 2003.**

**The Marine Casualty Investigation Board was established on the 23<sup>rd</sup>, May 2002 under The Merchant Shipping (Investigation of Marine Casualties) Act 2000**

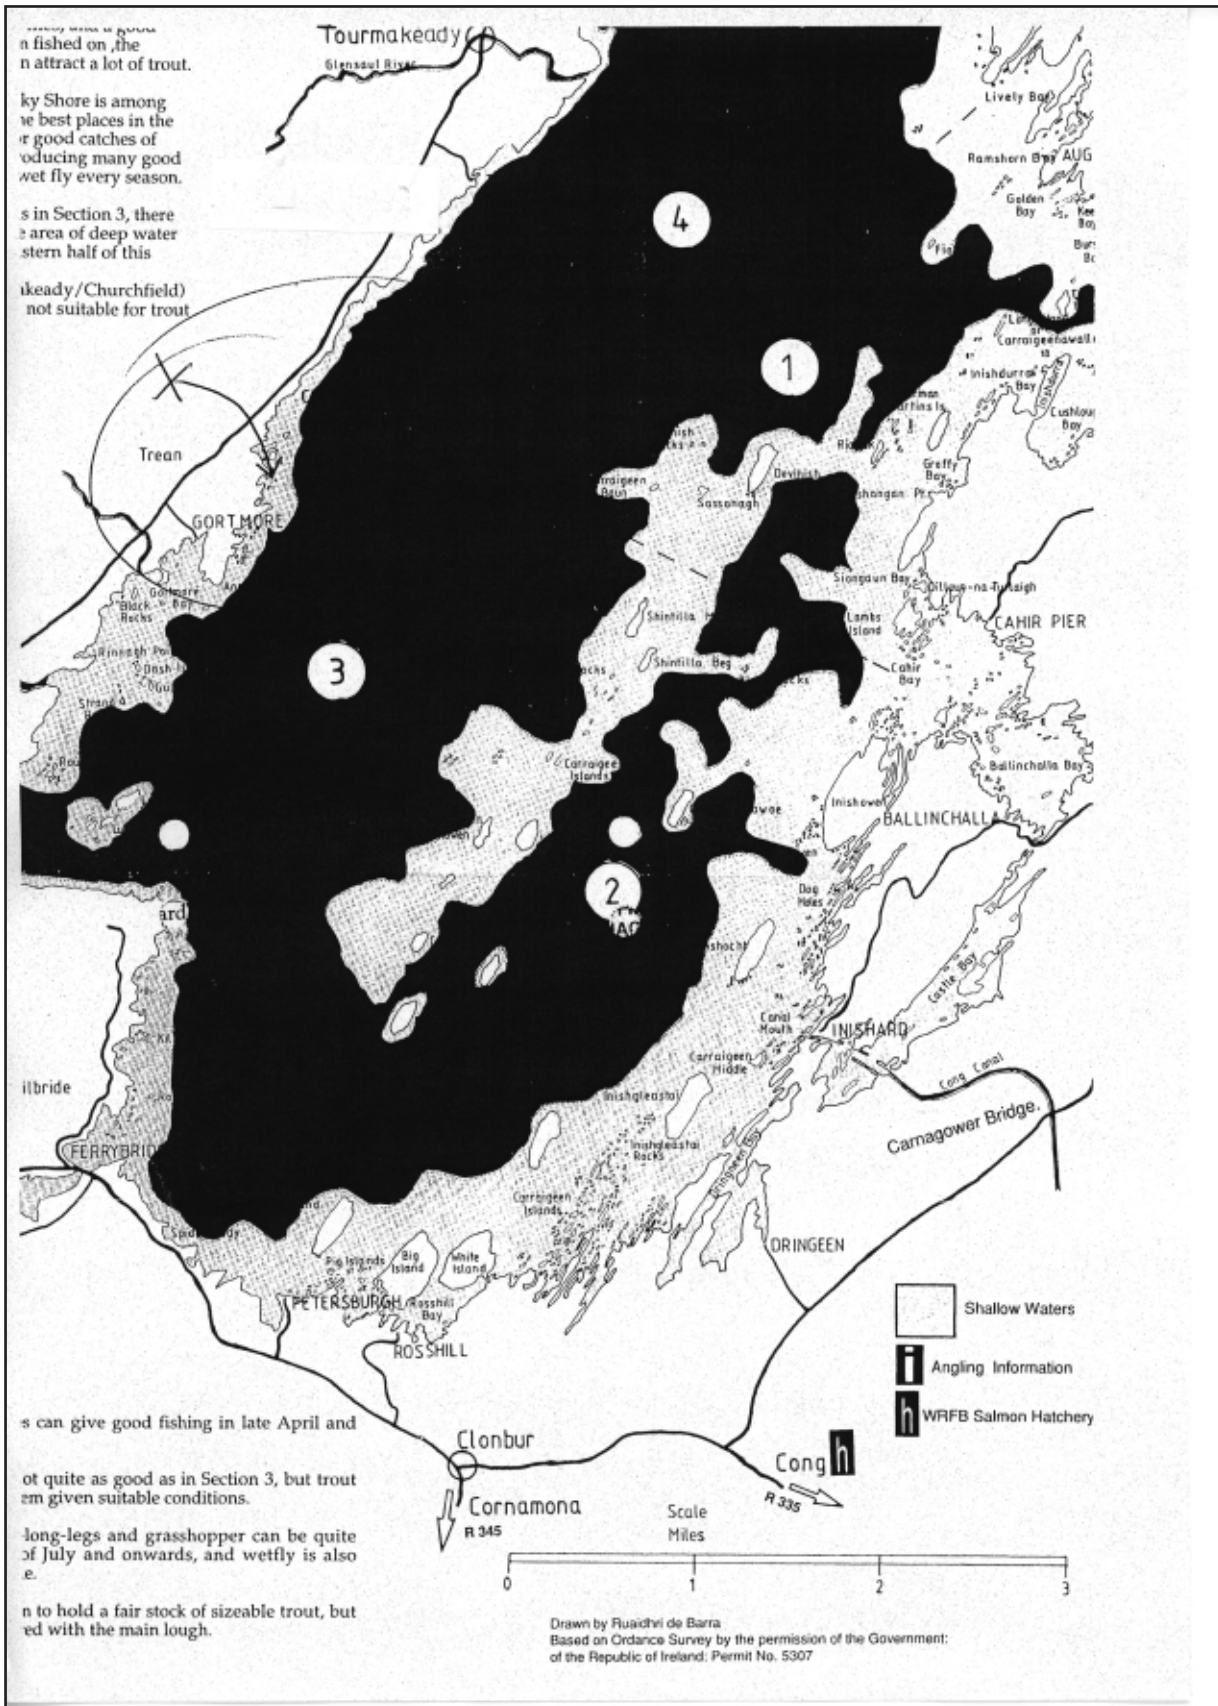
## 8.2 Scene of Casualty

- 4.9 The scene of this incident is set out in Appendix 8.2. Photographs of the scene, the boat and lifejackets and clothing worn are contained in Appendix 8.3.
