**REPORT OF THE
INVESTIGATION INTO THE
GROUNDING OF
THE FISHING VESSEL “AINE”
ON 9TH NOVEMBER, 1997.**

On the morning of the 9th November 1997 at approximately 4.50am the steel hulled fishing vessel “Aine” ran aground at Inishnanooan, Co. Donegal.

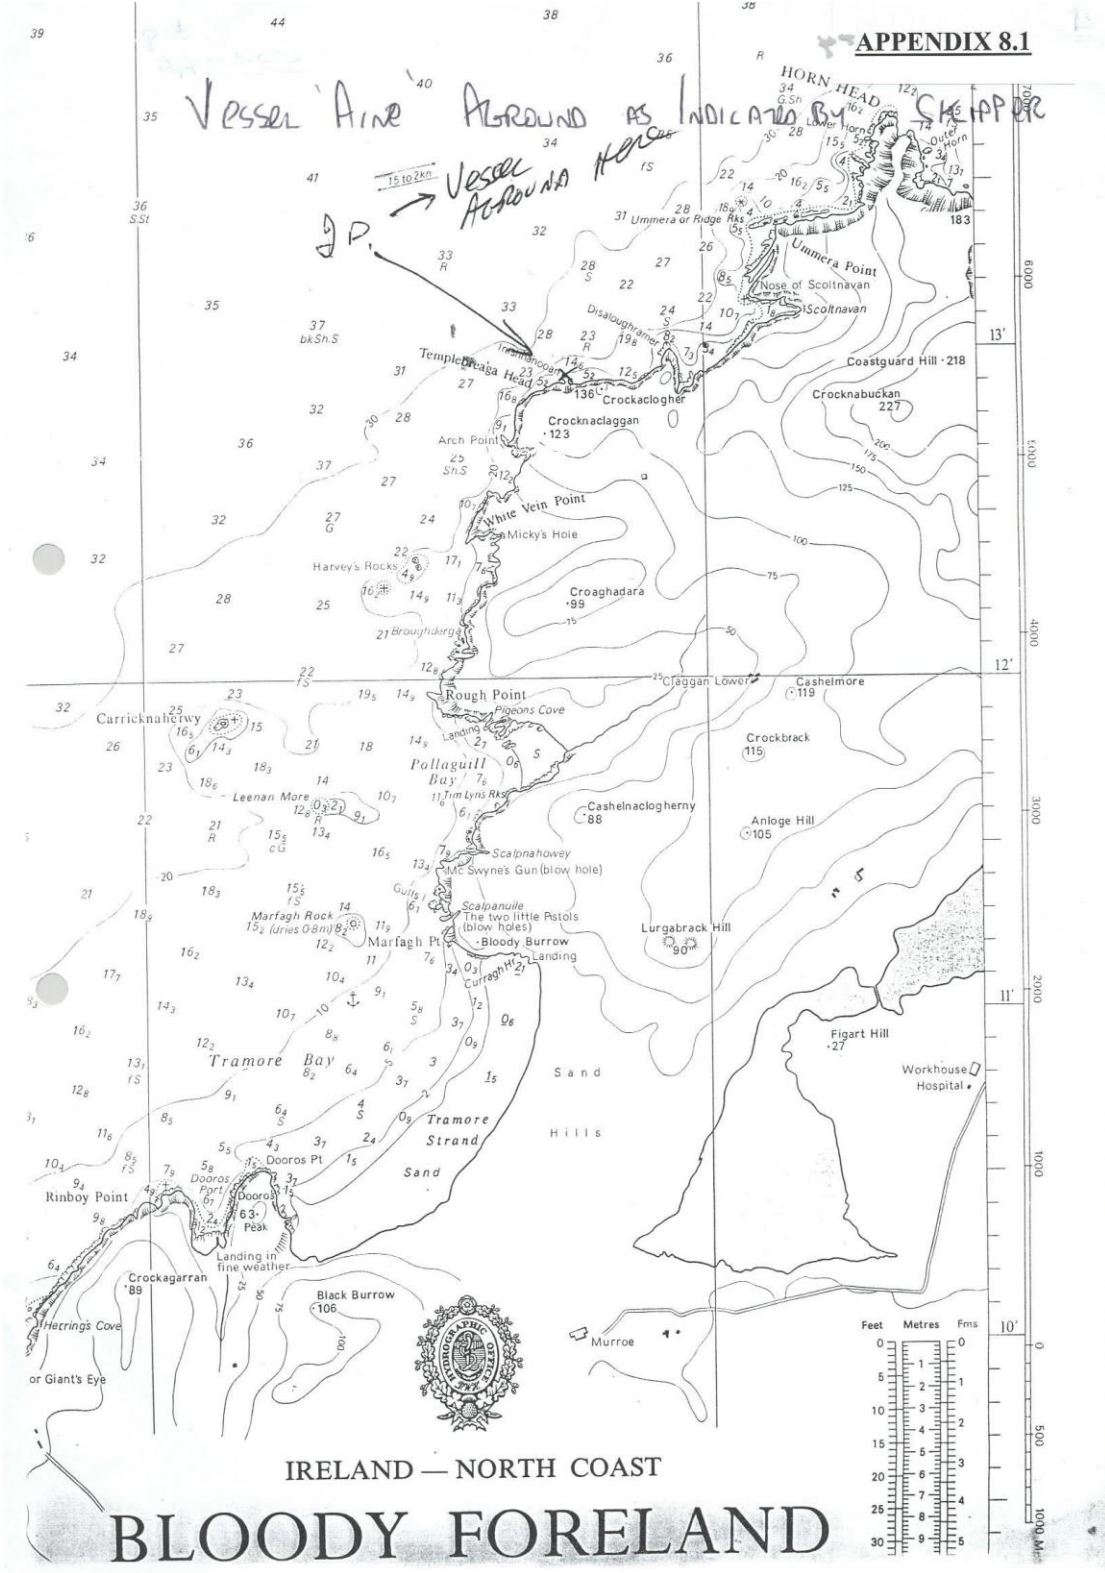
NOT TO BE USED FOR NAVIGATION PURPOSES

- 4.6** The vessel was found to be hard aground on a small headland called Inishnanooan Close east of Templebreaga Head. (See appendix 8.1)
- 4.7** Mr. Kieran Doherty had just left the wheelhouse when the incident occurred.
