**REPORT OF AN INVESTIGATION
INTO A MARINE CASUALTY
INVOLVING THE FISHING VESSEL
BREIZH ARVOR II
IN OR AROUND
100 NAUTICAL MILES OFF THE
BLASKET ISLANDS, CO. KERRY
ON OR ABOUT
14 DECEMBER 2023**

**REPORT NO. MCIB/334
(No.1 OF 2025)**

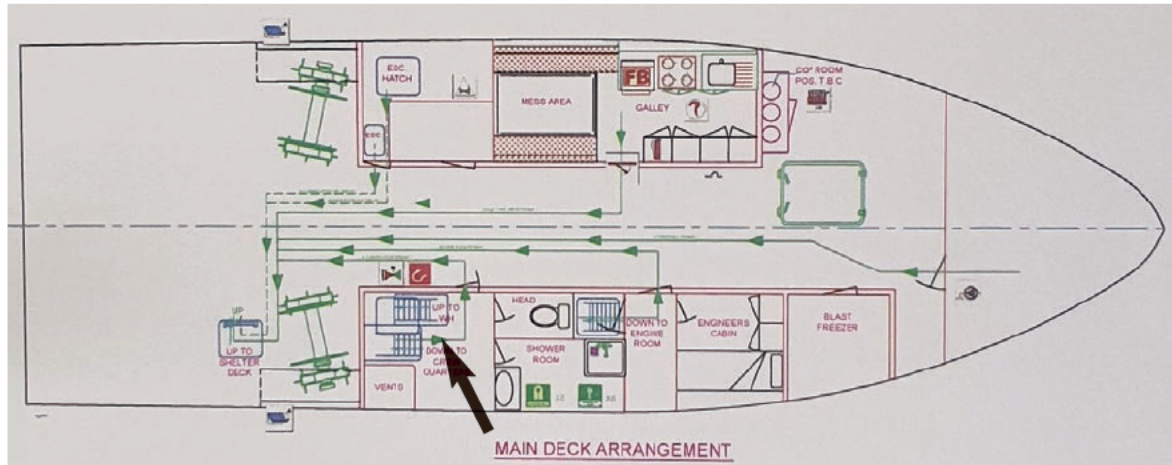
Main Deck arrangement where the crewmembers were working with an arrow showing the ladder down to crew accommodation.

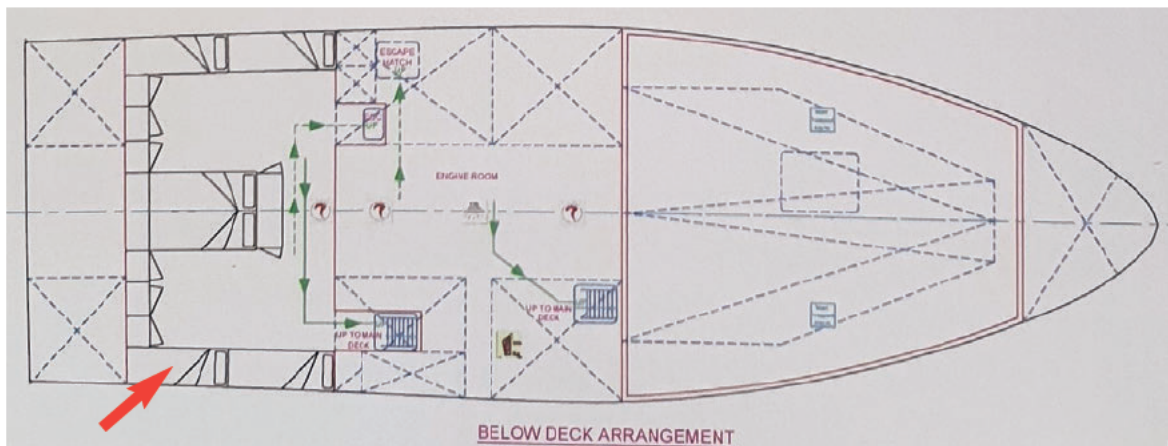
Accommodation area where the Casualty was found on the deck on the starboard side (in green). His effects were stowed on the after starboard bunk shown with a red arrow. After the accident the Casualty was placed on his sleeping bunk on the port aft side.

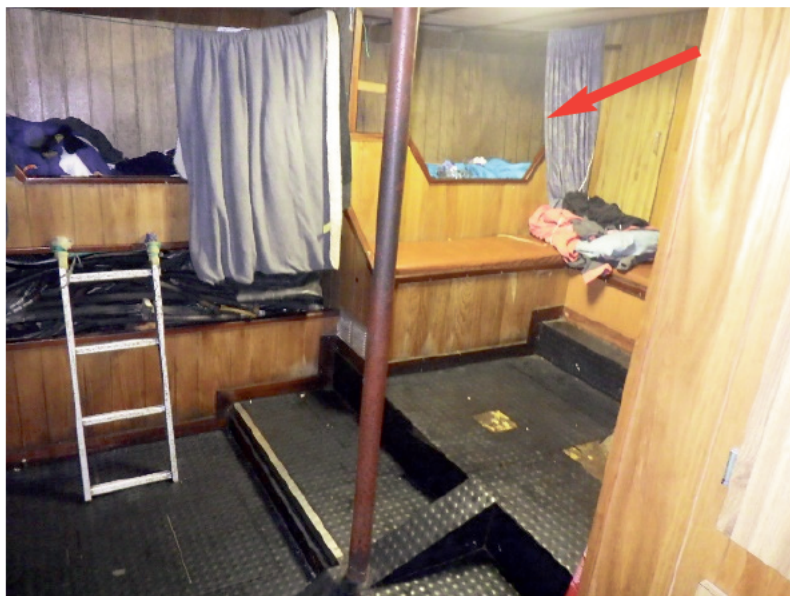
Photograph No. 1 - Looking to starboard in the accommodation. Red arrow shows starboard aft bunk where effects were stowed.

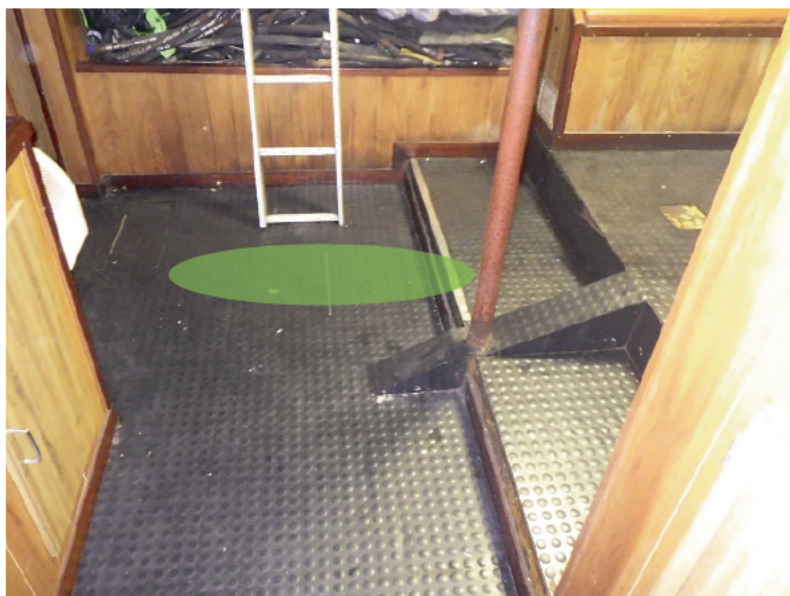
Photograph No. 2 - Two steps on the deck in the space can be seen and green shape shows reported location of Casualty when discovered. The ladder to/from the accommodation area is located on the left hand side.

- 4.11 The Casualty may have missed one of the two steps down from his berth in the accommodation area while moving forward in a crouched position, and heading towards the ladder, or, slipped as he stepped on to the ladder, thereby hitting his head and causing the fall. It also could have happened that the space configuration led him to misjudge the various heights and that he hit his head first. The vessel was also pitching and rolling, and this could have added to the possibility of unbalance and falling. A crewmember at the inquest gave evidence that carrying out CPR was difficult because of sea swells. It is also possible that irrespective of the condition of the Crocs, that they caused him to slip. The floor surface does not appear to have been a cause although the investigating Garda considered the floor surface material to be slippery. It is of note that the Health and Safety Authority (HSA) carried out an investigation and reported that there were no issues reported in and around the bunk space relating to flooring.

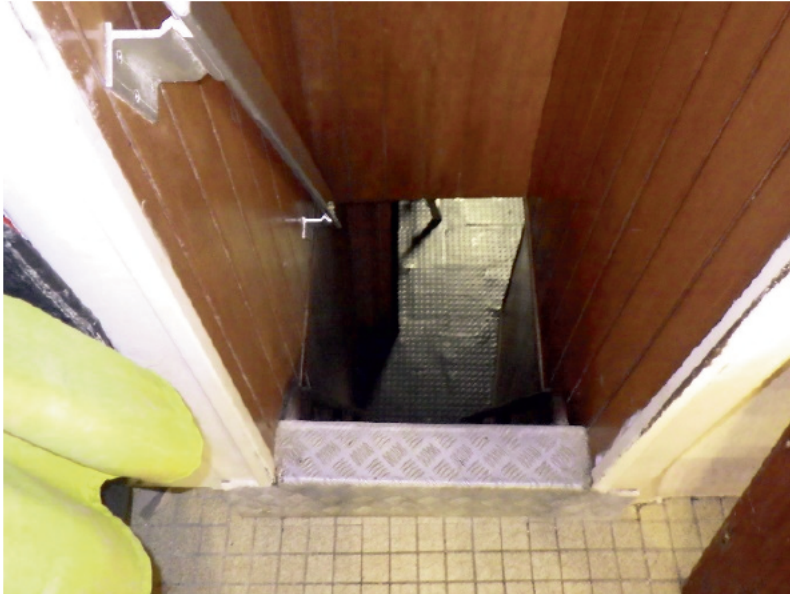
- 4.4 The stairwell is an enclosed type with the upper area surrounded by panelling and would be very difficult to fall forward into the lower accommodation. The ladder in the stairwell was around ten to 15 degrees off the vertical and had a handrail on the starboard side for the right hand to hold while going down the ladder. The person using the ladder should turn around and descend facing forward. The steps were non-slip type. Having descended the ladder, the Casualty would then be in a space with low ceilings of different height.

Photograph No. 3 - Looking down the stairwell from main deck.

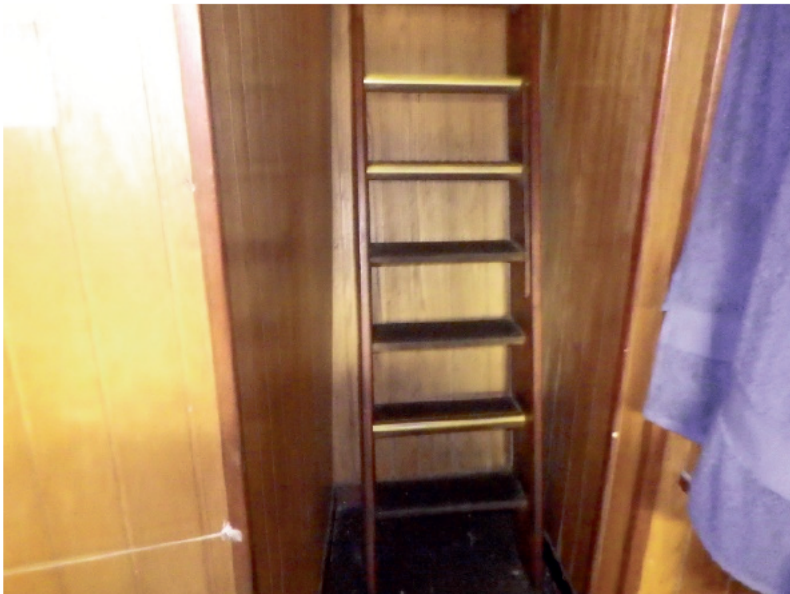
Photograph No. 4 - Looking forward at the ladder from lower accommodation.

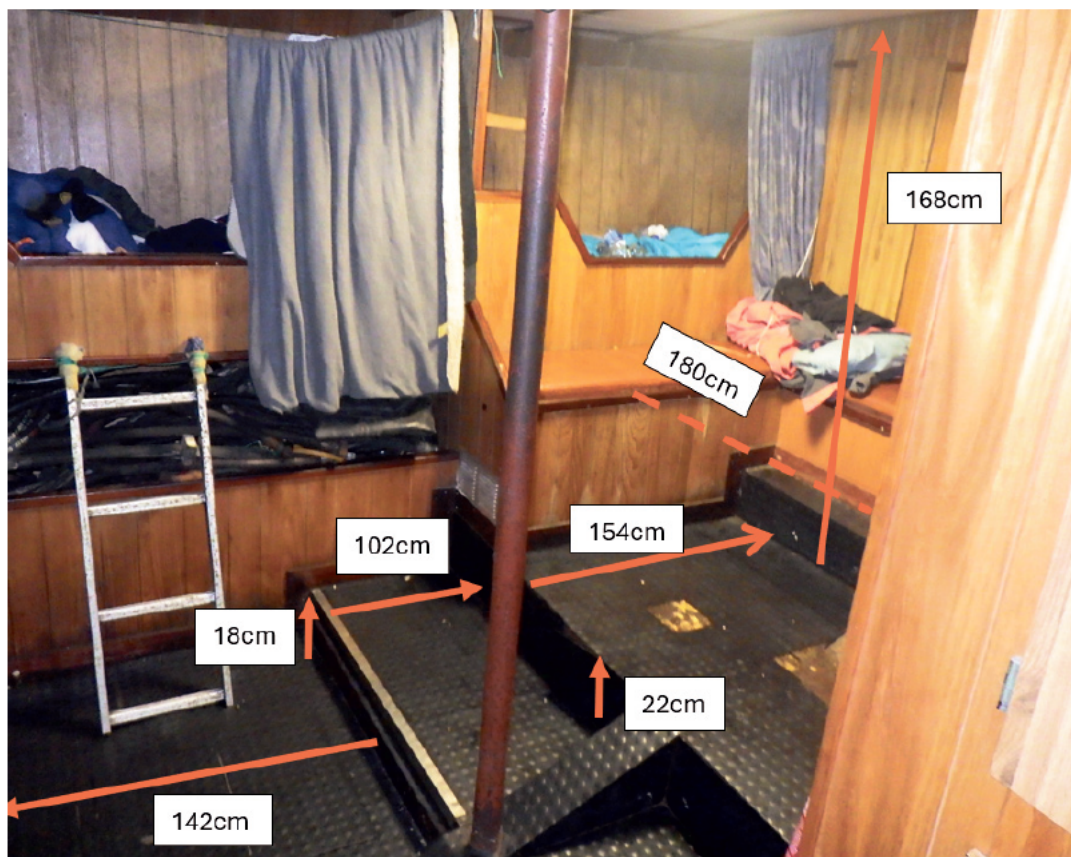
Photograph No. 5 - Showing space with dimensions added.

- 4.6 Regulation 152(1)(b) of the Merchant Shipping (Safety of Fishing Vessels) (15-24 Metres) Regulations 2007, S.I. No. 640 of 2007 provides that in sleeping rooms “(b) The clear headroom shall, whenever possible, be not less than 2.0m.” The Casualty was in a space with a deck to ceiling height of 1.68 m. The accommodation area in the vessel (built in 1991) did not have the minimum 2 m clear headroom in the sleeping room but according to the Regulations it is not compulsory but only where it is possible to have this. The Casualty was familiar with the vessel having been working on it for seven years.

- highlighting the importance of wearing secure footwear at all times onboard fishing vessels.
- advising owners regarding the dangers of restricted headroom in vessels
- to include this hazard in their risk assessment
- to have suitable warning signage at the entrance/exit to spaces with restricted headroom, such as:

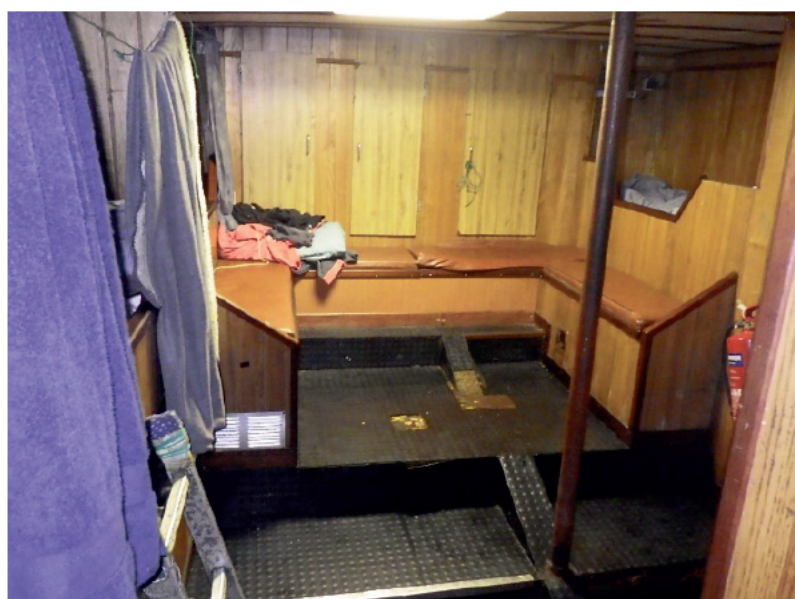
Photograph No. 6 - Looking directly aft.

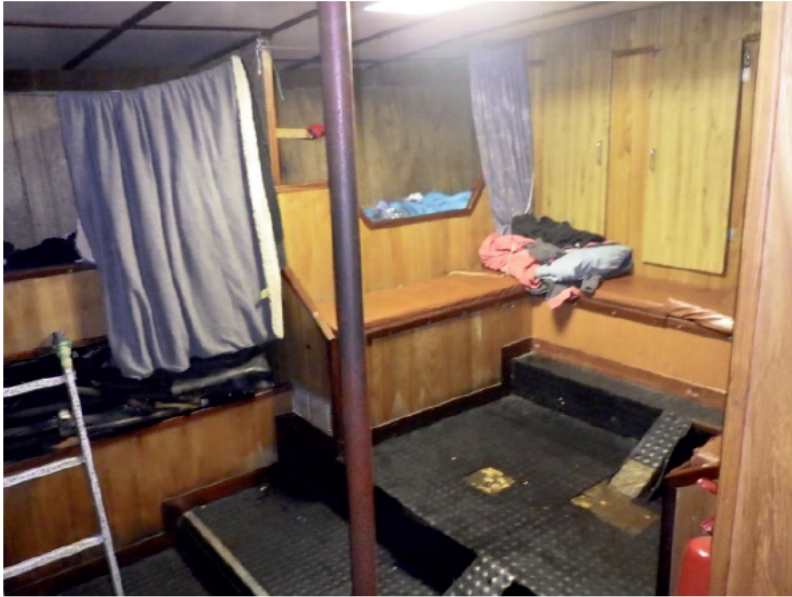
Photograph No. 7 - Looking aft to starboard at bunk with belongings.

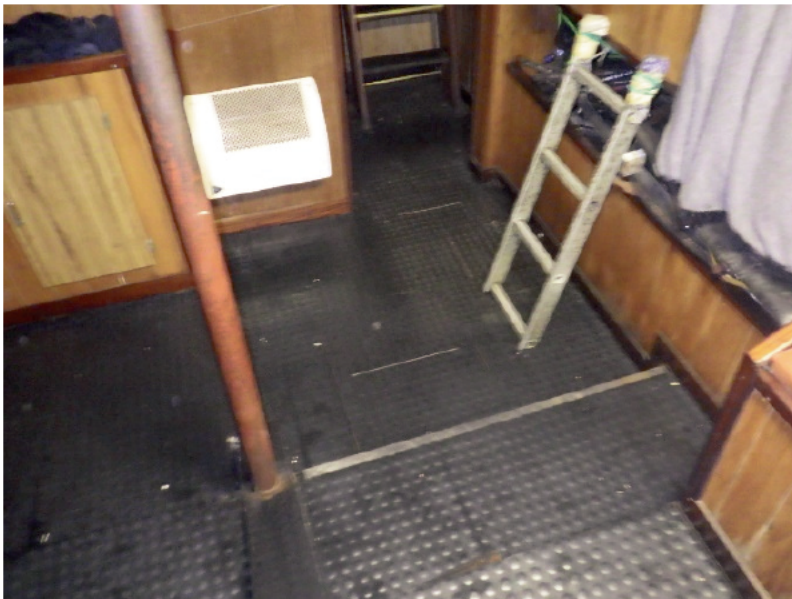
Photograph No. 8 - Looking at deck forward starboard.

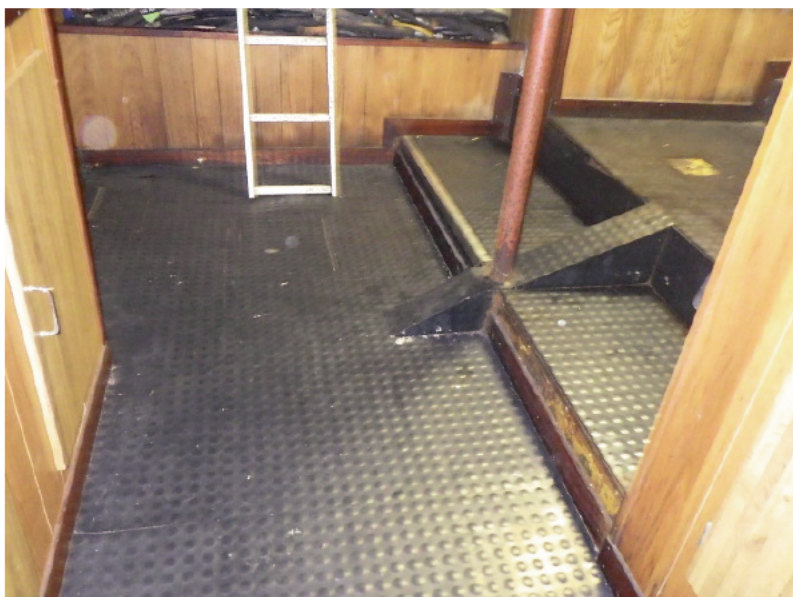
Photograph No. 9 - Looking to starboard with the steps on deck visible.

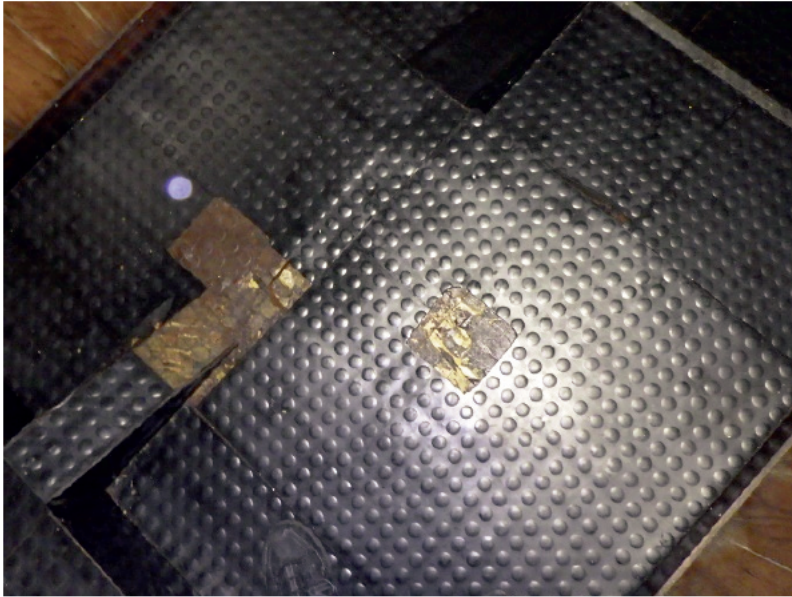
- 4.8 The deck covering in the accommodation space was rubber bubble-mat safety covering and this was generally in good condition with two small pieces missing (these pieces had been removed by AGS as a reference sample and were not damaged). This type of floor covering gives very good grip and is considered anti-slip. This part of the accommodation below deck is not normally wet and wellington boots are not worn below decks.

Photograph No. 10 - Looking down at deck aft.

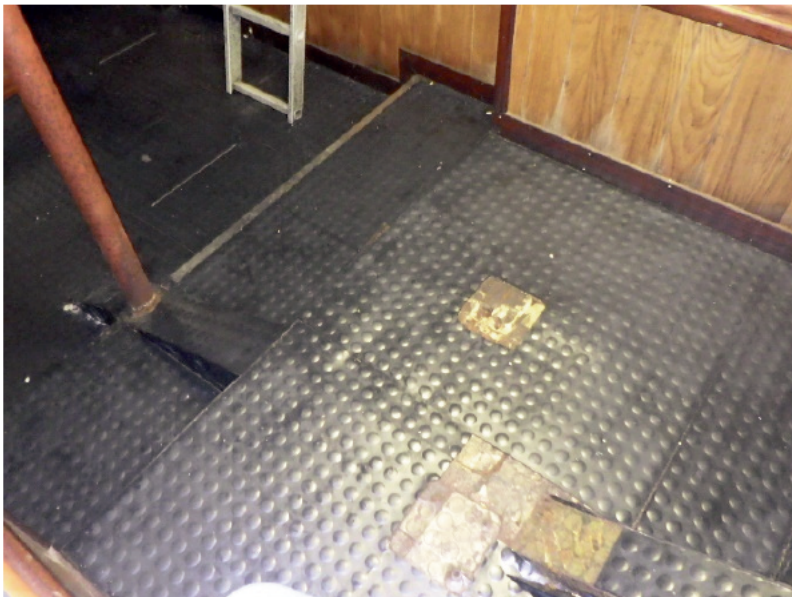
Photograph No. 11 - Looking at deck aft to starboard.

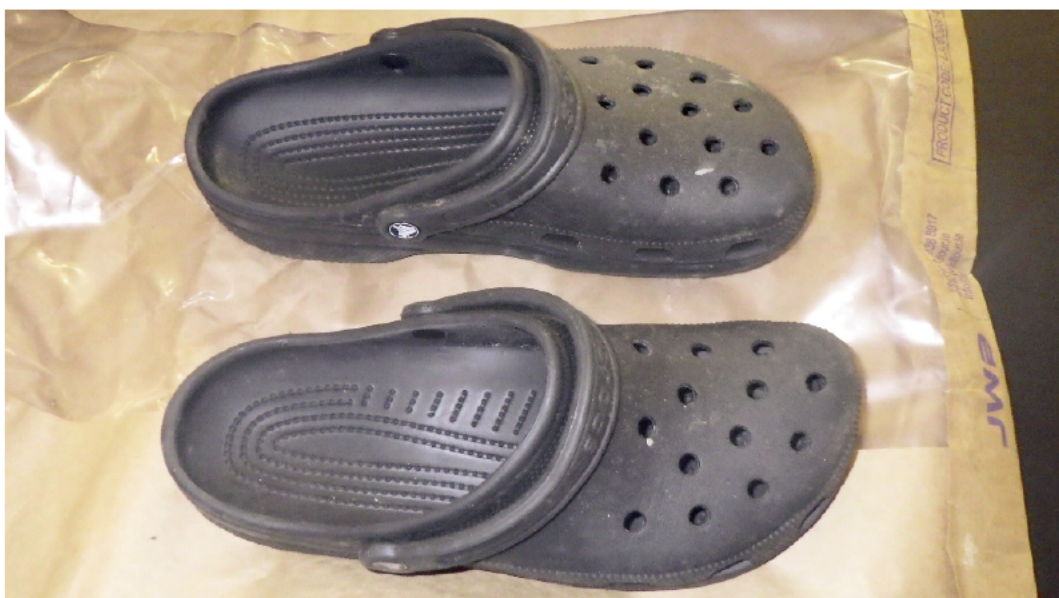
- 4.9 The lighting was inspected and was traditional twin tube fluorescent type lighting and was considered good in the space.
- 4.10 The Casualty was wearing a pair of slip-on Crocs at the time of the fall (and from when he had been up on deck). The back securing straps were found by AGS in the forward position and do not appear to have been secured around the heels. The Crocs were taken by AGS who investigated the fatality. They confirmed that they were on the Casualty when found and that they were provided to the MCIB for inspection with the straps forward as they had been found. The condition of

the Crocs and the soles was very good. The accommodation space was not reported to have been wet at the time of the incident.

Photograph No. 12- The footwear found in good condition with the securing straps forward as shown.

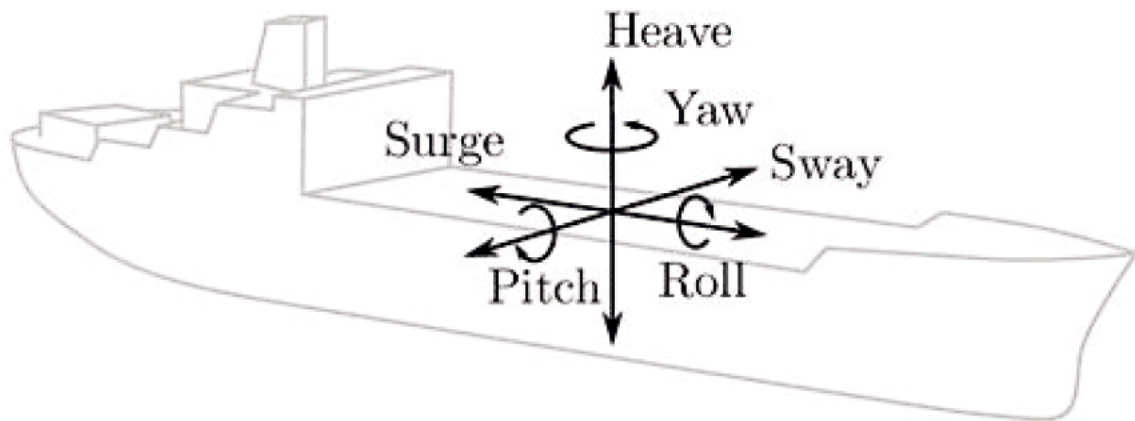
- 4.13 Vessel movement and the lack of convenient hand-holds may have contributed to the incident. By vessel movement it should be noted that any vessel has six “degrees of freedom”- three axis each with linear movement in direction of the axis and rotation about each axis.

The weather is described as “*Weather on Scene Wind: 5, W / Sea: Rough / Swell: Low wave*”. Sea roughness is an average of the wave heights and large waves will occur in the wave pattern. Such a large wave would create an unexpected motion which, with the Casualty in the crouched position, could have caused him to lose his footing and fall.
