**REPORT OF THE INVESTIGATION
INTO THE COLLISION BETWEEN
THE IRISH FISHING VESSEL
MFV “*STELIMAR*” AND THE
BAHRAIN REGISTERED TANKER
MV “*ALMANAMA*” OFF THE
SOUTH WEXFORD COAST ON 13TH
JUNE 2000.**

1. SYNOPSIS

On the 13th June 2000, off the south Wexford Coast a collision occurred between the Irish Fishing Vessel MFV “*Stelimar*” and the Bahrain registered tanker MV “*Almanama*”. Damage was caused to both vessels.
No injuries were sustained.

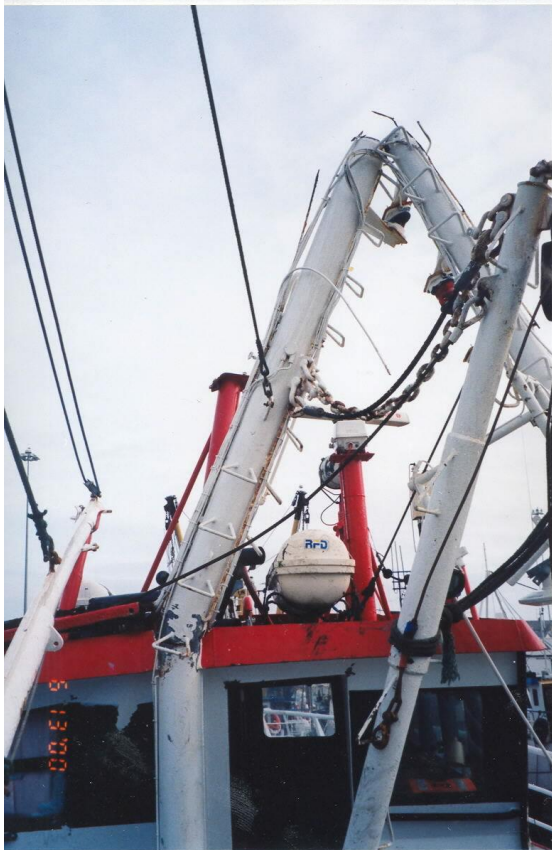
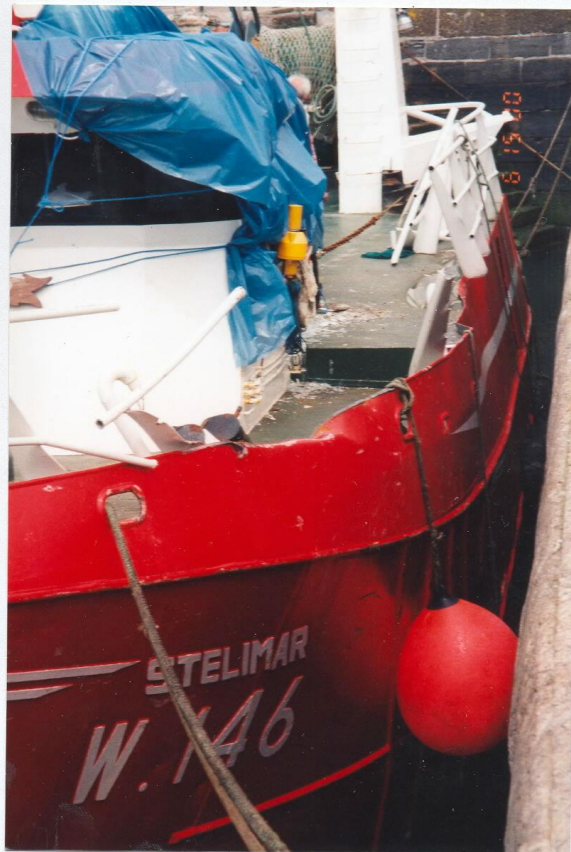
Appendix D.

- 4.17 The damage sustained by the MFV “*Stelimar*” consisted of a broken mast, severe damage to the wheelhouse and accommodation structure, substantial damage to the port side of the vessel incorporating under water hull damage, ship side rails and mooring bits. (see photographs in Appendix D). Subsequently it was discovered that there was damage to the propeller, which may have occurred in the incident.

Photographs showing damage to fishing vessel "Stelimar"

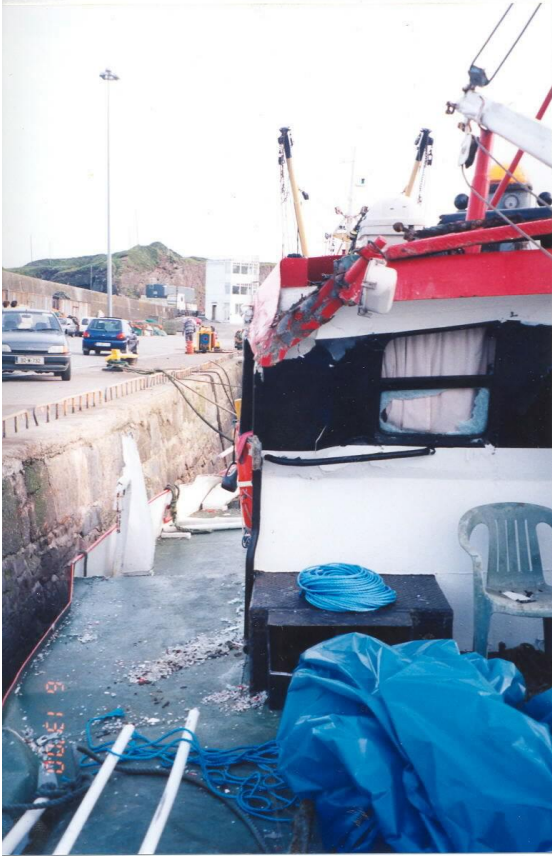
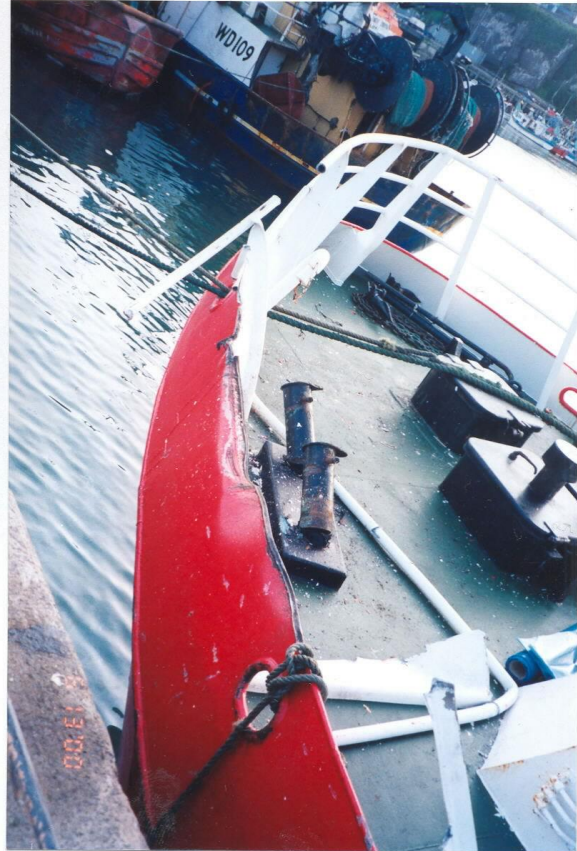
Photographs showing damage to fishing vessel “Stelimar”
