**REPORT OF THE
INVESTIGATION INTO THE
SINKING OF THE YACHT
"MEGAWAT" - 25 MAY 2005**

The Marine Casualty Investigation Board was established on the 25th March, 2003 under The Merchant Shipping (Investigation of Marine Casualties) Act 2000

Published by The Marine Casualty Investigation Board
5th December 2006

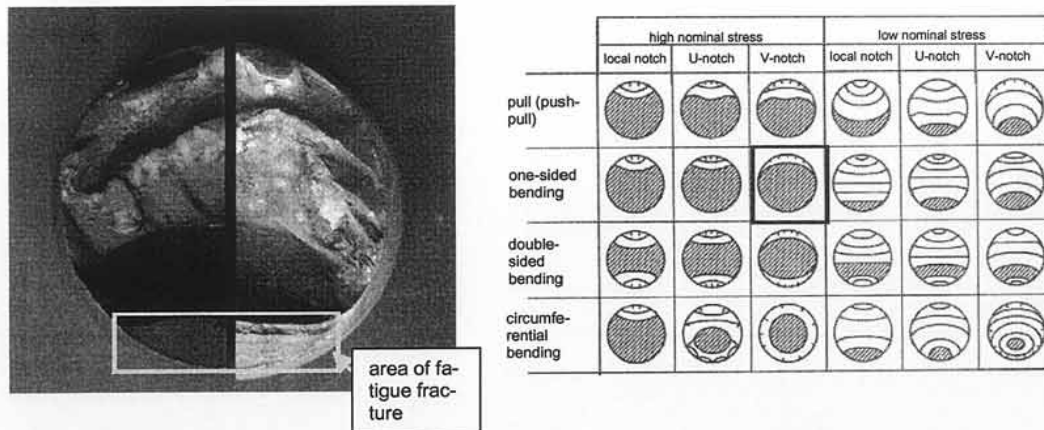
Fig. 1: Fracture area with fatigue fracture and forced fracture (left), classification of fracture areas according to the basic forms of fatigue fractures (right)

The macroscopic findings indicate an fatigue fracture due to a V-notch in the circumferential direction with unsymmetrical bending stress at the notch, corresponding to a comparison of cases of damage in the specific literature (Lange: System. Beurteilung techn. Schadensfälle, Fig. 1).

A fatigue fracture can be recognised by typical arrest lines. It amounts to about 10 per cent of the total fracture area, the part of the forced fracture, therefore, is about 90 per cent.

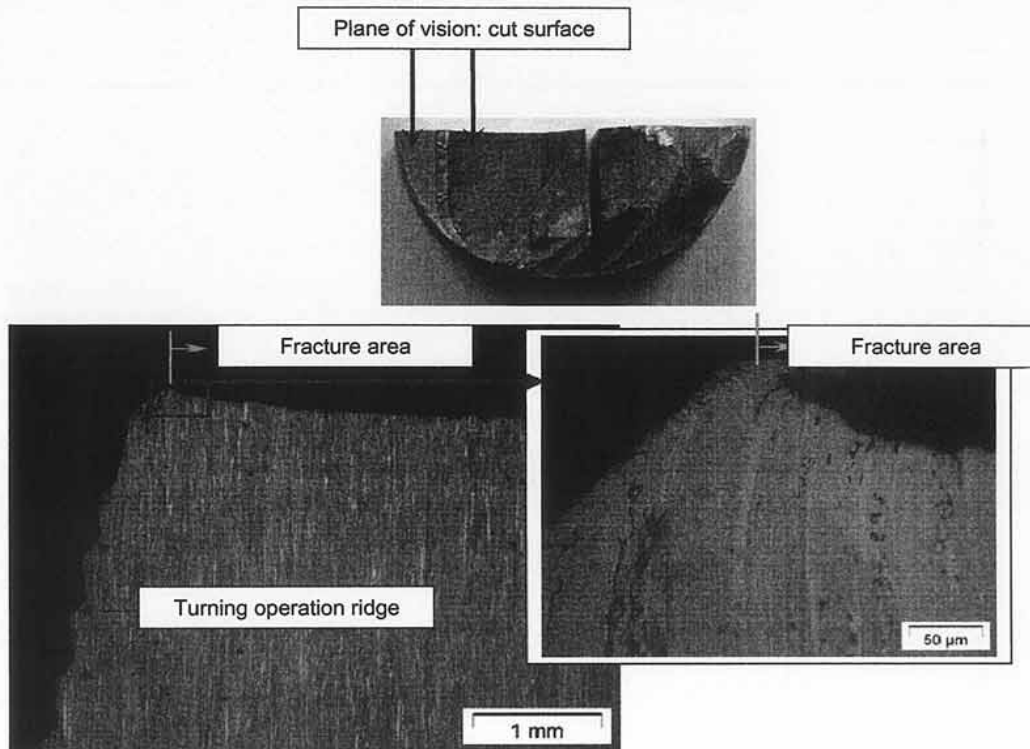
Fig. 2: Starting point of the fracture area (Source: Examination report Fa. IGHM Nr.10a/05)

A V-notch could be identified as the starting point of the fatigue fracture in the crack- starting area (Fig. 2).

Shape and position indicate that the starting point of the fatigue fracture is not a turning operation ridge in the conical area (with RZ about 80 μm), at the entrance into the cylindrical part a magnification shows areas of deformation and cracks (UB-Nr. 10a/05, p. 4) (Fig. 2, left side). The deviation from the line-structure of the material structure (Fig. 2, right side) may have been caused by a plastic deformation of the material prior to the beginning of the fatigue fracture.

Form and position of the starting point of the fatigue fracture do not indicate a turning-processing ridge of the conical area of an R_z of approximately 80 µm. At the entrance into the cylindrical part, areas of deformation and cracks are visible. This underlines the assumption that prior to the beginning of the fatigue fracture, the notch in the crack-starting area was caused by a plastic deformation of the material or by forcing an object into it.

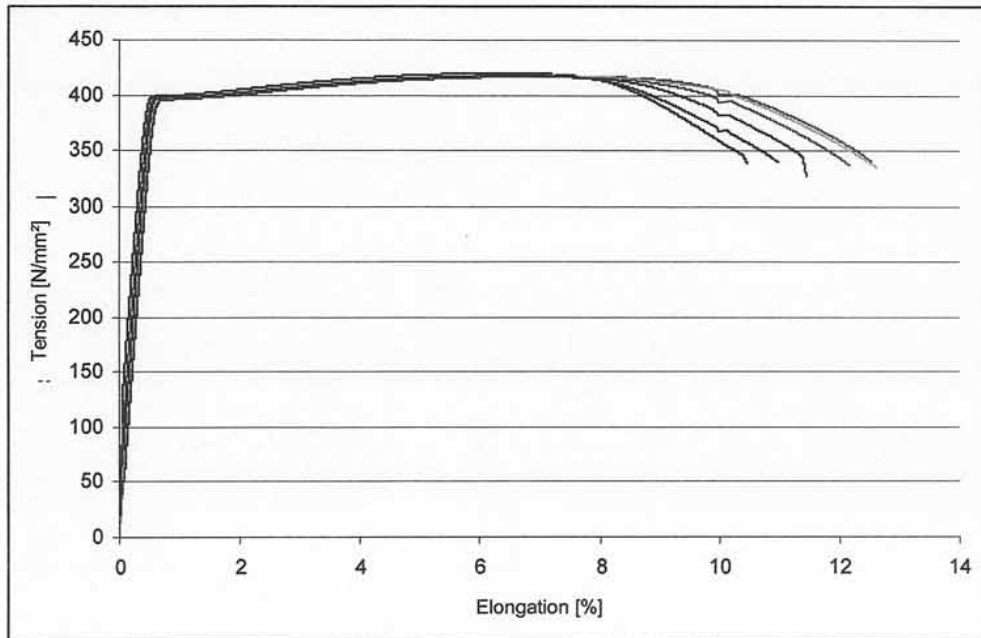
Fig. 6: Course of tension-elongation exhibited during the tensile strength test

5.3.2 The mechanical characteristics of yield point and tensile strength determined are about 10% above the upper limits of the strength class F32, which means the rudderstock had a reduced toughness leading to fast growth of any fissure present.

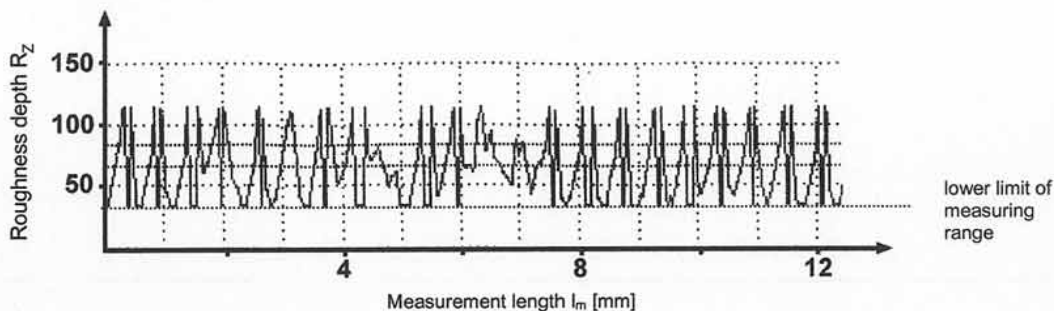
Fig. 8: Depth of roughness in the surface of the specimen $R_{Z\text{DIN}} \geq 80 \mu\text{m}$; (surpassing the lower limit of the measuring range)

The measurement shows that the medium roughness depth $R_{Z\text{DIN}}$ of the examined surface is in the range of $\geq 80 \mu\text{m}$ (surpassing the measuring range).

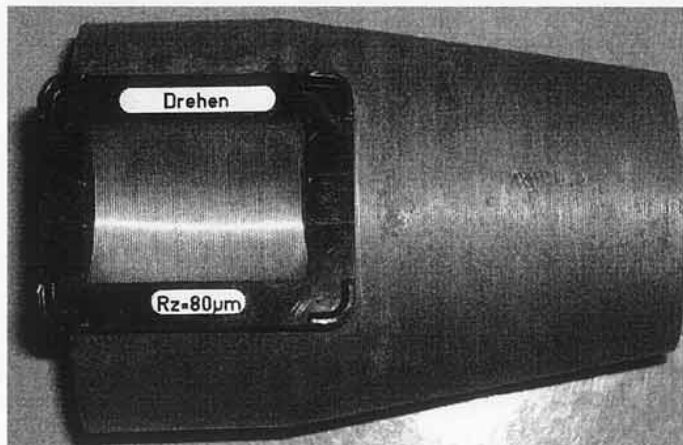
Fig. 9: Comparison of the specimen surface with the roughness standard $R_z=80 \mu\text{m}$

processing showed that an R_z of about $50 \mu\text{m}$ can be obtained e.g. by rough cutting, which means that the present value of about $80 \mu\text{m}$ can be considered as a very rough machining work.

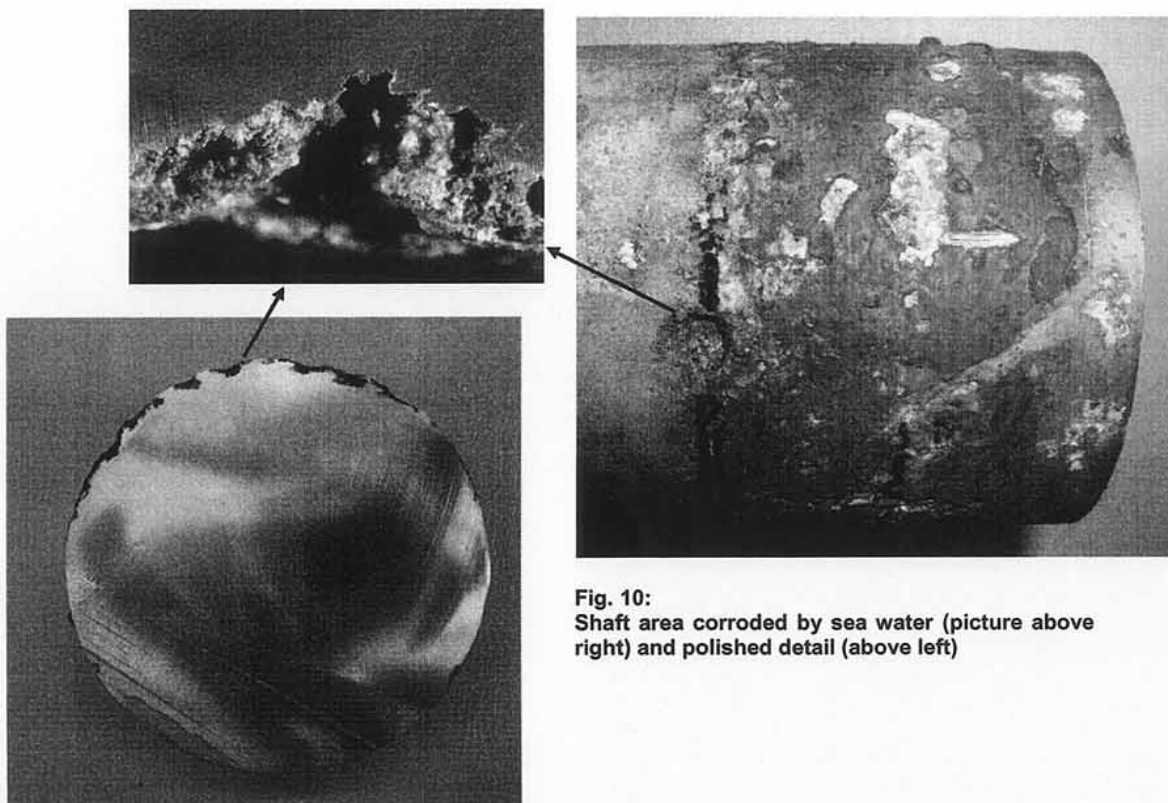
Fig. 10:
Shaft area corroded by sea water (picture above right) and polished detail (above left)

- 5.3.8 The exposed part of the rudderstock between the underside of the hull and the top of the rudder blade was corroded.

The antifouling (Awlgrip Gold) was incompatible with the aluminium rudderstock. The manufacturers of Awlgrip have advised that Awlgrip Gold should not be used on aluminium components as it is copper based and causes corrosion if applied to aluminium. Hanse Yachts advised that this type of corrosion has been found on other Hanse Yachts. Continued corrosion of the rudderstock could eventually lead to failure.

An area of high damage in the part of the shaft that was exposed to seawater was exemplarily examined for cross-sectional weakening by corrosion. In the cross-section examined (Fig. 11) the weakening of the cross-section amounted to about 3 per cent (2 cm² of an overall cross-section of 60 cm²).
