**REPORT INTO THE FIRE  
AND SUBSEQUENT GROUNDING  
OF THE MV "PATRIARCH"  
ON 1ST SEPTEMBER, 2004**

Published by The Marine Casualty Investigation Board  
10th November 2005

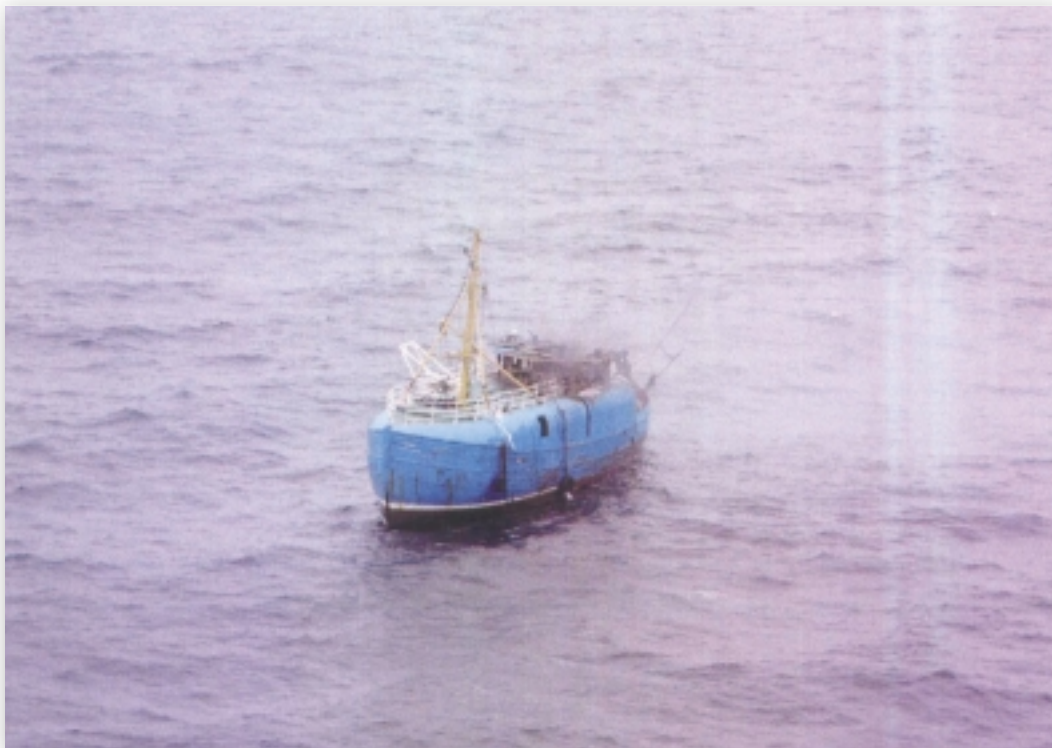
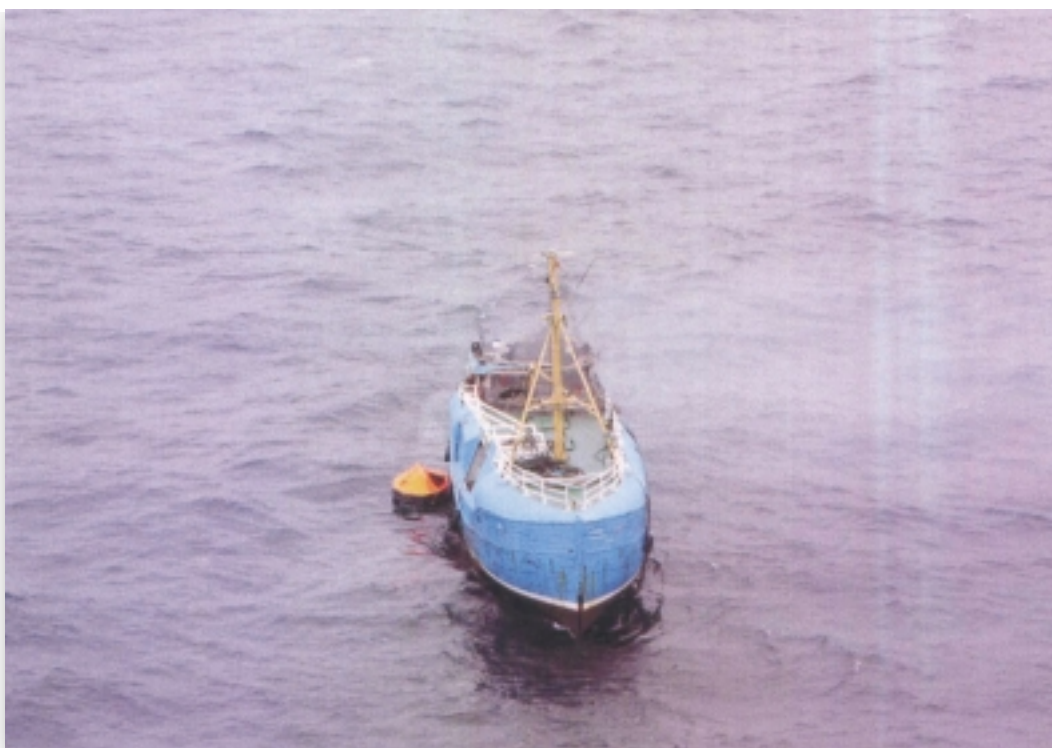
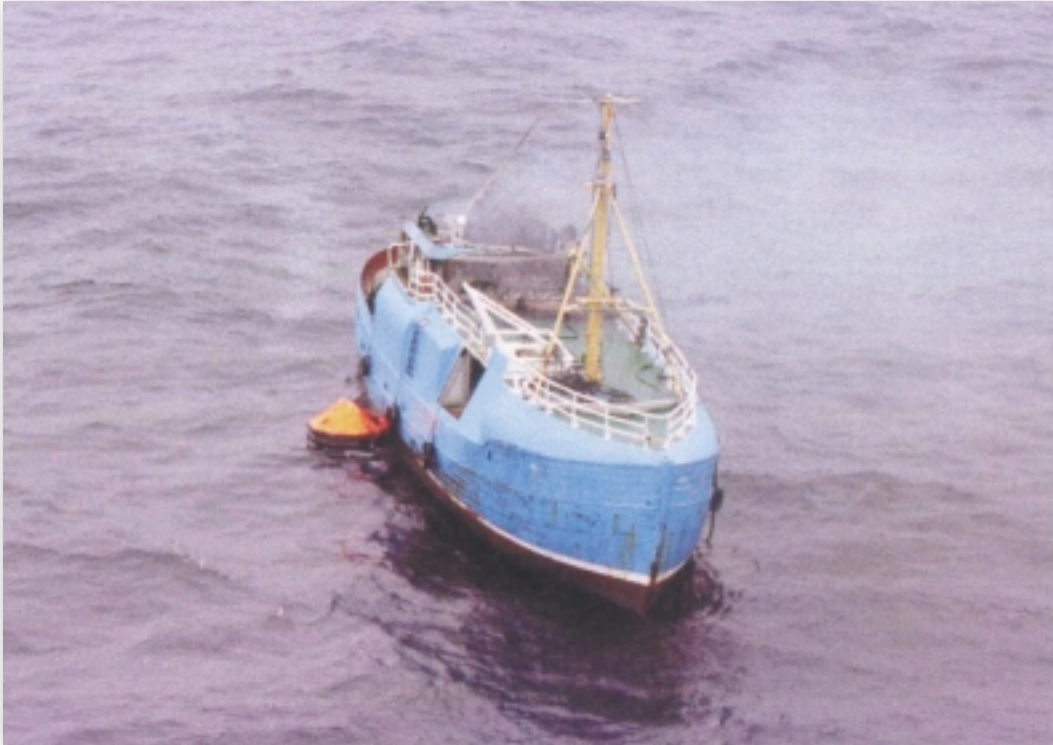
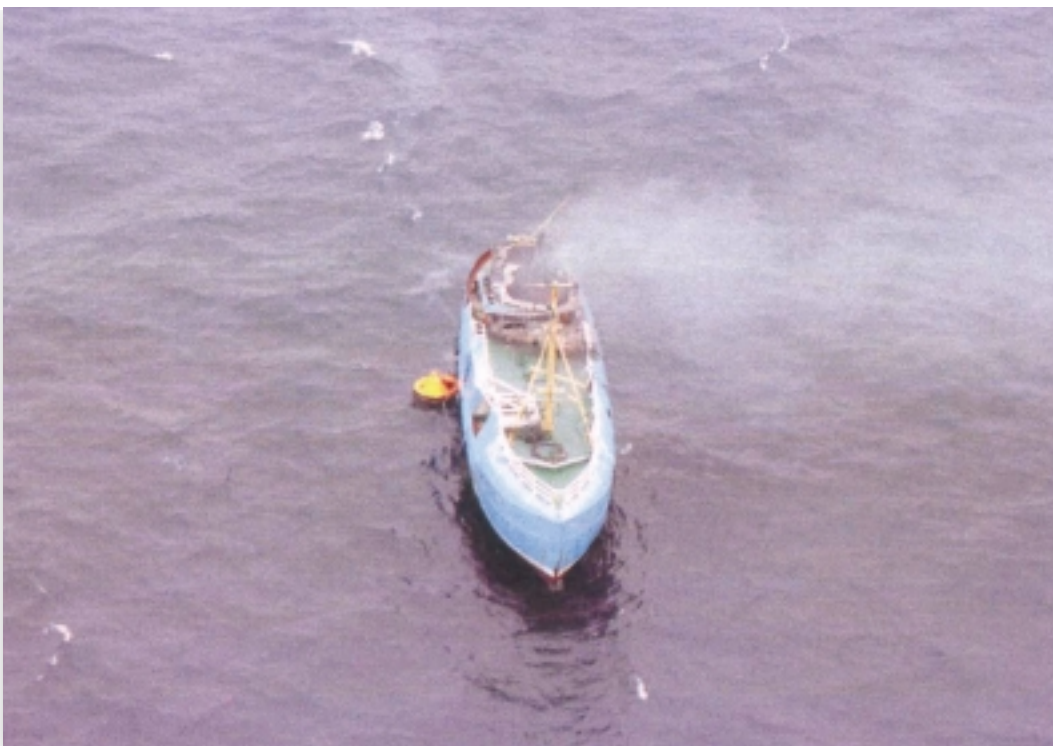
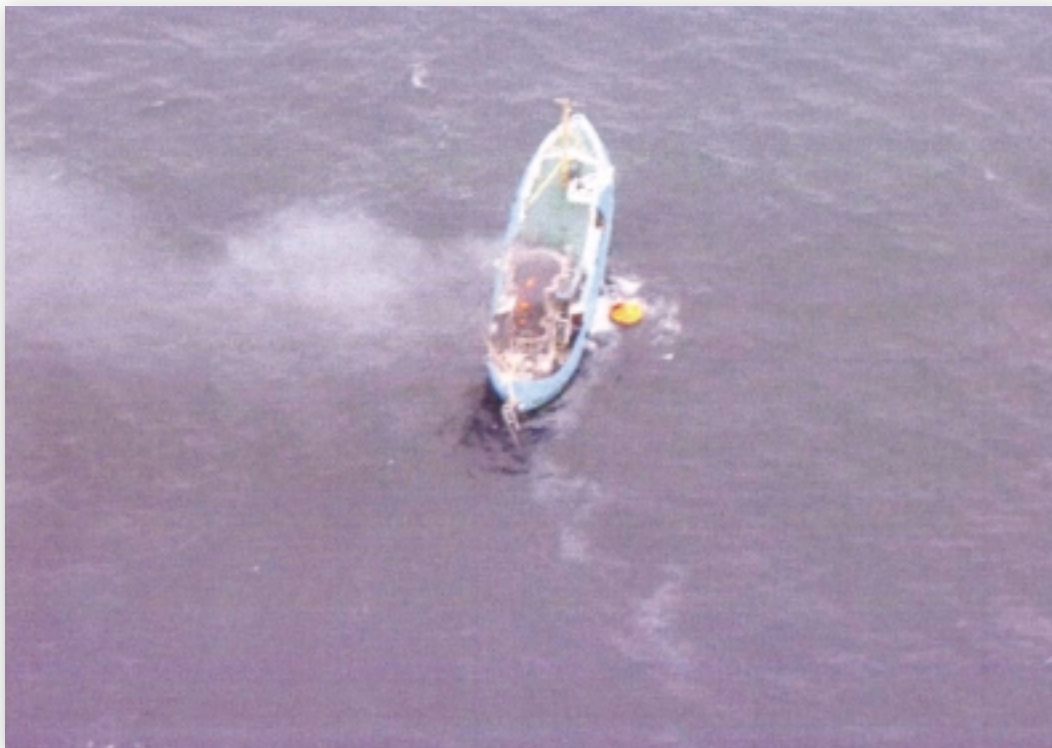
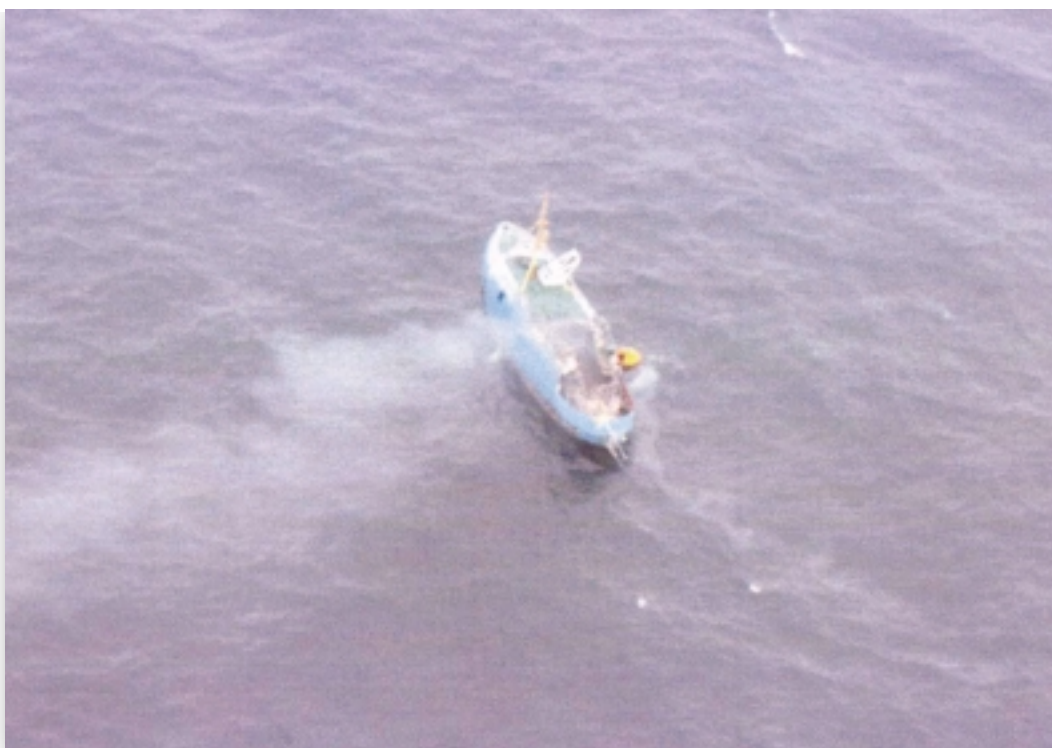
Photographs of Patriarch taken by Coast Guard helicopter based in Shannon on 1st September 2004.

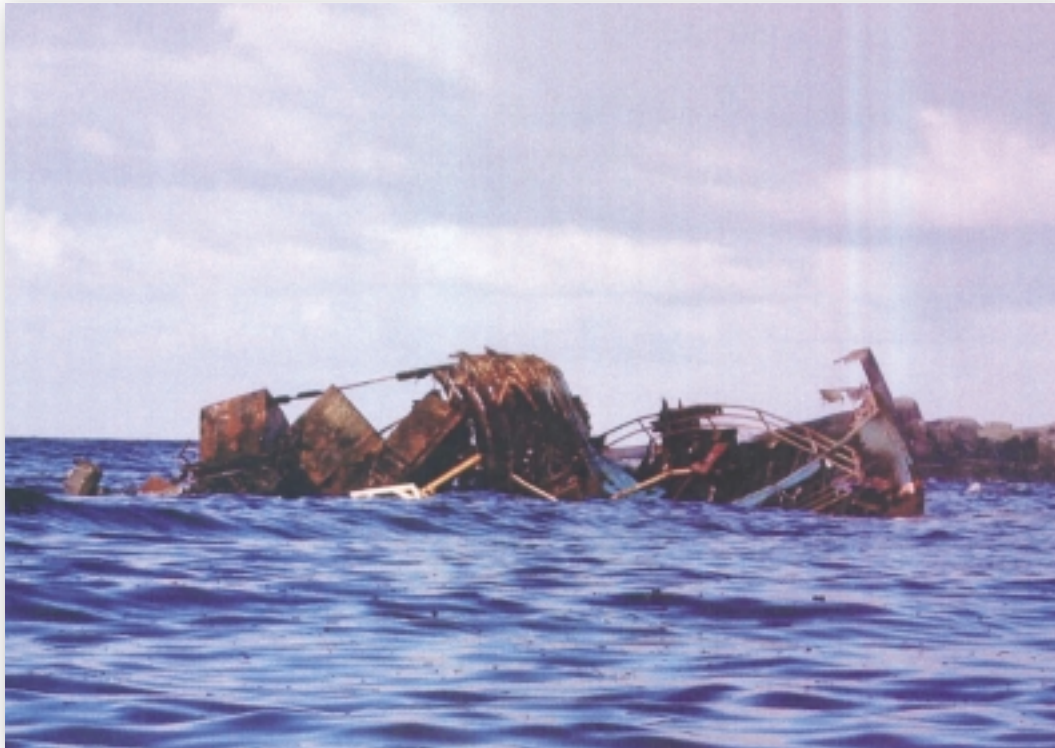
Photo of the Patriarch taken on the morning of the 2nd. September 2004 by LE Roisin.

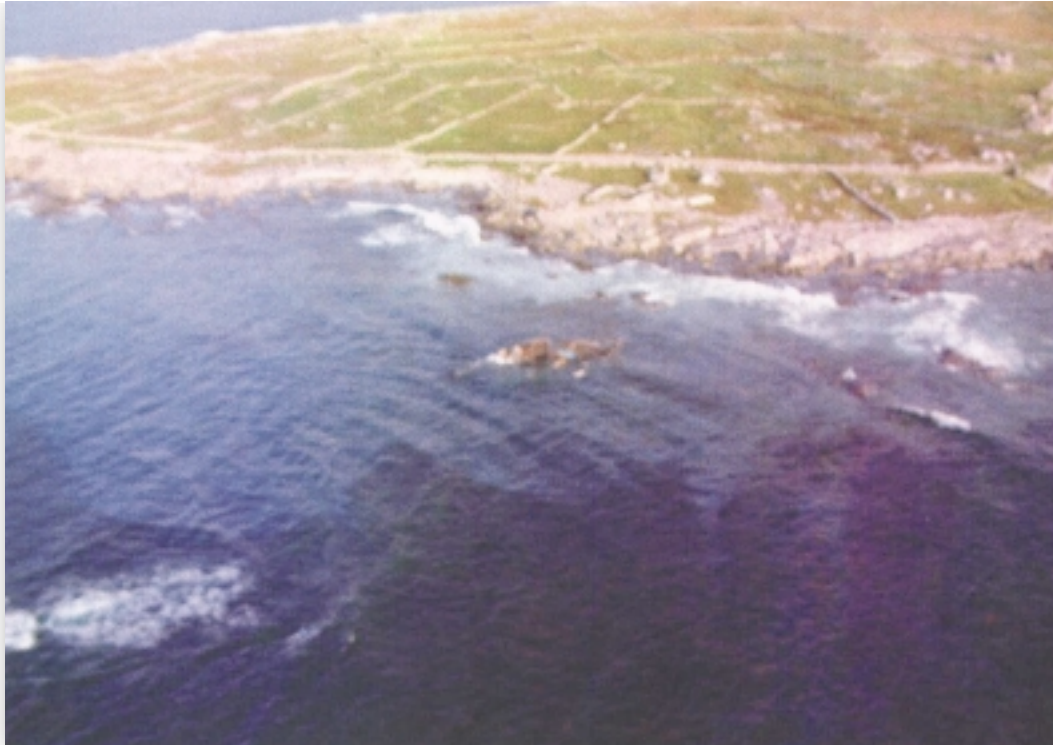
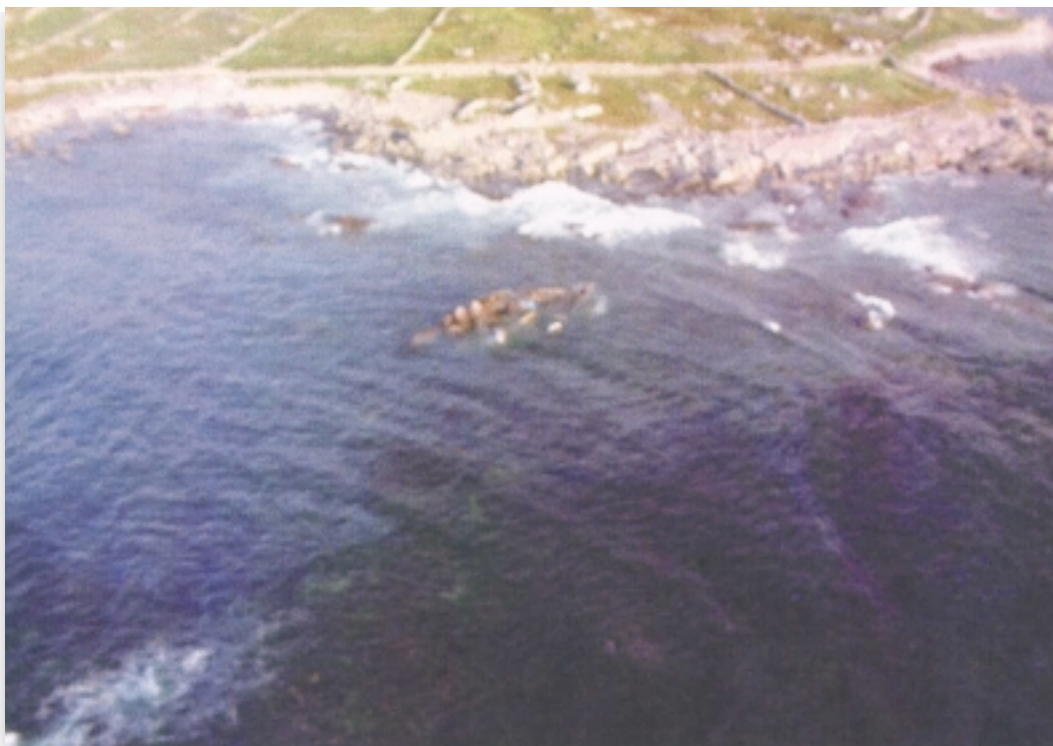
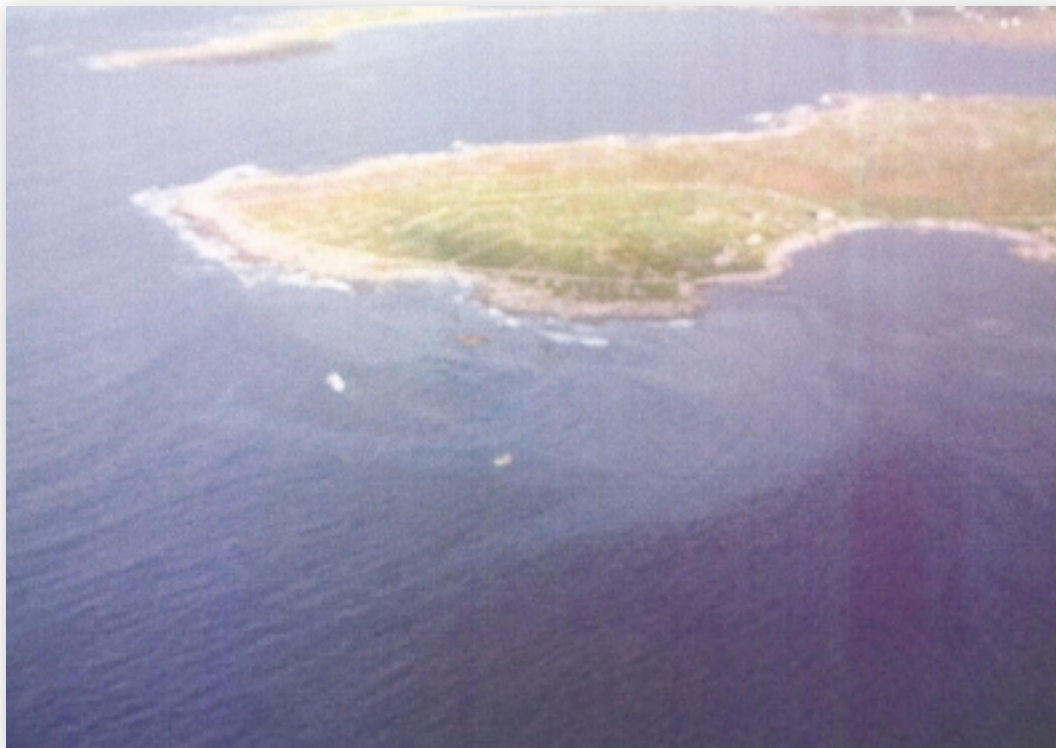
Selection of photographs of Patriarch taken on the morning of 2nd. September 2004.
