**REPORT INTO THE  
CAPSIZING AND SINKING  
OF THE “DINISH”  
ABOUT 170 MILES SOUTH WEST  
OF THE SCILLY ISLES  
ON 24th MAY 2006**

**REPORT No. MCIB/125**

Report MCIB/125 published by The Marine Casualty Investigation Board  
10th October 2008

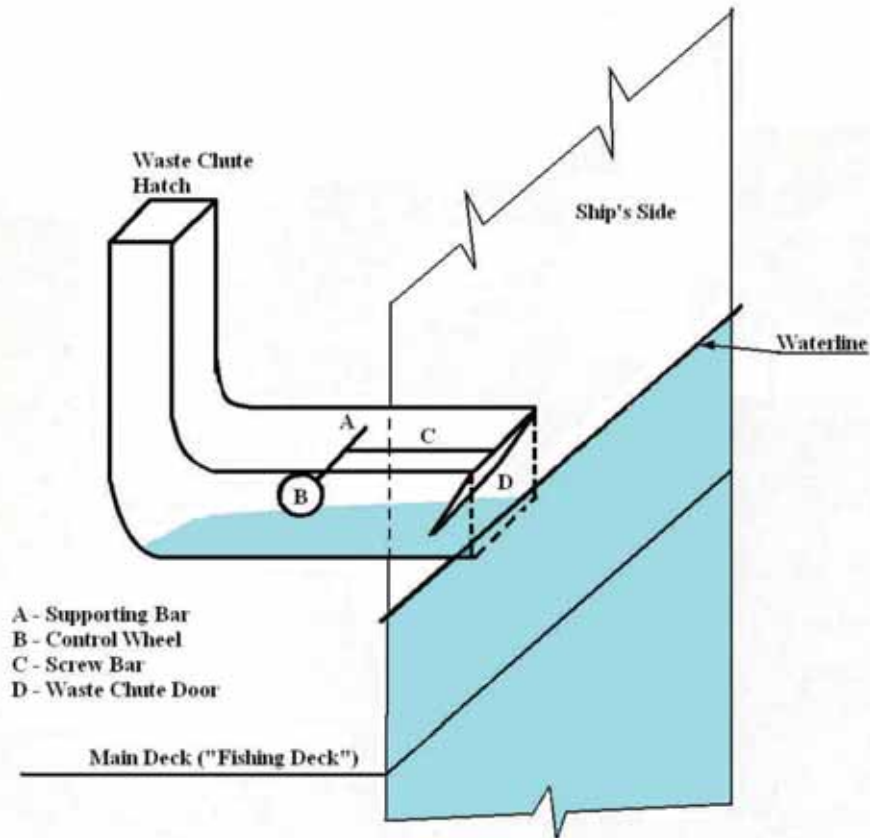
Fig. 4 Diagram of Waste Chute

At the starboard aft end of the fishing station was the waste chute. This chute had a raised coaming and went directly overboard. It was used for discharging waste fish and guts. It had a closure on the coaming and at the ships side. The ships side closure was operated by turning a wheel with a screw thread. The ships side penetration was at or slightly below water level when the “Dinish” left Vigo in the fully loaded condition (See fig. at Appendix 9.4).

- 7.6 The owners and crew did not pay sufficient attention to the condition of the fish chute and its connection with the ships side. Fish chutes are subject to abnormal wear and tear as they are continually wet and dry and also used to discharge abrasive waste from the trawl nets - stones, flotsam etc.

- 7.13 No attempt was made to stop the ingress of water through the crack in the fish chute other than trying to close the shipside connection. It is likely that excessive force used to close the fish chute door had the effect of opening up the crack even more and allowing more water into the vessel.

Owners, operators, Masters and crew should make every effort to ensure that all personnel on board are trained in safety procedures, familiar with the vessel, have the latest safety information available to them and that they comply with the legislation. All parts of the vessel that could reasonably be expected to lead to flooding should be inspected frequently for damage and effective operation.

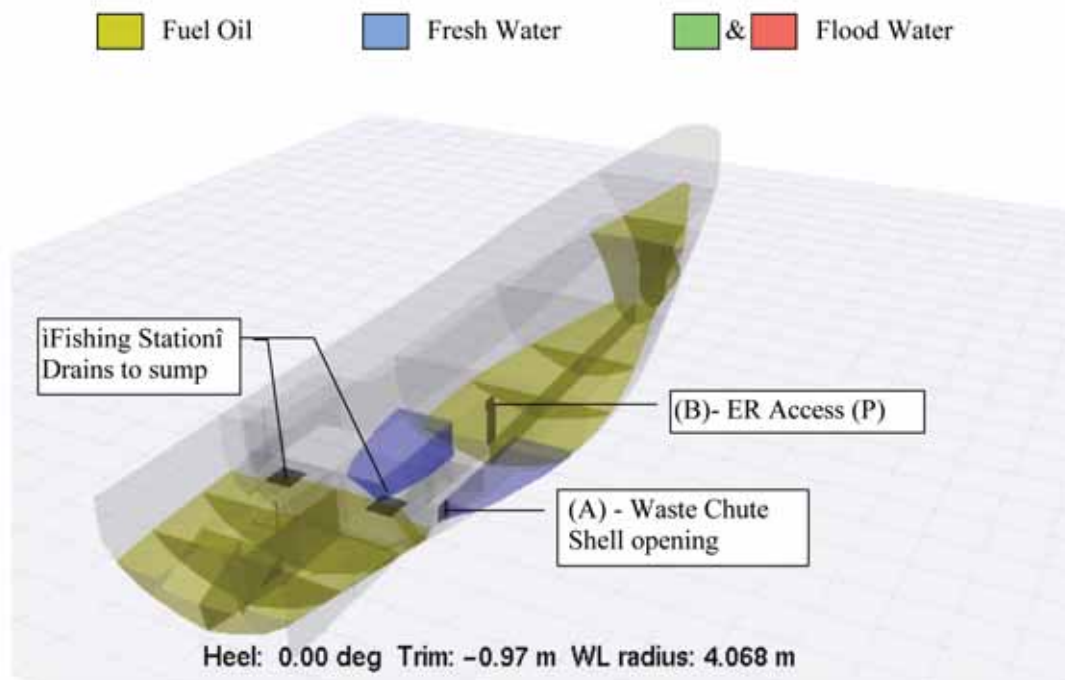
Fig.5

Figure 5 shows the openings through which the initial flooding took place. Initial flooding was through a crack at the waste chute (A), which would have flooded on to the fishing station. Water on the fishing station normally drains in to sumps at the aft end of the deck and is pumped overboard by dedicated pumps. As these pumps were not running at the time the water would have accumulated in the sumps and eventually overflowed onto the fishing station. This would have continued until the water reached the engine room access door (B) and then started to flood in to the engine room.

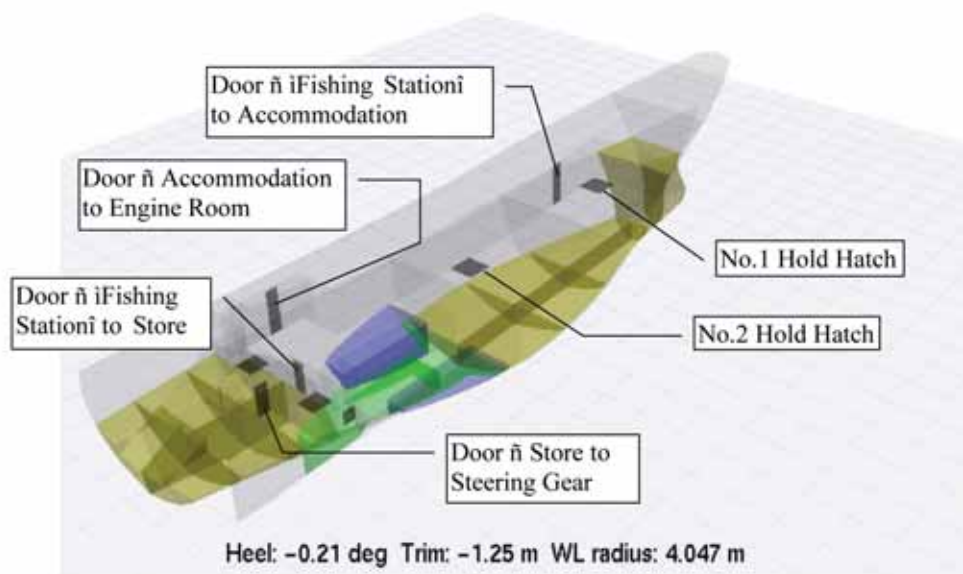
Fig.6

Although door (B) to the engine room was closed when the water in the fishing station and engine room was discovered, a number of other doors and hatches were still open which allowed progressive flooding to occur. These openings are shown in Figure 6.

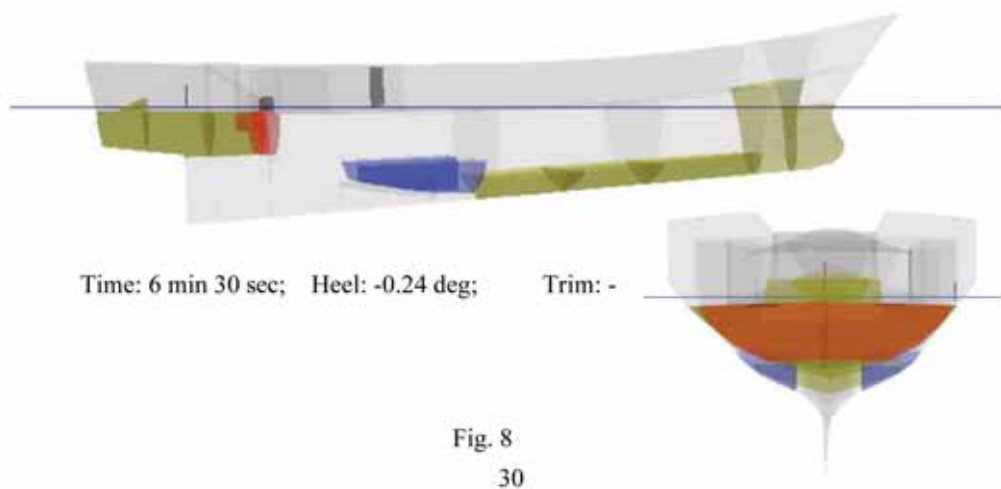
Fig. 8 The fishing station drain sumps are filled and just about to overflow on to the fishing station.

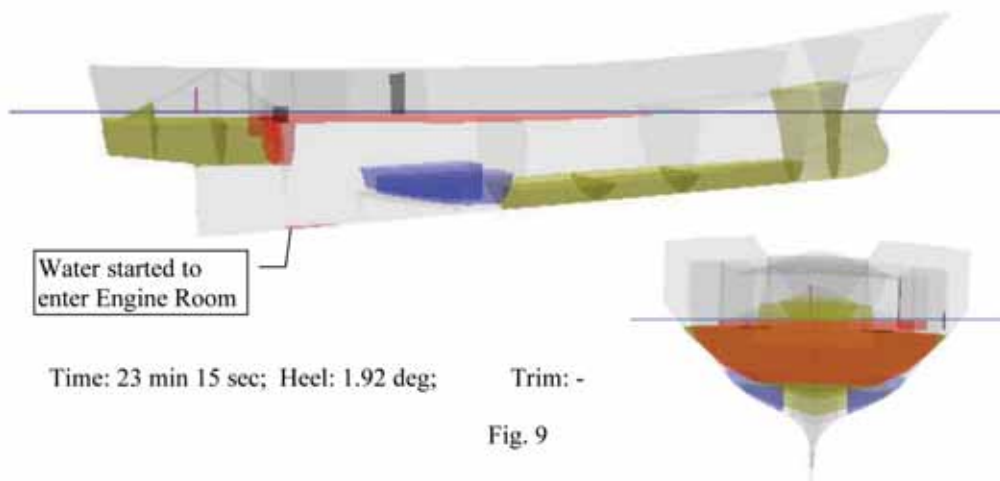
Fig. 9 Water has flooded on to fishing station to the level of the starboard engine room door and has just started to flood down in to the engine room. Vessel now has a slight heel to starboard.

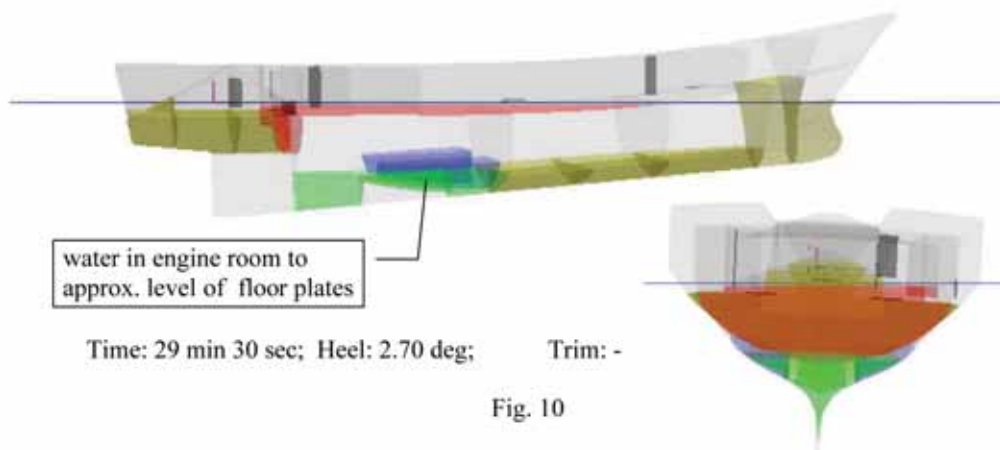
Fig. 10 The water level in the engine room has reached approximately the level of the floor plates. This is approximately the time when the flooding was first discovered and when the starboard engine room door was closed.

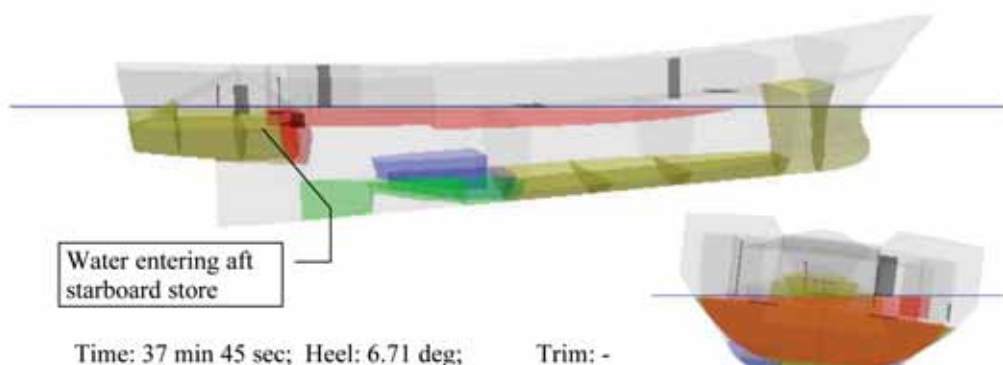
Fig. 11 Water in fishing station has reached the level of the top of the coaming at the door to the aft starboard store and has started to flood the store.

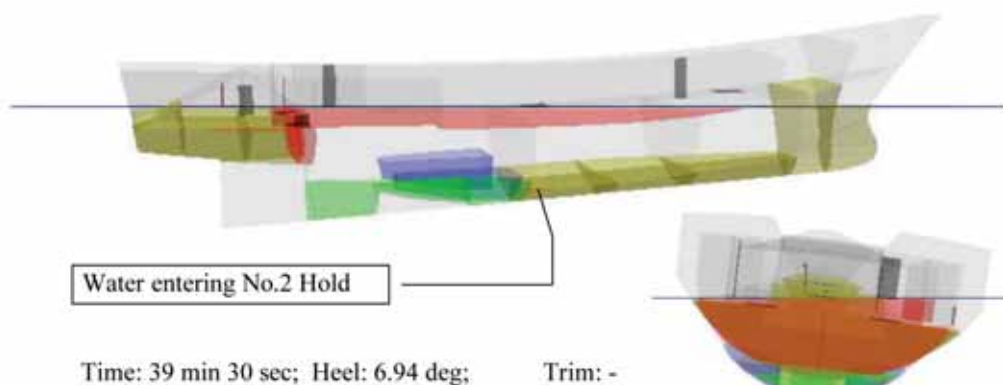
Fig. 12 Water level in fishing station has now reached the hatch to No.2 Hold and it is assumed that No.2 Hold will start to flood.

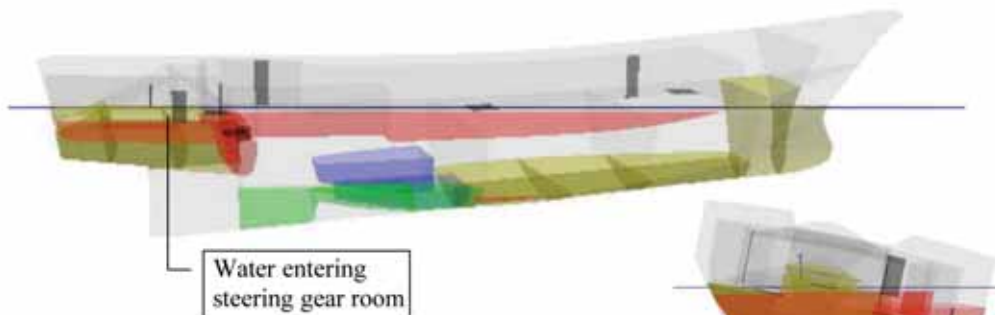
Fig. 13

Fig.13 Water in aft starboard store is now at the level of the coaming at the steering gear room door and is starting to flood the steering gear room.

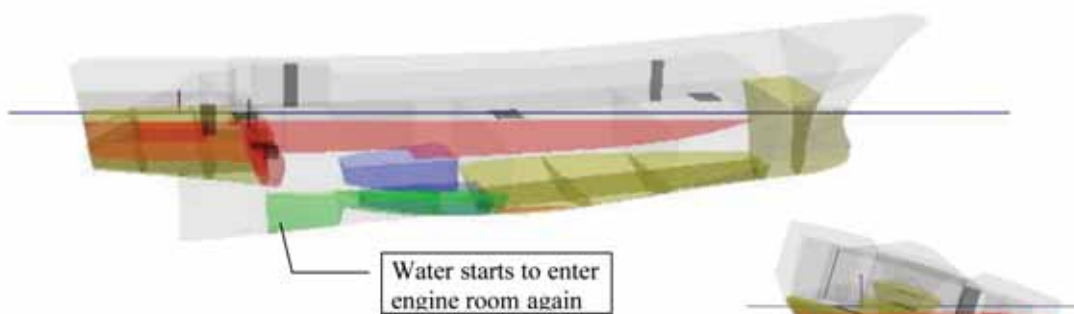
Fig. 14 Water is now flooding through a drain from the steering gear room into the engine room bilge. It is probably about this time or shortly after that the crew started to abandon ship.

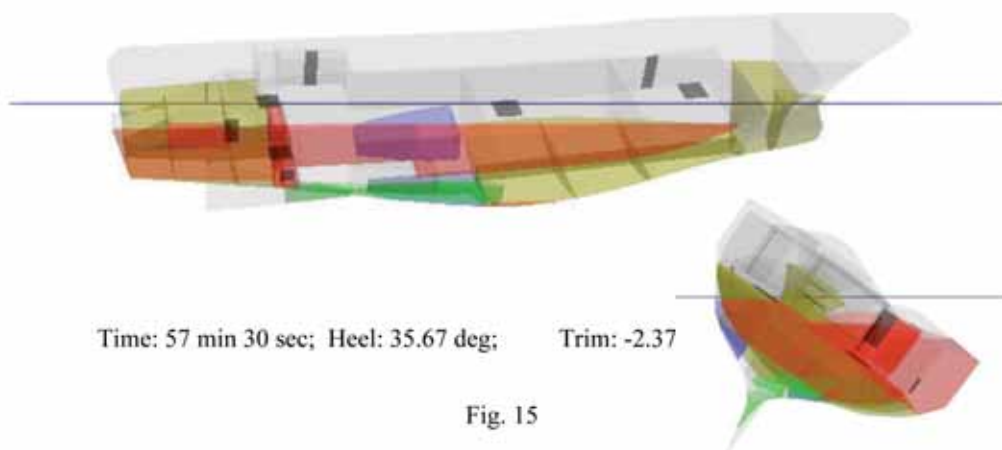
Fig. 15 Vessel continues to flood until it reaches an angle of approximately 36 and then capsizes.

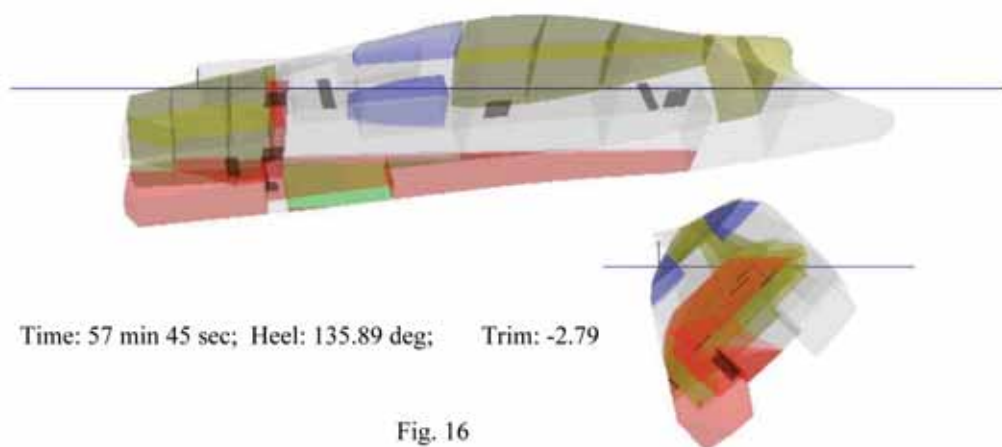
Fig. 16 Vessel has capsized and lies at an angle of approximately 136. Simulation stops shortly after this point but vessel will continue to progressively flood until it sinks.
