**REPORT OF INVESTIGATION
INTO INCIDENT INVOLVING
THE PASSENGER FERRY
“PIRATE QUEEN”
ON ITS APPROACH TO
ROONAGH PIER
OUTSIDE LOUISBURG,
CO MAYO
ON 20th DECEMBER 2011**

**REPORT No. MCIB/211
(No.2 of 2013)**

Report MCIB/211 published by The Marine Casualty Investigation Board
Printed 29th January 2013.

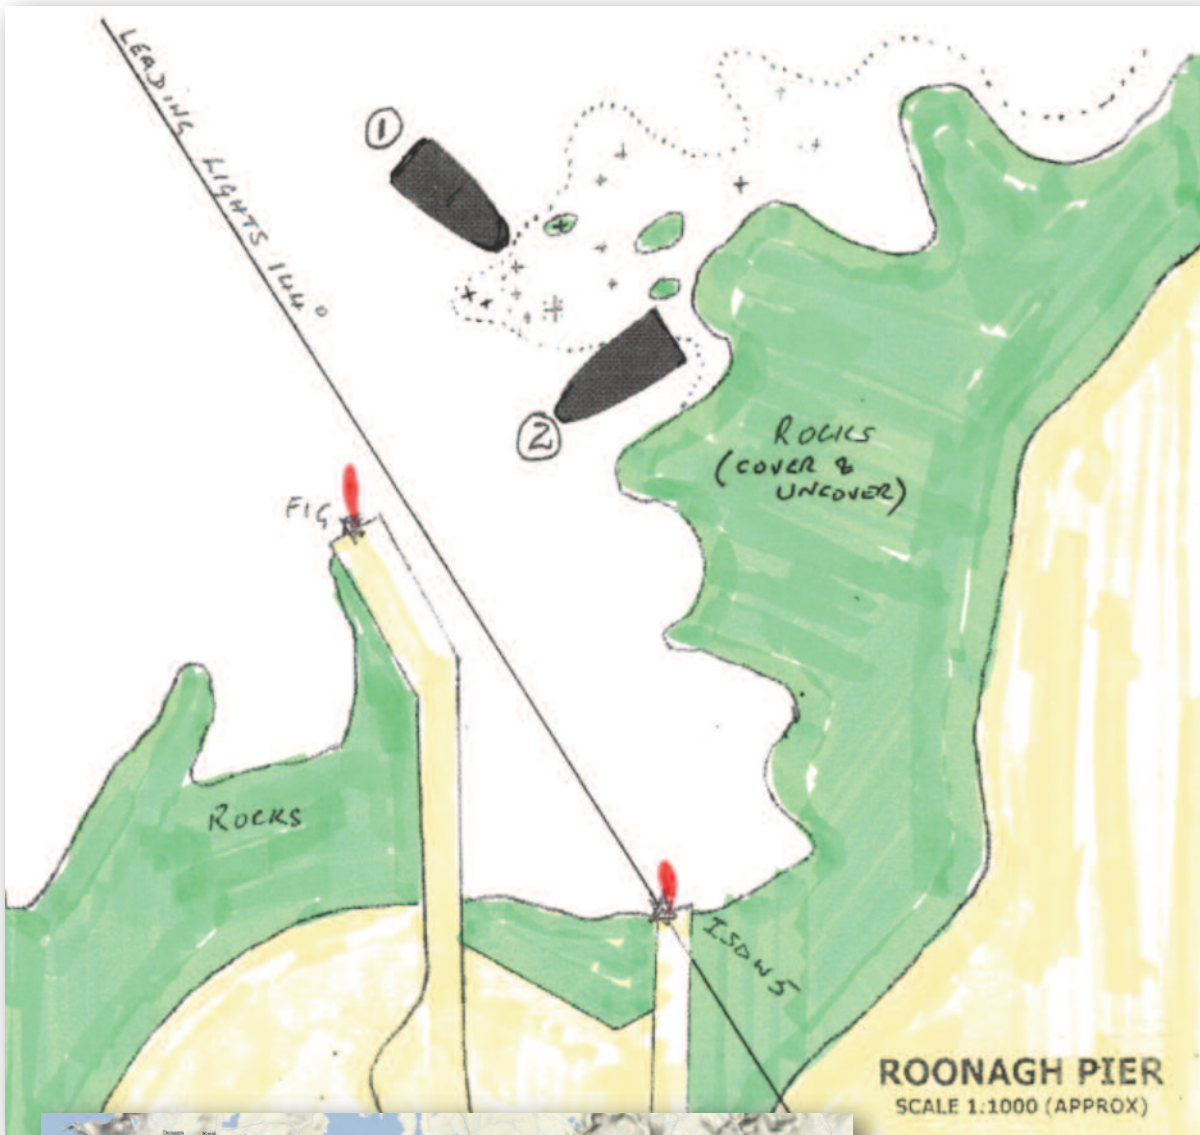
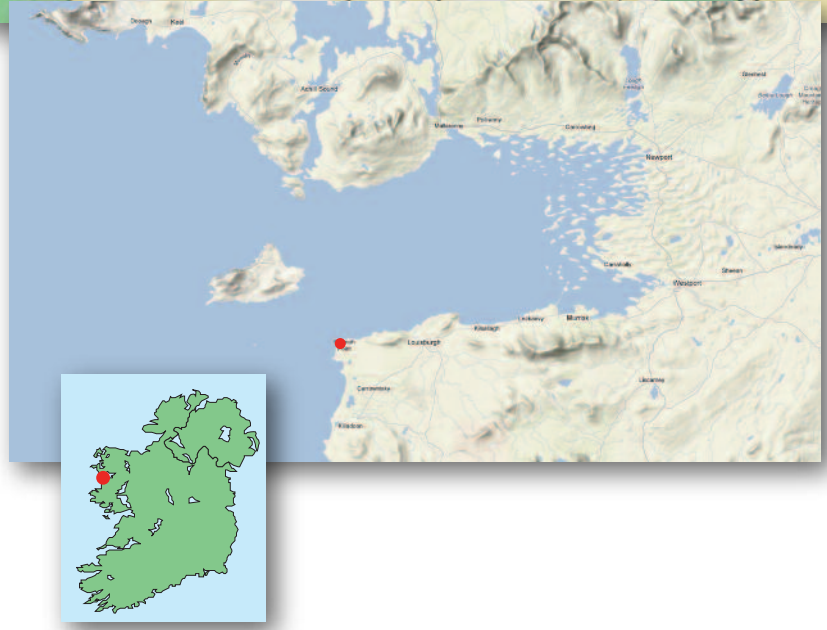
Appendix 7.1 Charlet of Roonagh Pier and Approaches.

- 3.2.1 At 18:20hrs the “*PIRATE QUEEN*” was making the approach to Roonagh Pier. The Master was steering the vessel and the full time crewmember was on the port wing of the bridge keeping lookout. The search light was not manned. The lookout reported that they were too far to the east and at that point a large swell forced the vessel over onto the rocks on the east side of the pier. (Labelled position 1 in chartlet in Appendix 7.1).

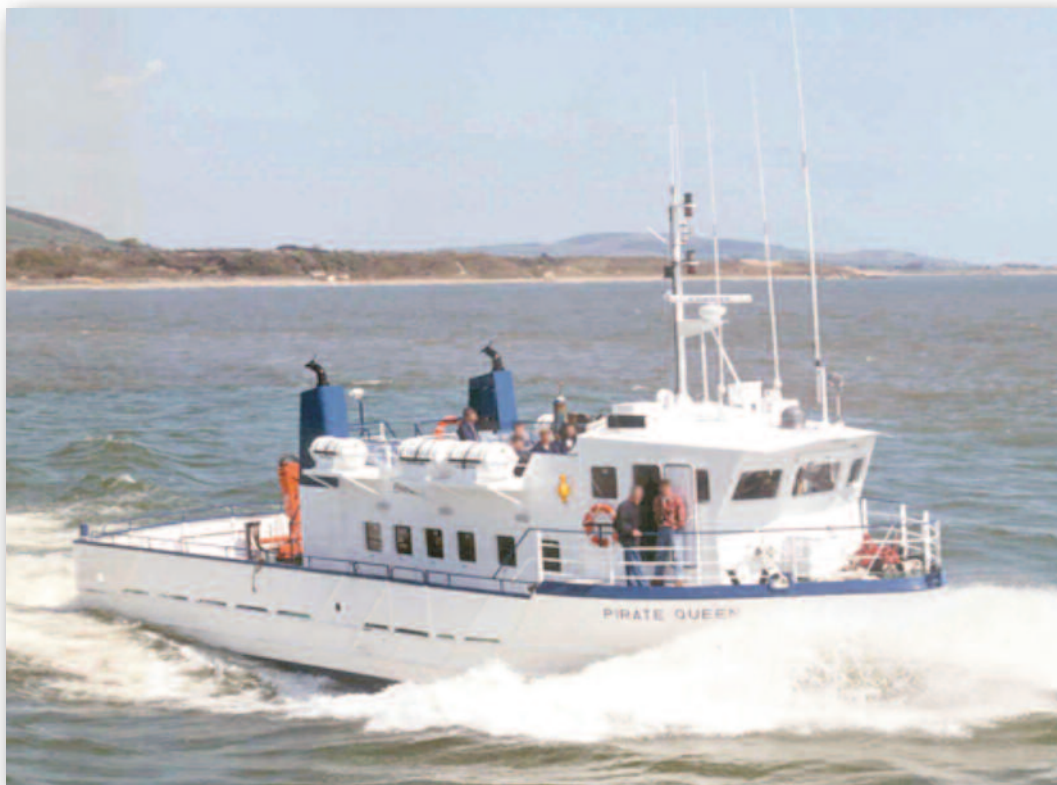
Photo 1: The Pirate Queen.

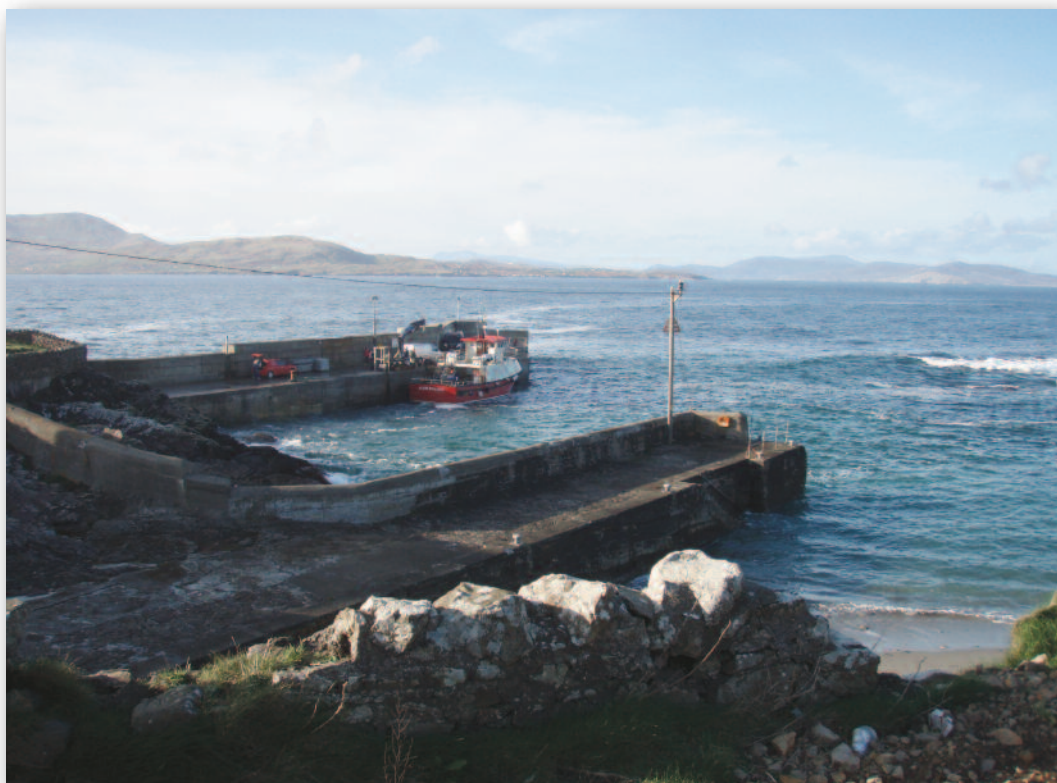
Photo 2: General view of Roonagh Pier.

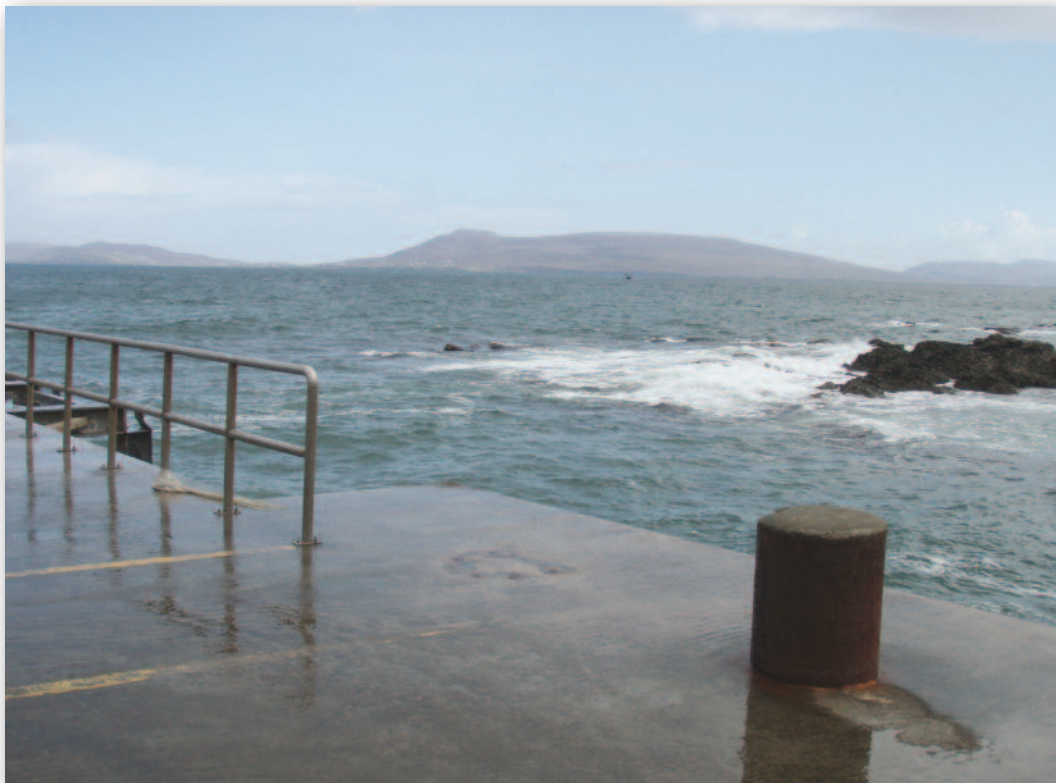
Photo 3: Just right of rails - Rocks where vessel grounded.

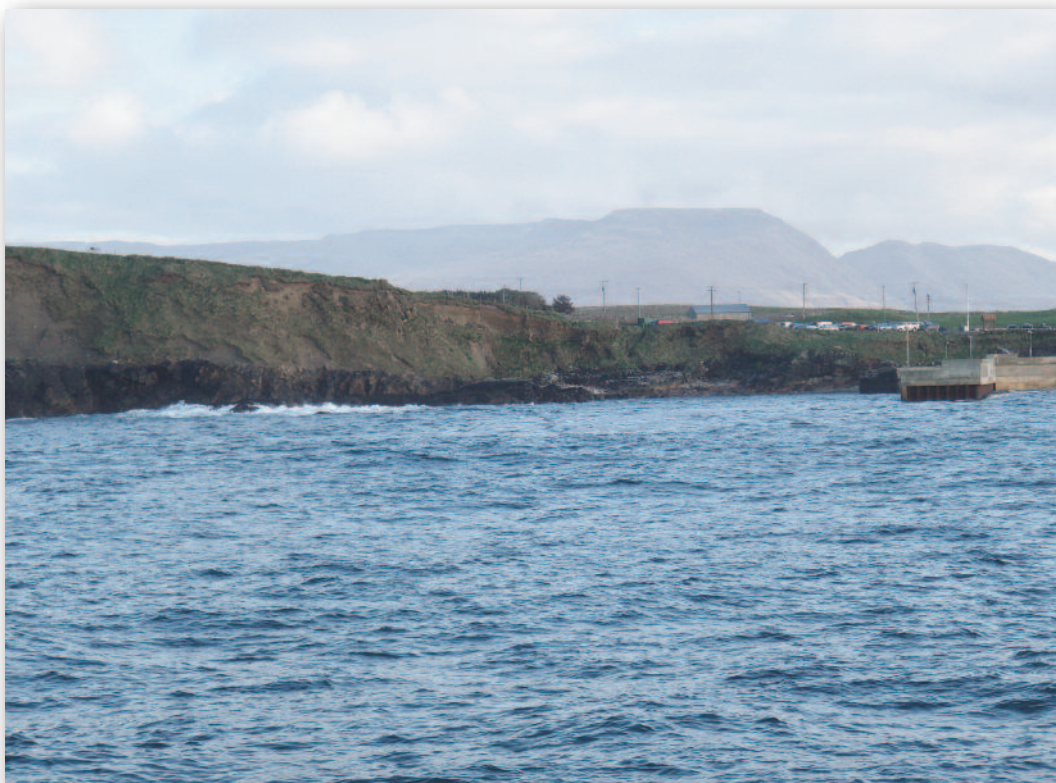
Photo 4: Approach to Roonagh pier from seaward.
Approaching Vessel in good position just to west of leading line

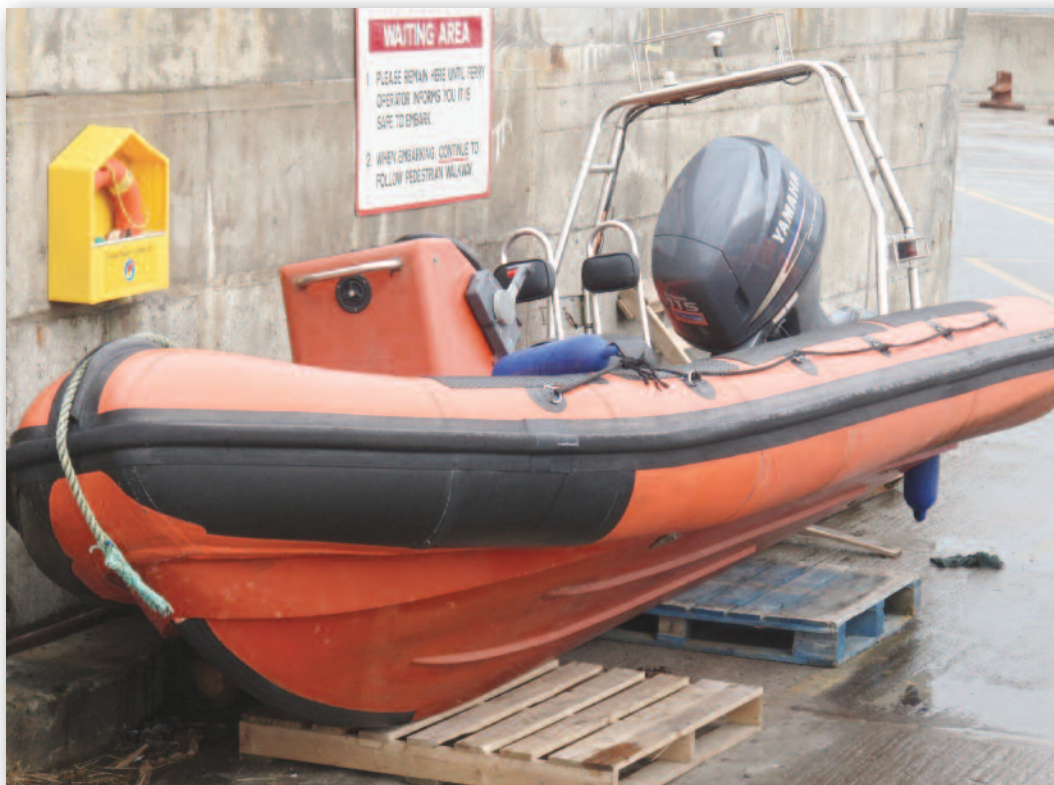
Photo 5: RIB used to evacuate the passengers.
