**REPORT ON
THE CIRCUMSTANCES
SURROUNDING THE
DETENTION OF THE OIL
TANKER "PRINCESS EVA" IN
KILLYBEGS, IRELAND ON
28 JANUARY, 2003.**

The Marine Casualty Investigation Board was established on the 25th, March 2003 under The Merchant Shipping (Investigation of Marine Casualties) Act 2000

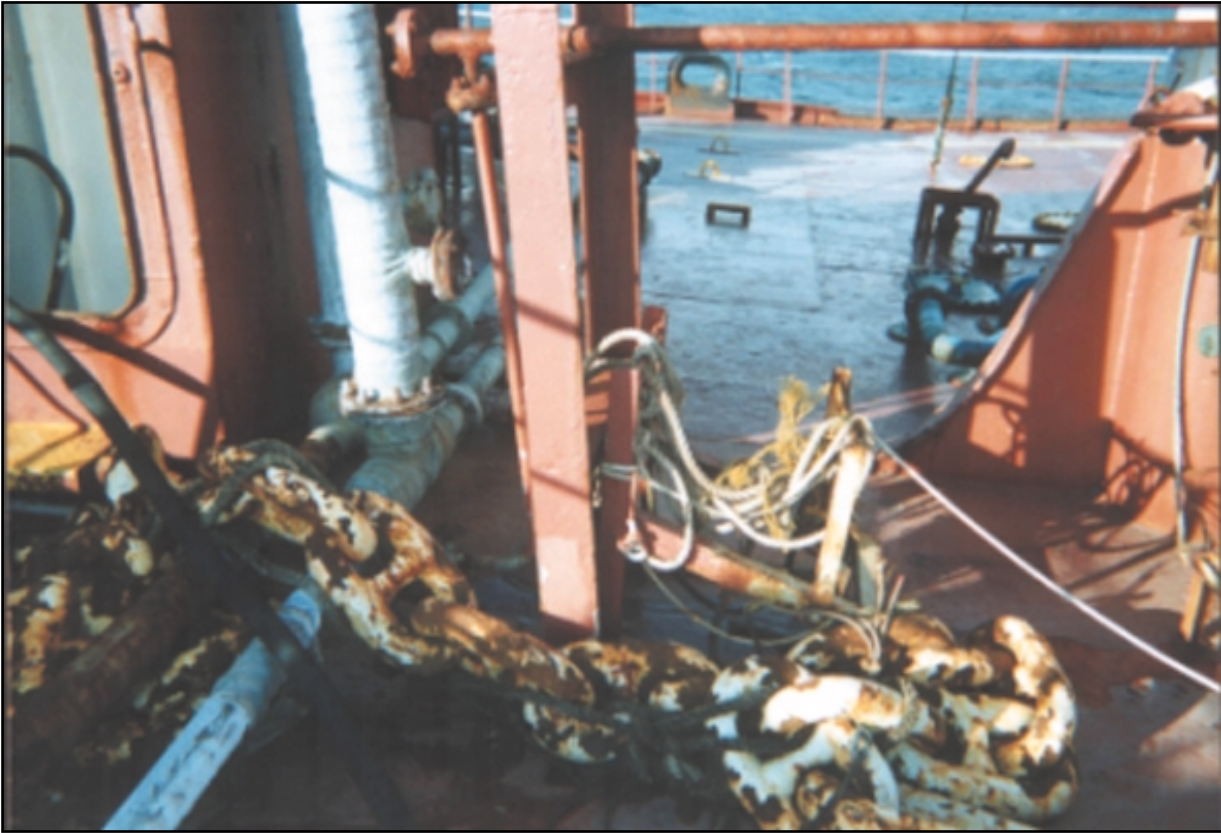
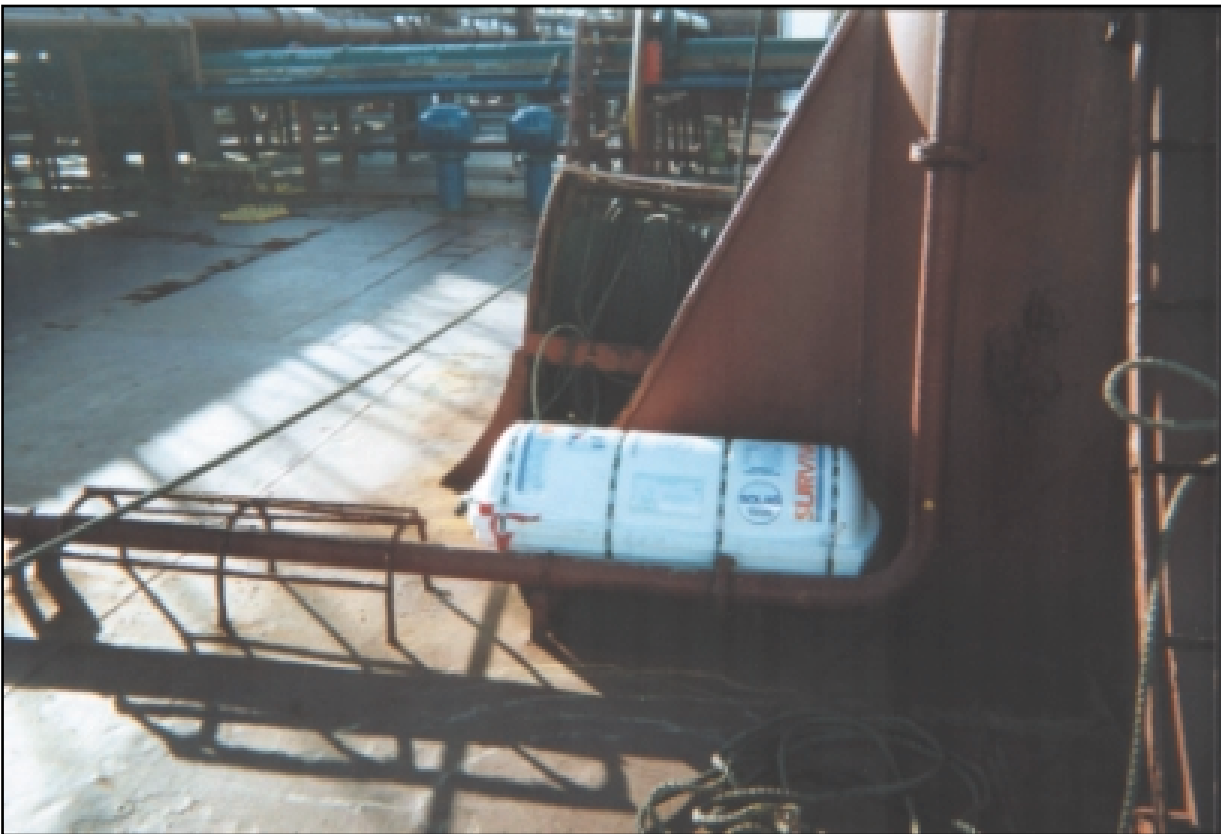
At approx. 11.00hrs GMT on the 28th January, the bridge watch reported that the forward liferaft had broken free and had inflated on the starboard side of the fore deck. A decision was taken to send personnel forward to attempt to secure the liferaft. The Chief Officer - Mr. Andres Manrique, the Bosun - Mr. Pedro Sanchez and an AB - Mr Carlos Hernandez were tasked and donned heavy weather gear. During the attempt to recover the raft, it was reported that the vessel's heading was altered to reduce effects of sea and wind on bow. The recovery of the raft was from the starboard side. The raft was successfully recovered and dragged into a position forward near the centreline of the ship and under the walkway and cargo / steam piping. While it was being made fast, a very large wave, described by the master as coming from an unusual direction, broke over the bow and washed over the deck as far aft as the midships housing. The three crewmembers on the foredeck were hit by the wave. The remaining ship's crew immediately undertook a rescue operation and all three were recovered to the accommodation aft. The bosun was dead when recovered. The Chief Officer had sustained serious injuries and died on board later the same day. The AB had lost his left leg and sustained other serious injuries. He was evacuated from the ship by Coast Guard helicopter at 18.00 hrs and taken to Galway Regional Hospital. He survived and was repatriated on release from hospital three weeks later. (See photographs 7.1.1, 7.1.2 showing details of liferaft & position of cradle).

Figure 7.1.1 showing ford liferaft cradle (top) and replacement packed liferaft

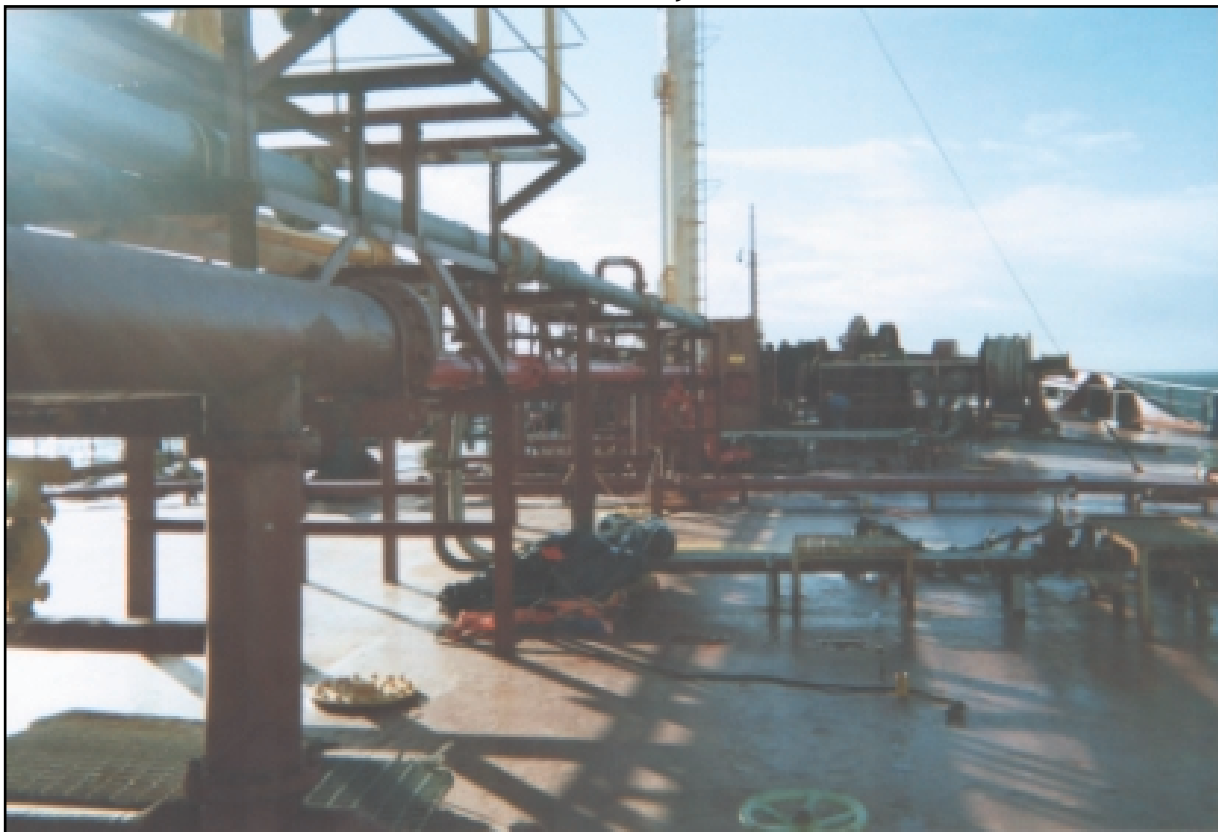
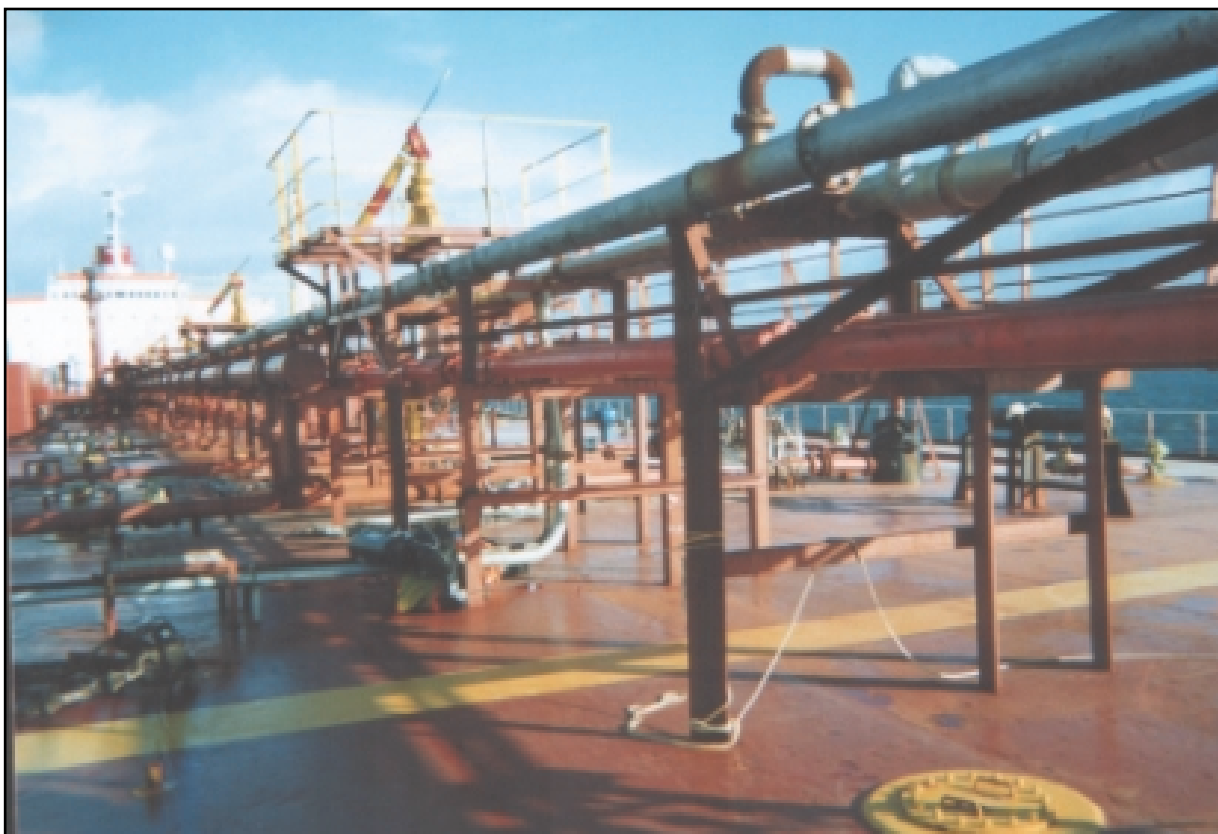
Figure 7.1.2 Views looking forward (top) and aft at recovered liferaft - approx. position of three crewmembers struck by wave

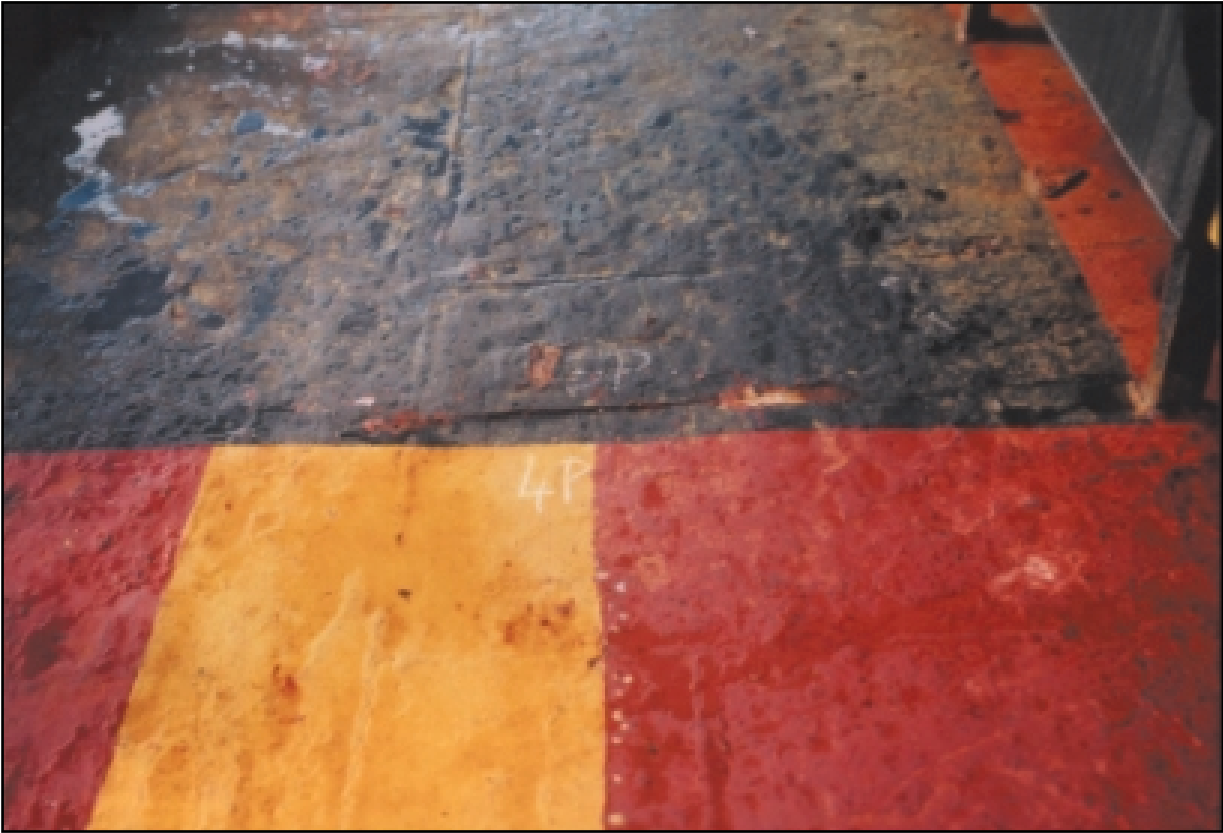
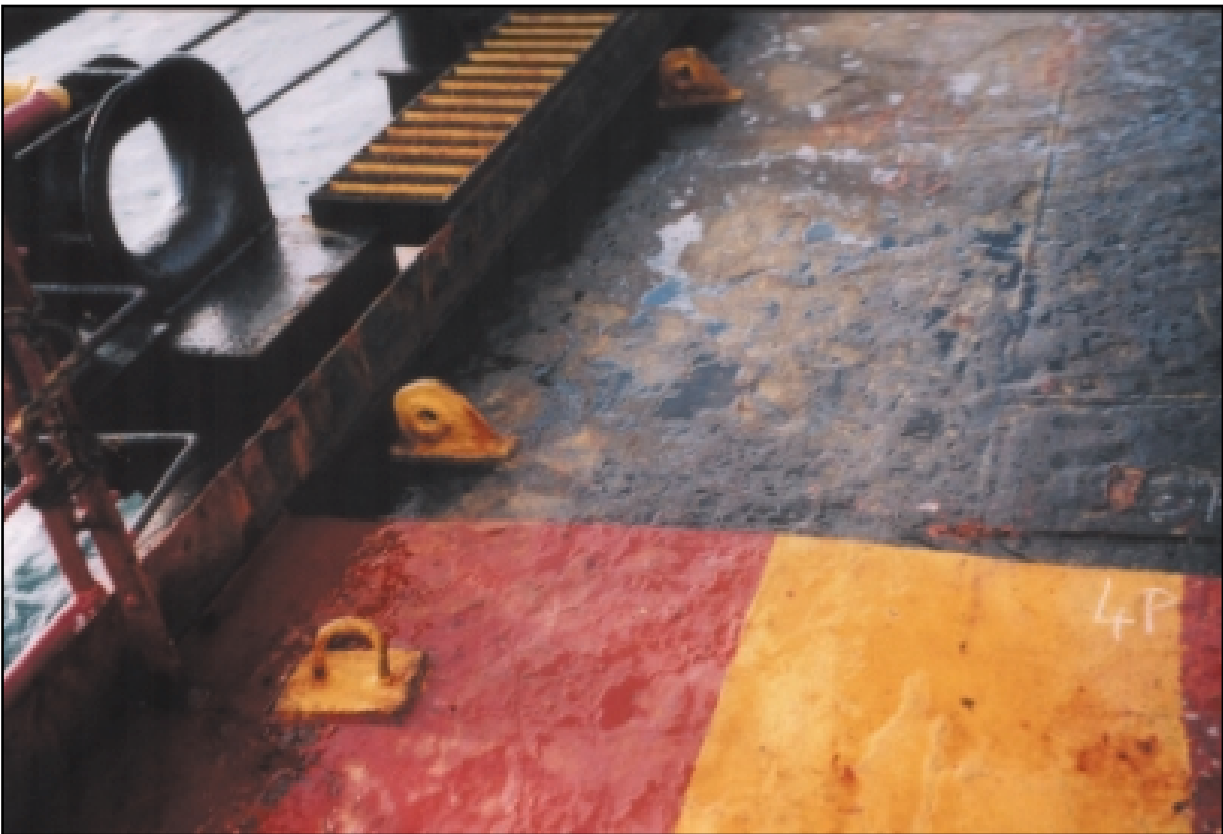
No repair work was carried out at frames 59 or frame 69 (location of deck fractures at detention Killybegs). In the thickness measurements, the deck longitudinals (No. 20 & 21 port) at frame 58/59 were noted to have a spot diminution of 19%. This was the site of one deck fracture. Certain areas of the vessel were highlighted as "points of attention for future survey". Included in these areas were the web frames in WBT No.2 and various maindeck plating. The protection coating condition of all these tanks at that time was described as "Fair". A separate note described the web faceplates in WBT 2 & 4 (P&S) as having 20-30% diminution with "corrosion in general".

Figure 7.1.3 Crack at frame 59 port showing (top) cargo manifold save all and (bottom) to ship side length of crack approx. 0.65 m

- (1) the drilling of ends of all deck cracks to prevent propagation.
A total of eight separate cracks were treated by this method;
- (2) Gouging out and welding up all cracks;
- (3) the welding on of doubler plates of sufficient size to bridge weakened areas of deck plating;
- (4) Damaged longitudinal frames were gouged and welded and fitted with doubler plates as found necessary;
- (5) Local corrosion and hole in deck plating midships was closed with doubler plating.

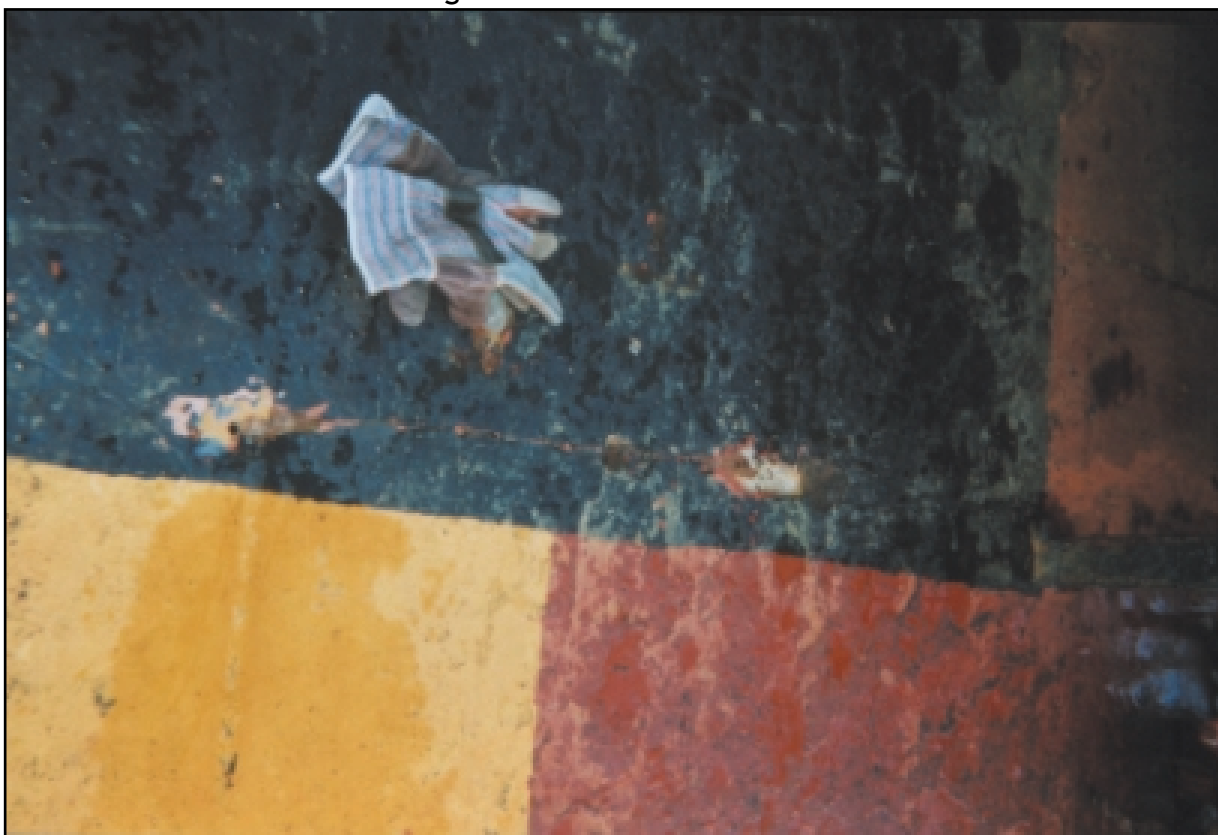
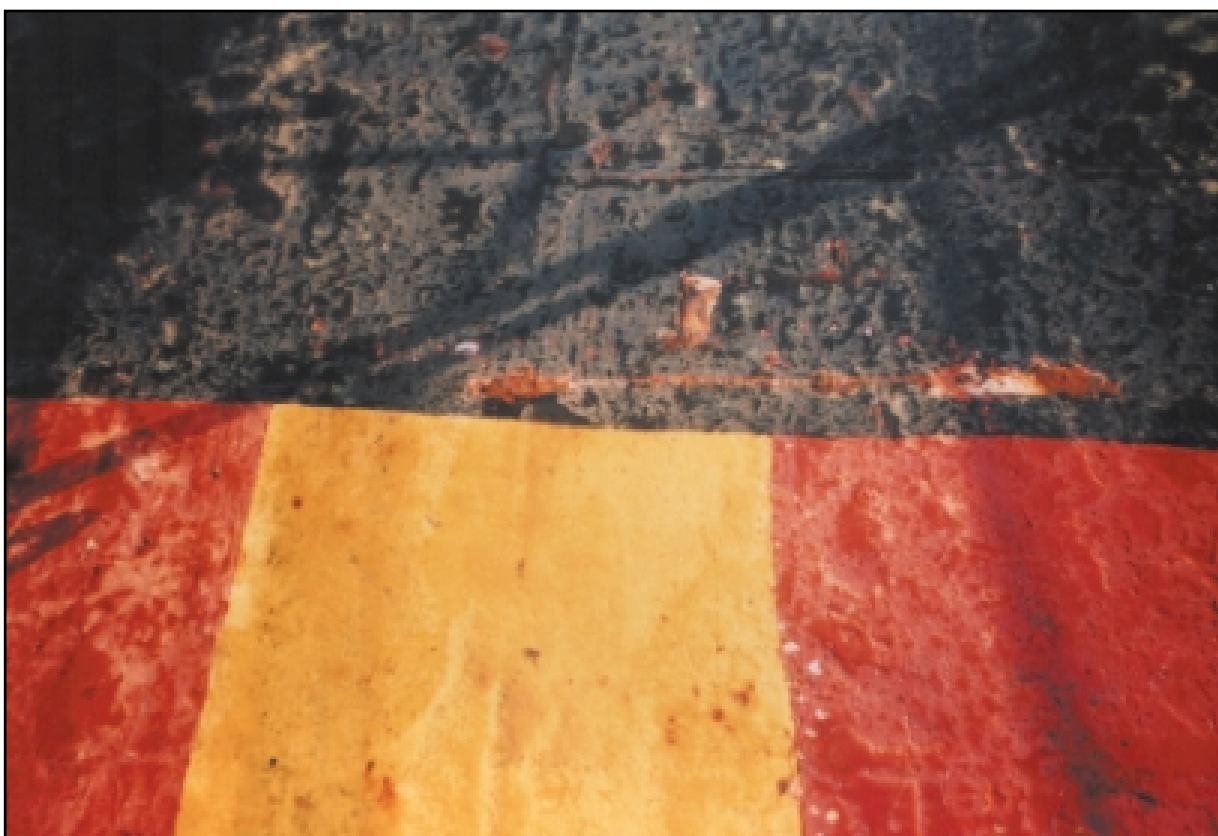
Figure 7.1.4 Deck at frame 59 port side showing same crack and general spot corrosion wastage of deck

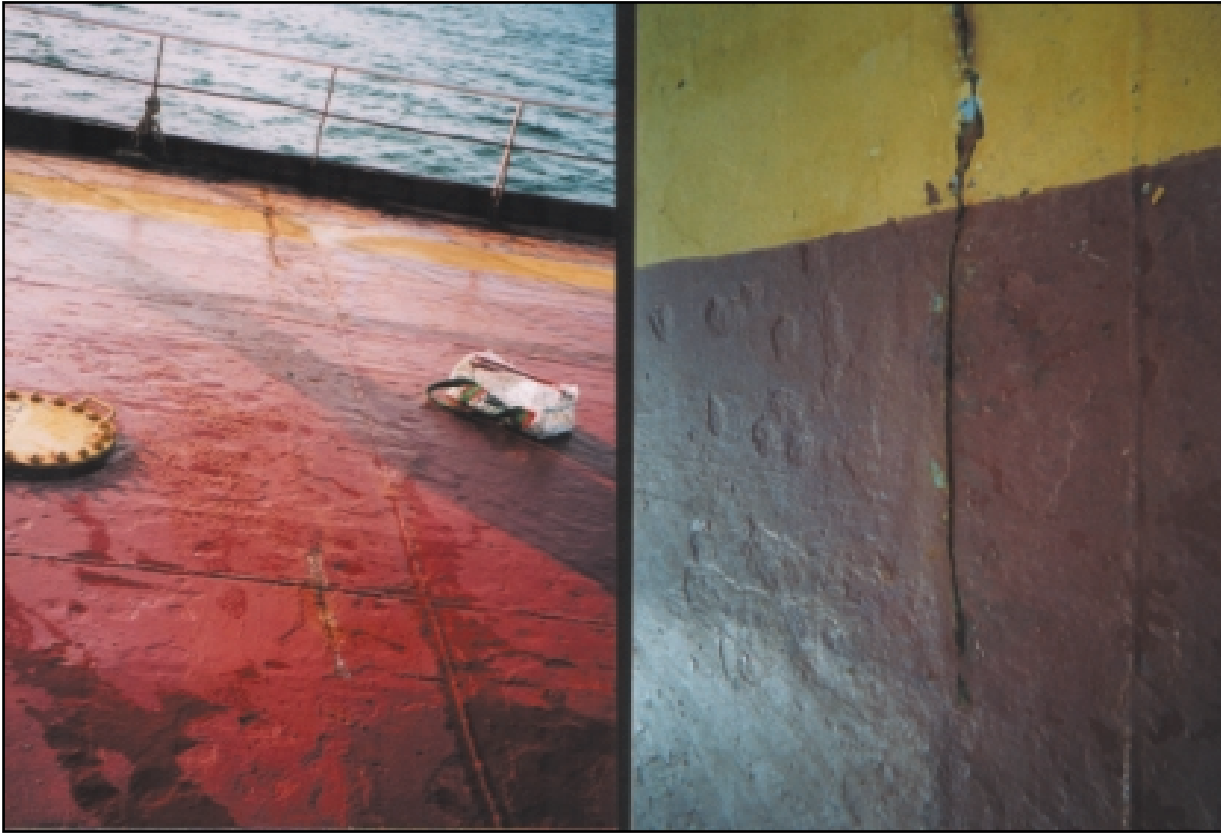
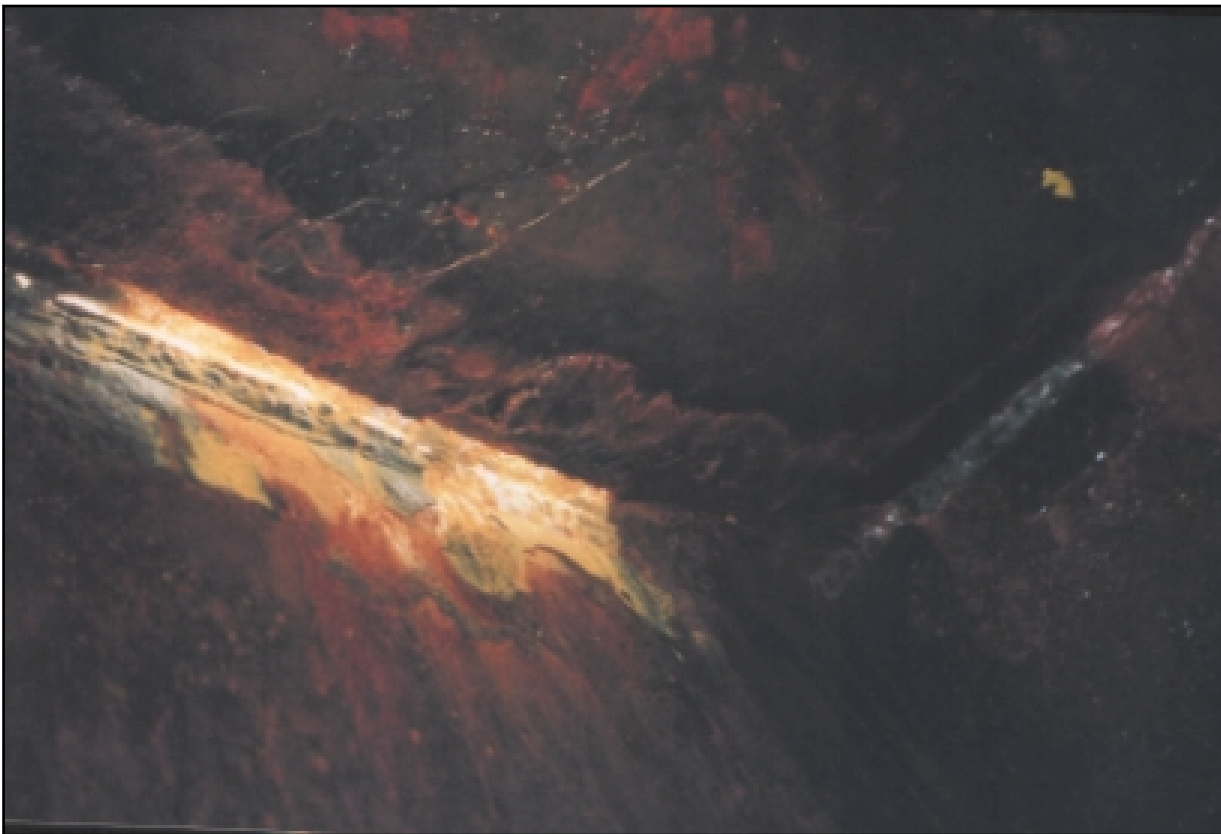
Figure 7.1.5 Double crack at frame 69 port side 1.6 m long at ship's side and 1.2 m long inboard in way of No. 2 WBT aft bulkhead with No. 3 COT

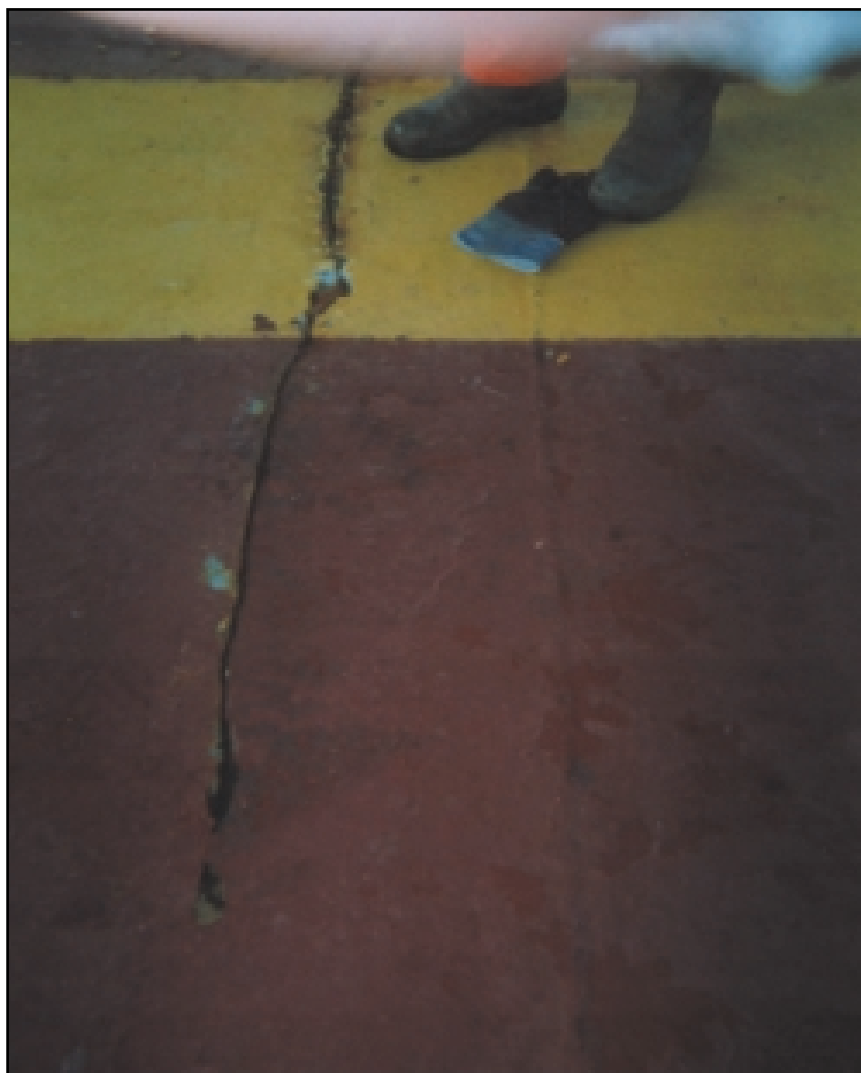
Figure 7.1.6 view of 1.6 m crack from within ballast tank

Figure 7.1.7 view of 1.6 m crack from above deck

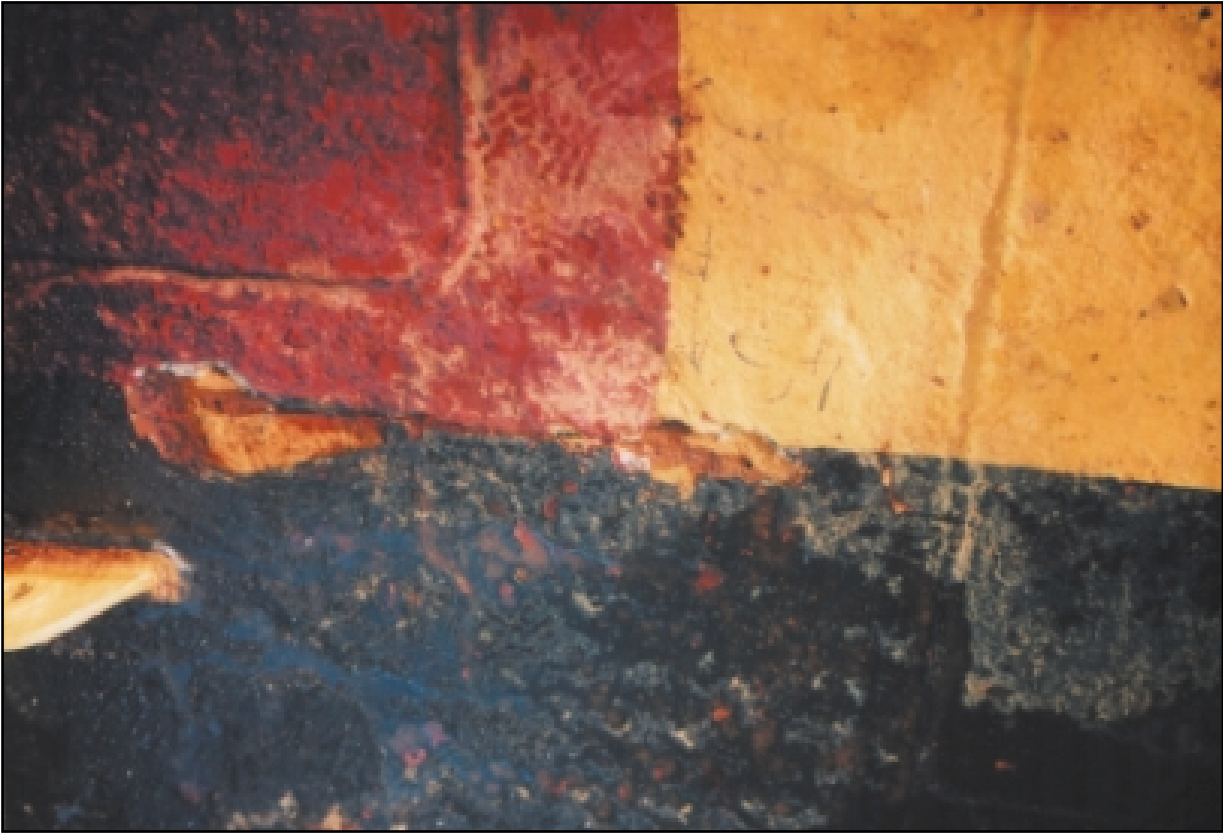
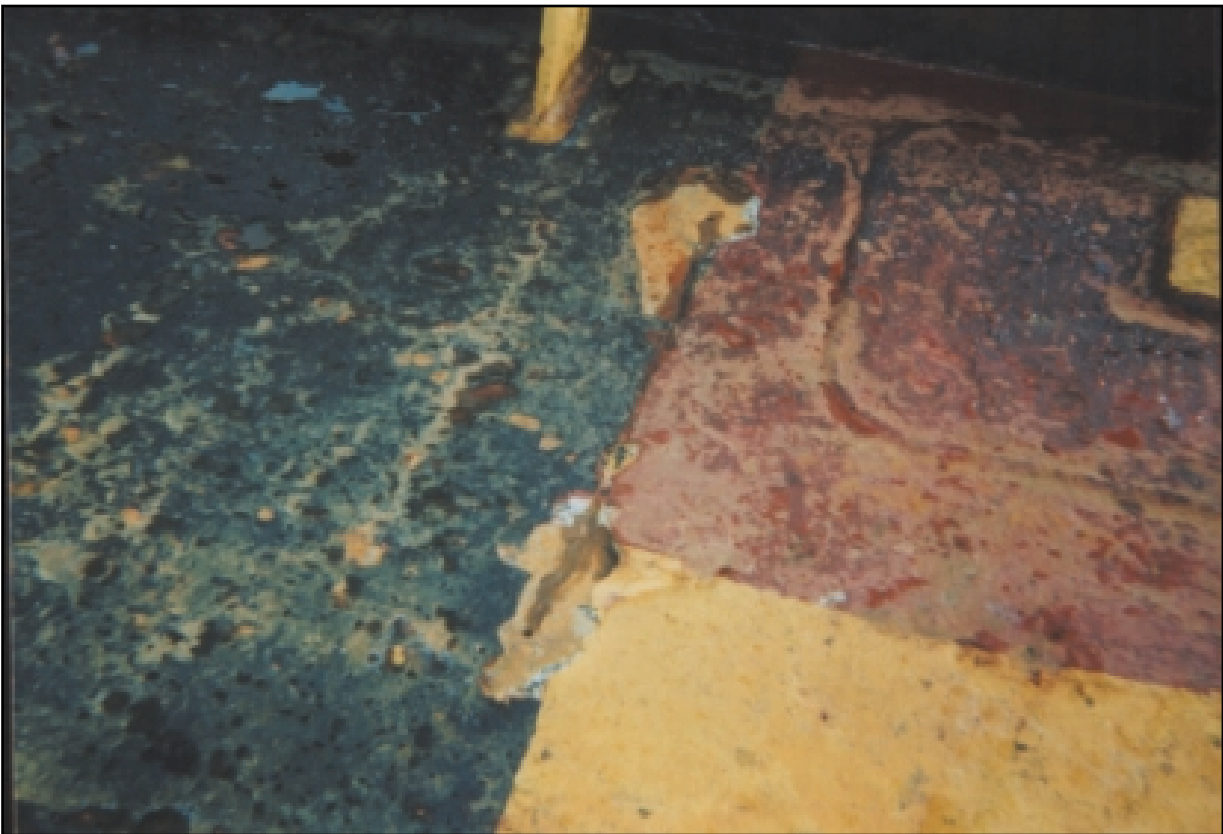
Figure 7.1.8 Crack at frame 59 starboard side length approx. 0.8 m

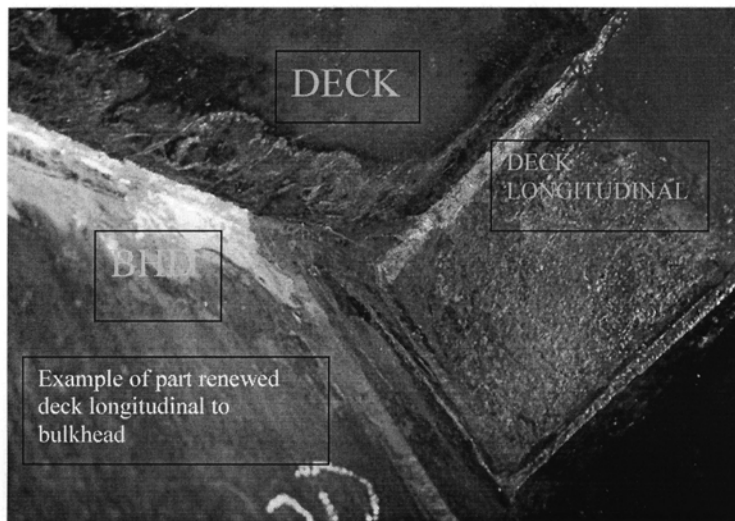
Fig. 8.6.1

- 2 longitudinals to which there was adequate access were found corroded and holed.
- The bulkhead collar areas at the longitudinal penetration were found generally heavily corroded.

- The Inboard Bulkhead longitudinals were found to be evenly corroded particularly on the web plating and adjacent to the transverse bulkhead to the cargo tanks.

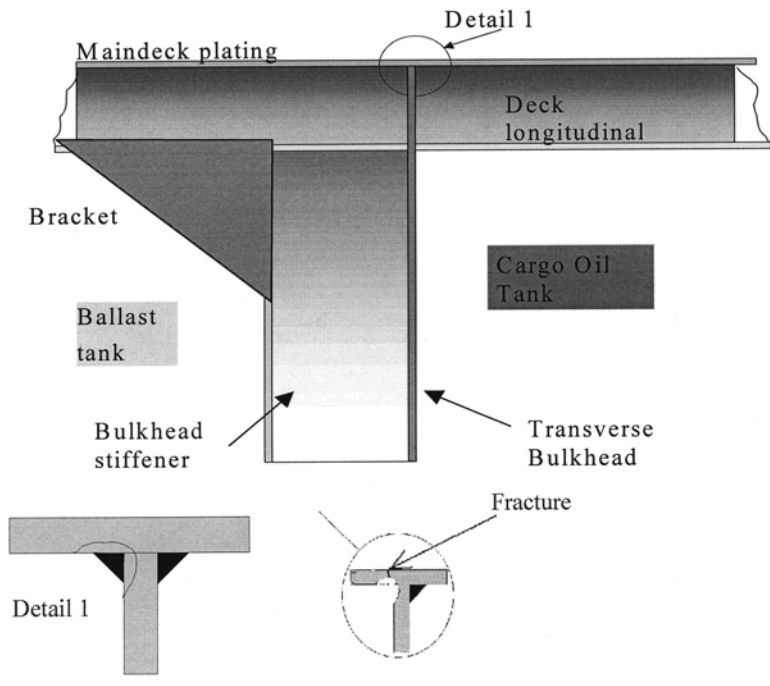
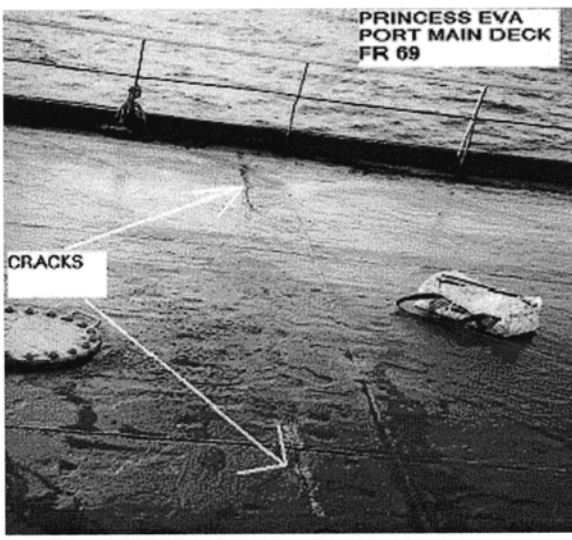
Fig. 8.6.2

It is not the intention of this report to research and make conclusions as to the mechanism of the grooving corrosion found and the probable causes are only suggested. This report does assume that the nature of this corrosion is progressive and is developed over a period of years. This report does enquire into the probable series of events by which this type of structural deficiency was allowed to progress to the extent that it led to failure (fracturing) of the deck plating with the possibility of serious global failure of the hull.
