**MCIB**  
Marine Casualty Investigation Board

**REPORT INTO THE  
GROUNDING OF THE  
"PRINCESS VANYA" IN  
THE SHANNON ESTUARY  
ON 1 DECEMBER, 2001.**

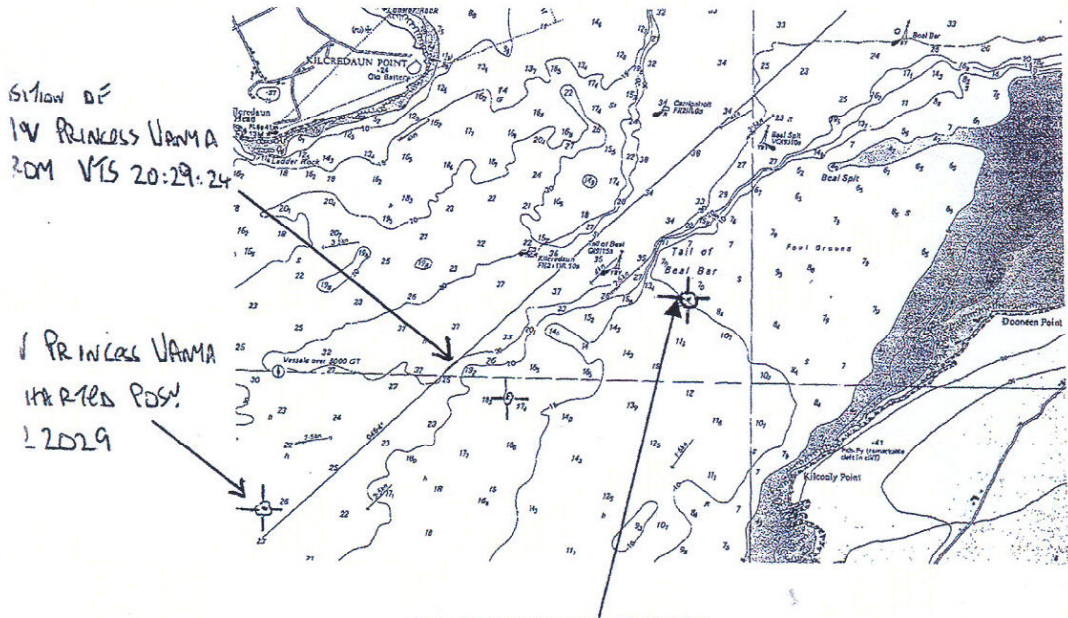
8.1 Chart extract (BA 1547) showing location of grounding.

Section of BA Chart 1547 indicating the position of the vessel at the time of going aground.

MV Princess Vanya  
aground in position  
52°34.28'N  
009°40.34'W

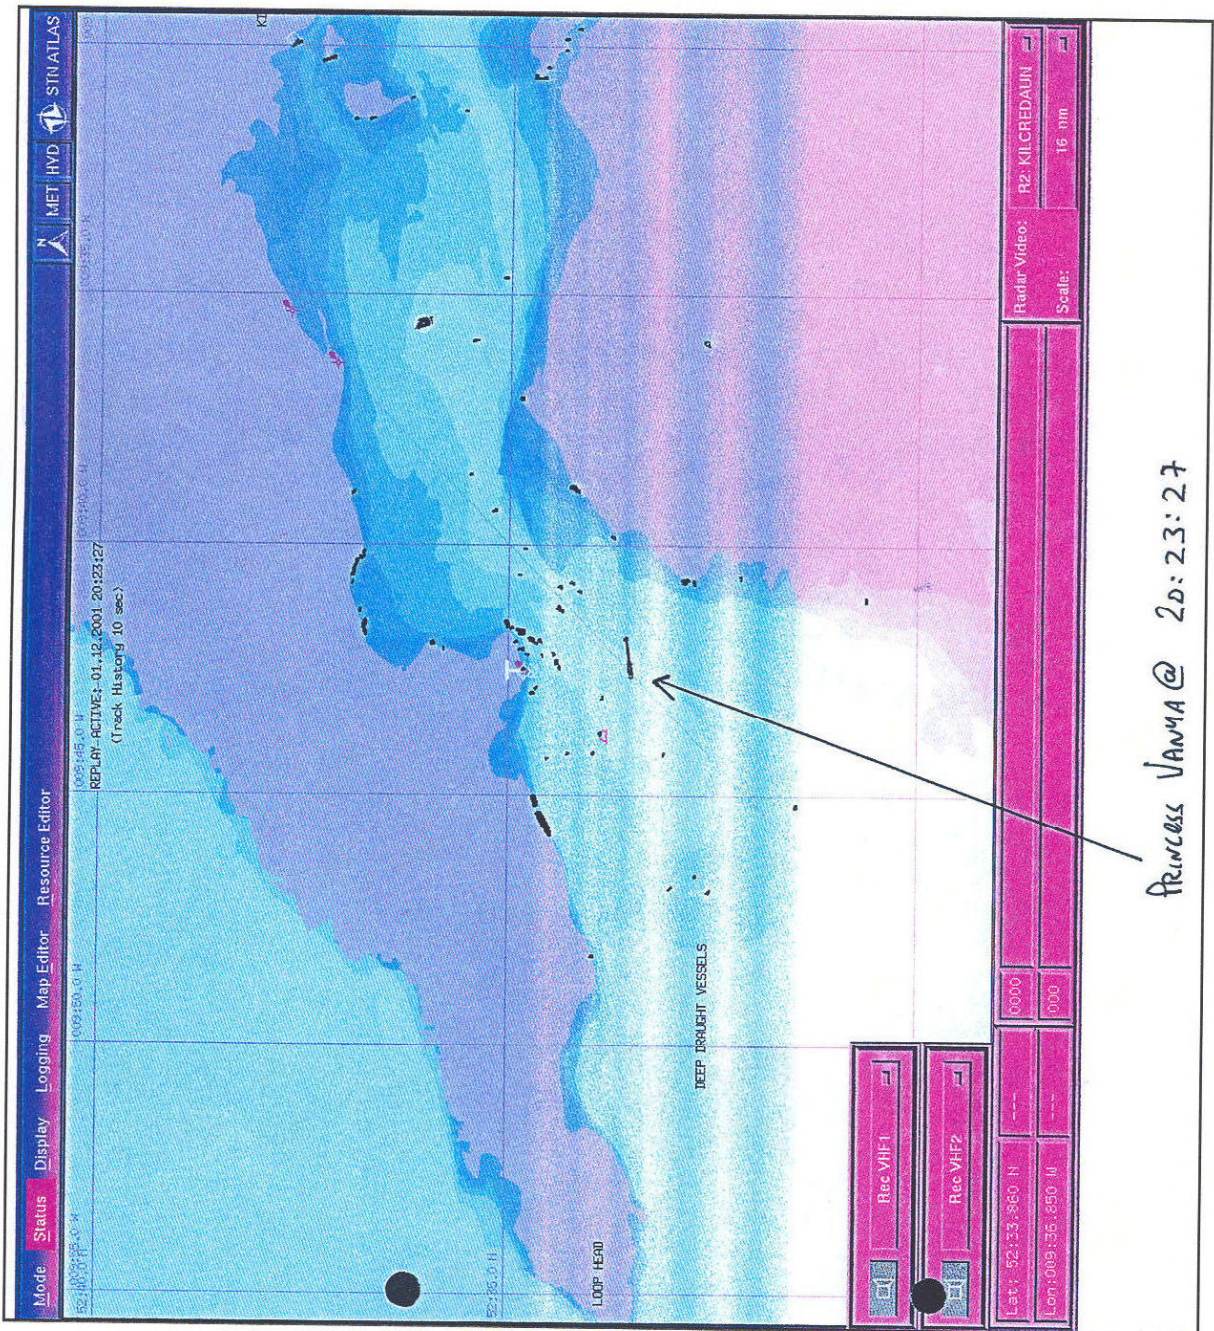
- 3.18 The VTMISS recording of the track of the Princess Vanya conflicts with the statement of the Master. It appears that the vessel passed due south of Kilcredaun Point at approximately 2023. At this time the vessel should have altered course to follow the leading lights. It would appear that the Master waited until the vessel was abeam of Kilcredaun before altering course. When the vessel did alter course at approximately 2029 the vessel was already too far to the south and east of the course line.

VTS extracts showing location of Princess Vanya at 20.23.27hrs

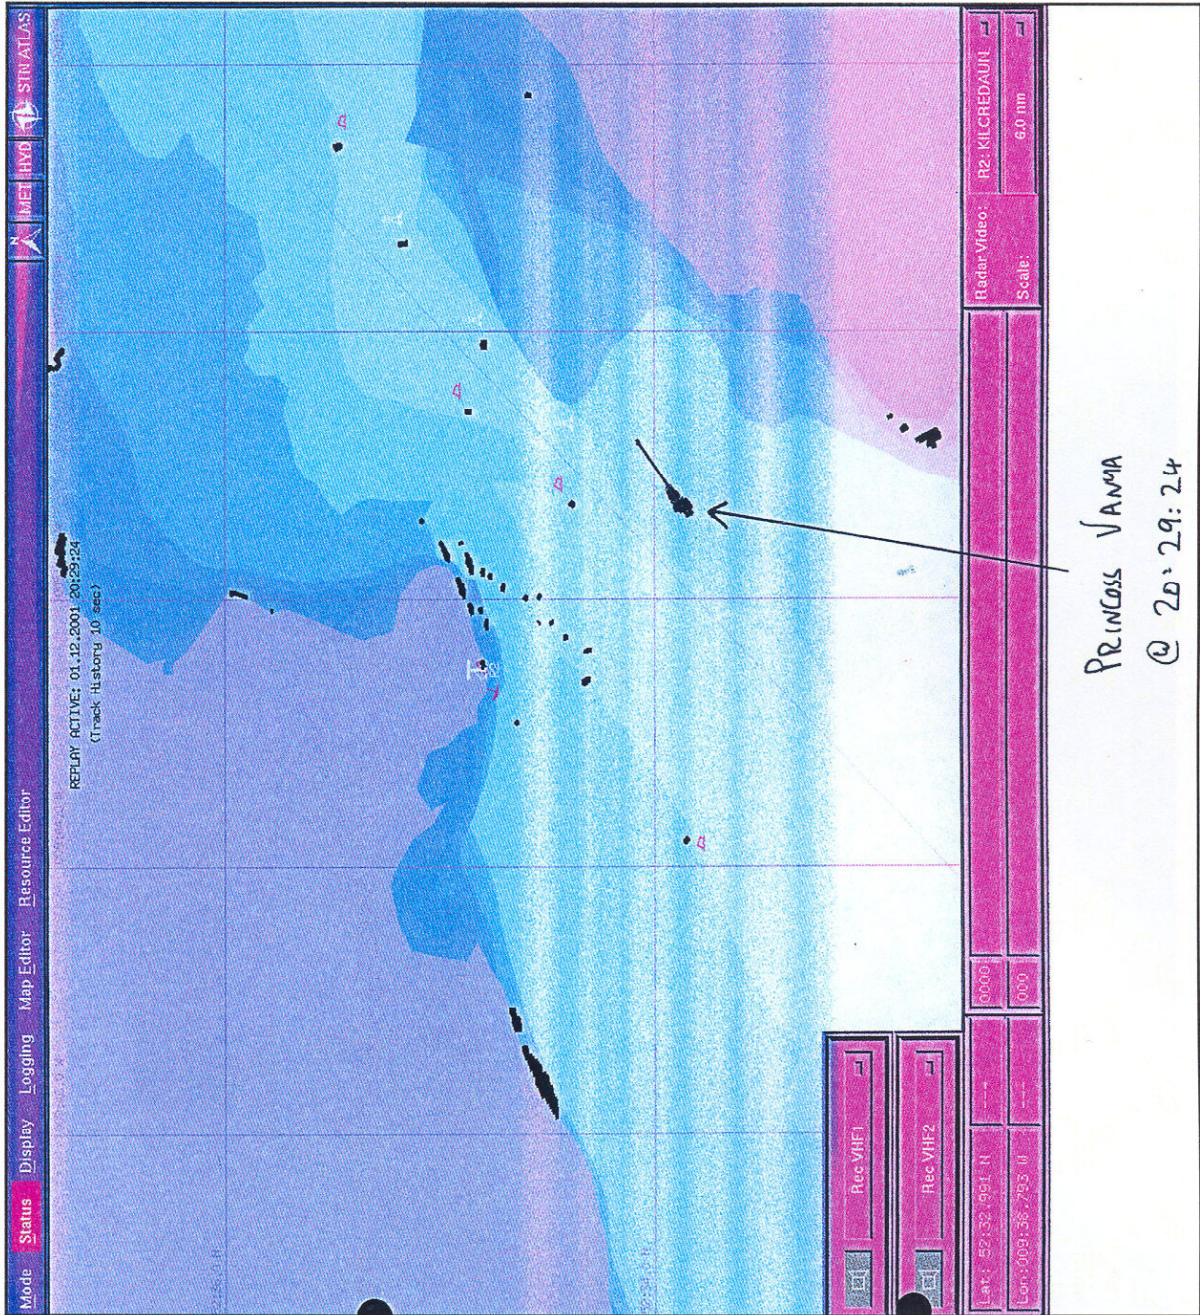
PRINCESS VANYA  
@ 20:29:24

- 6.3 At 2029 the third officer stated that he took a radar range and bearing of Kilcredaun. The charted position for the Princess Vanya at 2029 is the last charted position prior the vessel going aground. This position is approximately 0.6' West Southwest of the position of the Princess Vanya as indicated by the VTMS. The vessel went aground at approximately 2035. The distance between the position that the vessel went aground and the 2029 position is approximately 1.5 miles. To cover this distance the vessel would have been making good a speed over the ground of 15 Knots. The Master indicated that his vessel was abeam of Kilcredaun at 2029 on a course of 075° (T). However, the charted position is due south of Kilcredaun and not abeam as stated. This may have caused confusion amongst the bridge team.

VTS extracts showing location of Princess Vanya at 20.29.24hrs

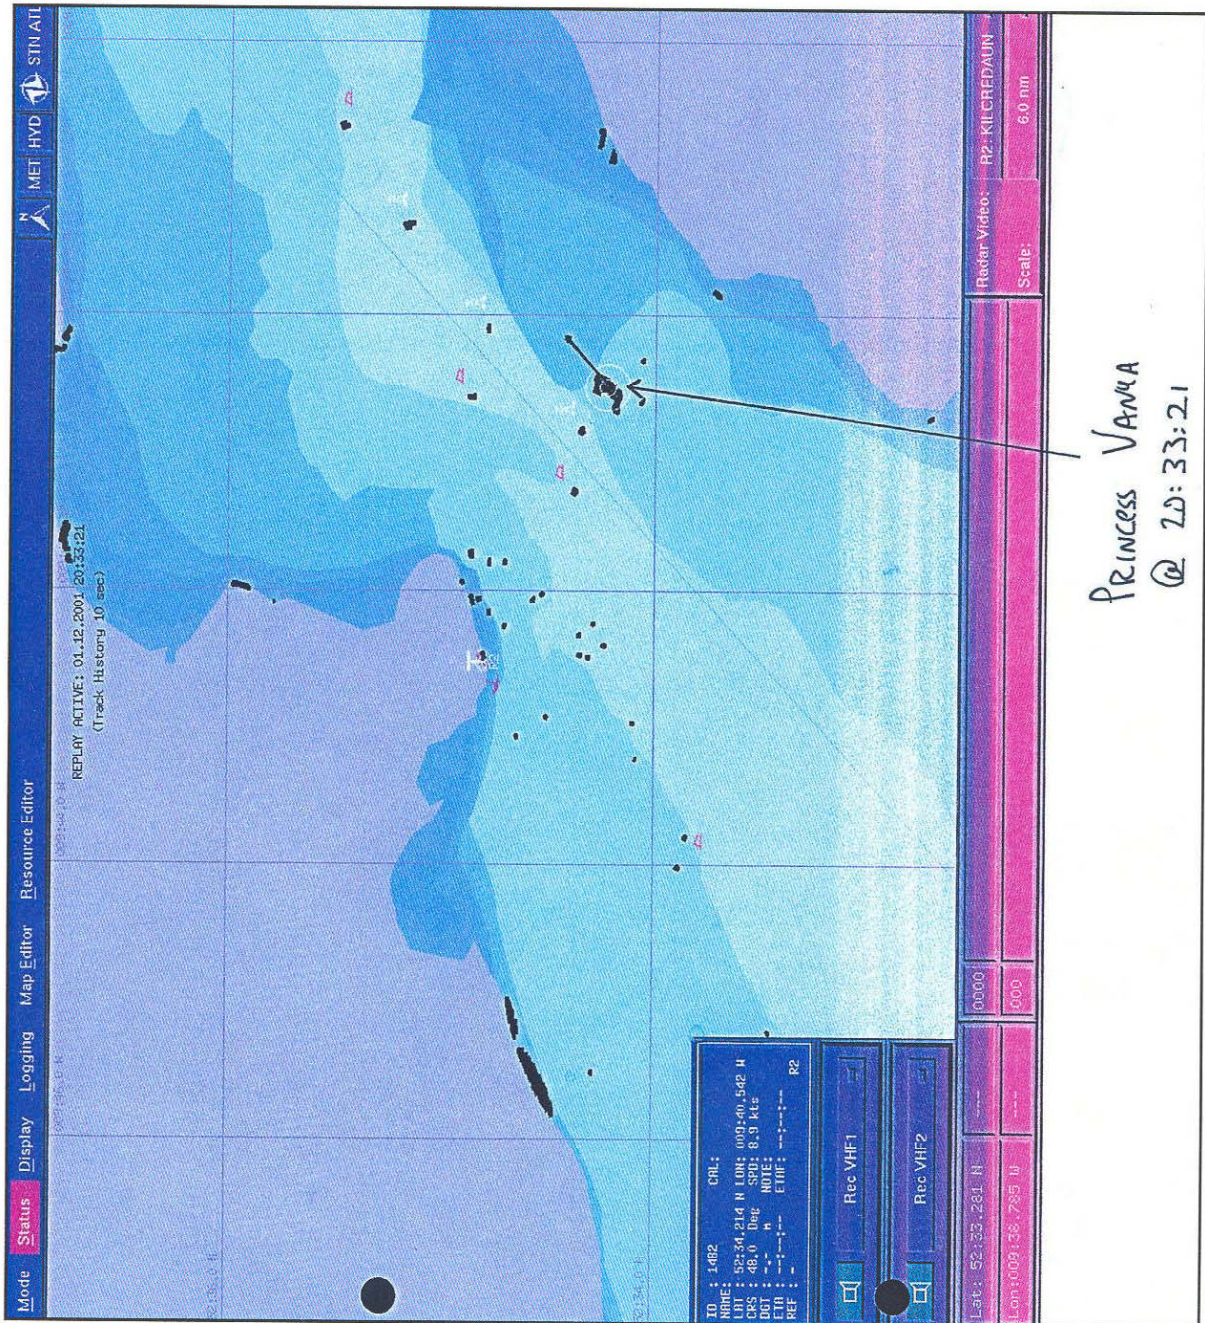
PRINCESS VANYA  
@ 20:33:21

- 4.1 At 2033 the Master stated that he suddenly noted that the vessel was not on the leading lines and noted that the Tail of Beal Bar buoy about one point on the port bow. He noted that port hand buoy was now three points on his port bow and that his vessel was in a critical situation. The Master said that he ordered the helmsman to go hard to port but at 2035 the vessel touched the bottom and the Master ordered the engines to be stopped.
- 4.2 The vessel went aground doing full manoeuvring speed in approximate position  $52^{\circ} 34.28'N$   $009^{\circ} 40.34'W$ .

VTS extracts showing location of Princess Vanya at 20.33.21hrs
