**REPORT INTO THE
COLLISION BETWEEN
THE IRISH FISHING VESSEL
"RENEGADE" AND AN
UNIDENTIFIED VESSEL
IN THE IRISH SEA
ON 25TH JULY, 1999.**

The Marine Casualty Investigation Board was established on the 25th, March 2003 under The Merchant Shipping (Investigation of Marine Casualties) Act 2000

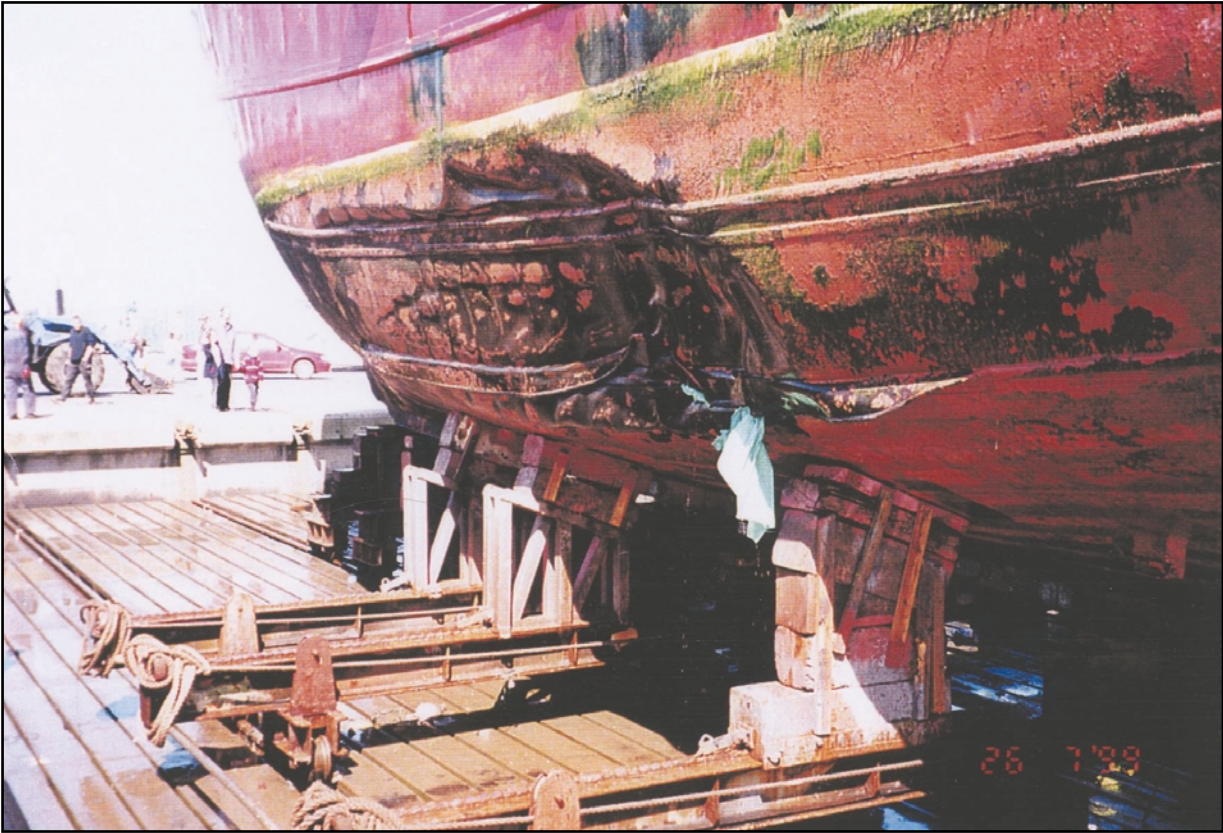
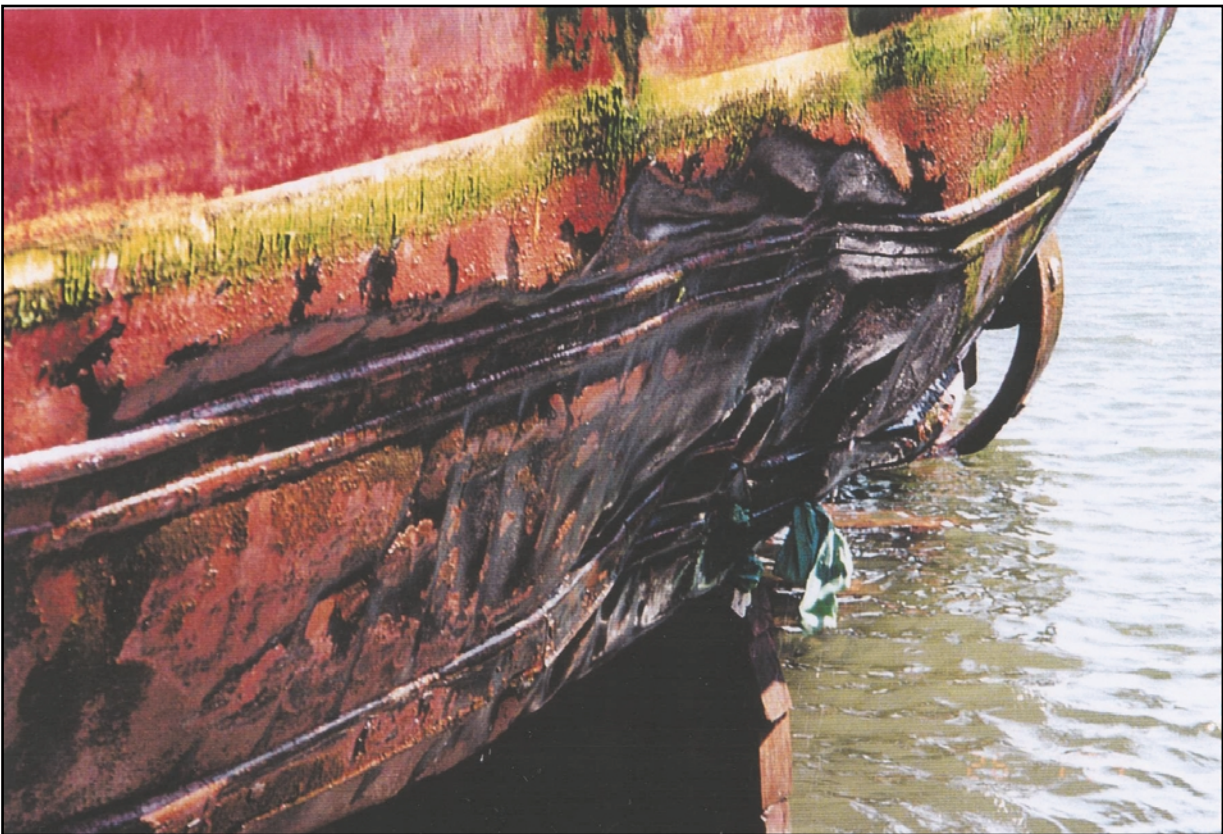
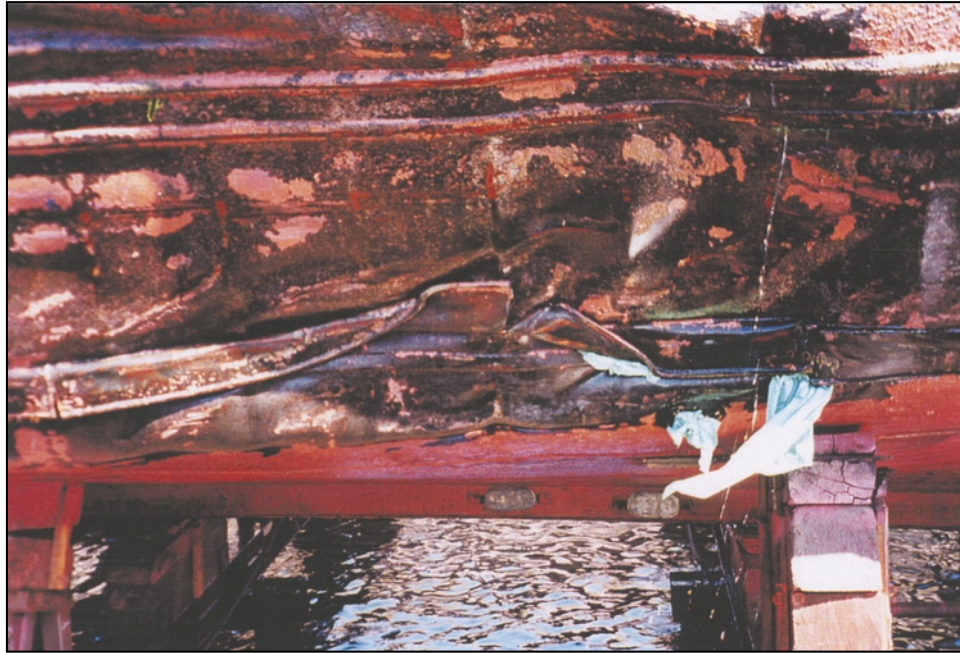
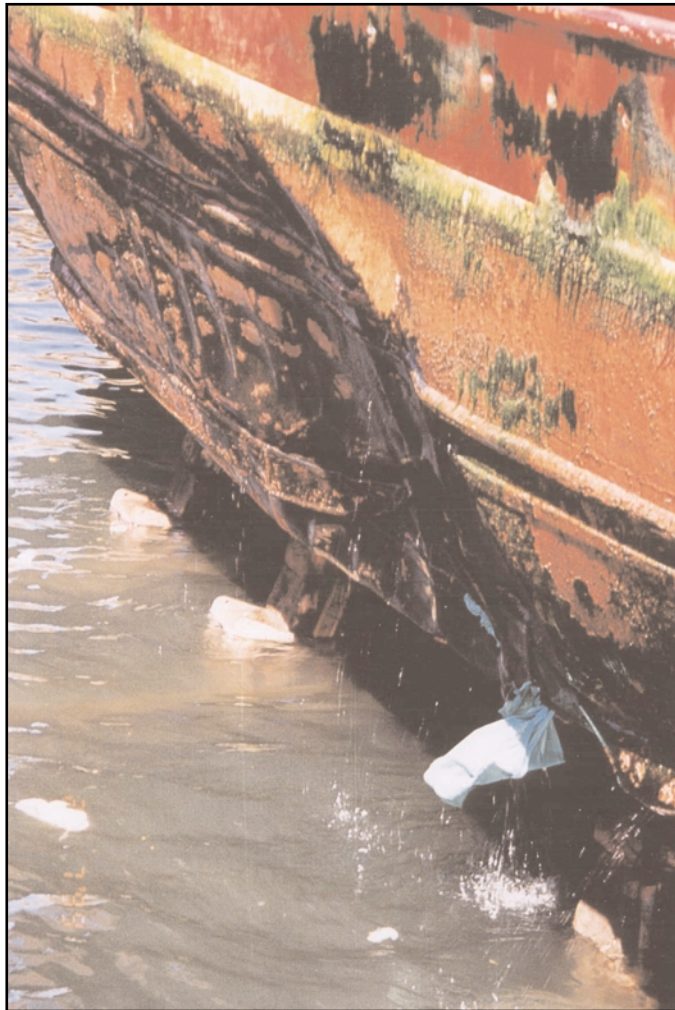
8.3 Photographs showing damage to the "Renegade"

- 5.14 This fishing vessel was struck on the port side at watertight bulkhead between the engine room and the fish hold approximately one metre below the water line.

- 5.15 The ship's side plating was set in over an area of approximately 12 square metres, from the water line to below the bilge keel. The maximum plate set in was about 0.25 meters. (See photographs in Appendix 10.3)
- 5.16 The side plating was holed in the engine room in way at the bilge keel. These holes were plugged by divers when the vessel reached Howth.
- 5.17 The bulkhead between the engine room and the fish hold was buckled.
- 5.18 The bilge pump, which is located in the forward port side of the engine room, was displaced and associated pipework was damaged.
- 5.19 Some engine holding down bolts were found to be loose.
- 5.20 There was no damage sustained above the waterline. It would appear that the damage to the "Renegade" was caused by the bulbous bow of the other vessel, which did not stop after the collision.
