**REPORT OF INVESTIGATION  
INTO FATAL INCIDENT ON THE  
CLODAGH RIVER,  
CO. WATERFORD  
ON  
7th APRIL 2010**

**REPORT No. MCIB/180  
(No. 4 of 2011)**

Report MCIB/180 published by The Marine Casualty Investigation Board  
Published 26th April 2011.

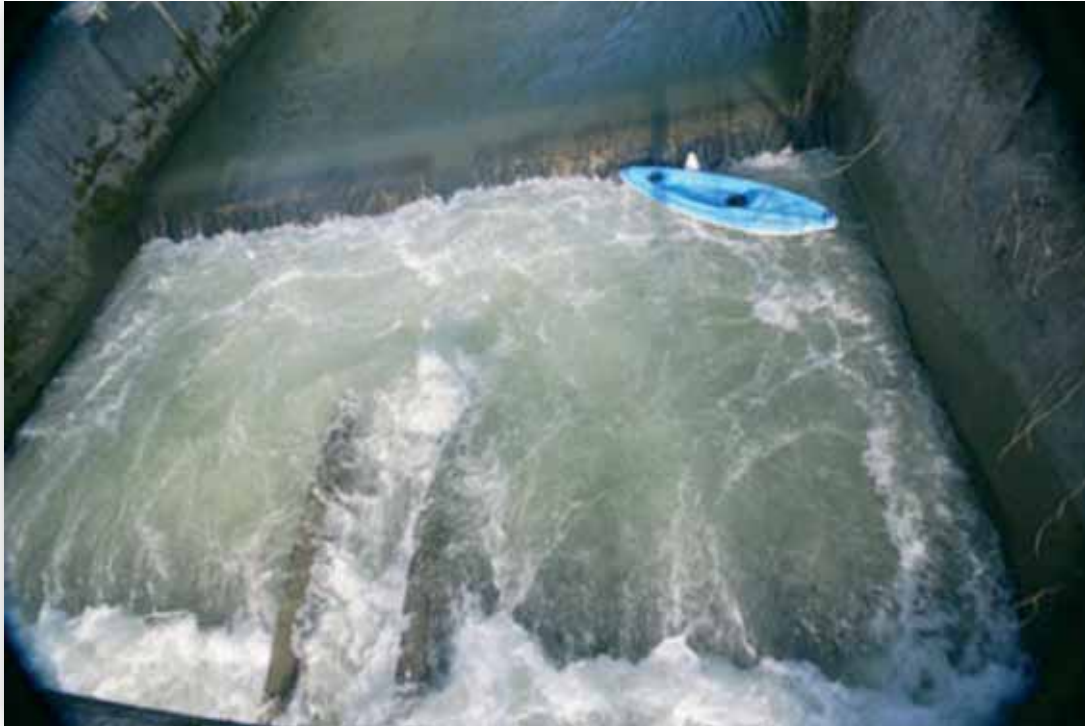
Note that the Bic Sports Kayak sit-on type Kayak is lodged firmly in the weir back flow after twelve hours.

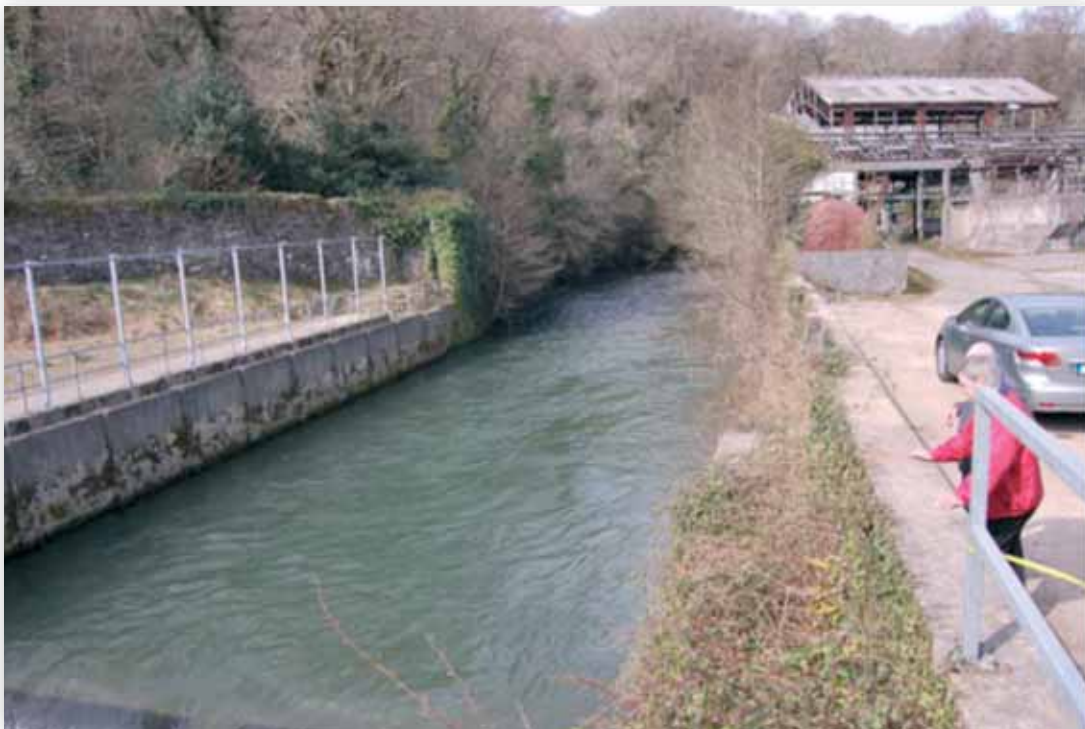
Above is the entrance to the weir. After the two men re-entered the water there was no easy way back.

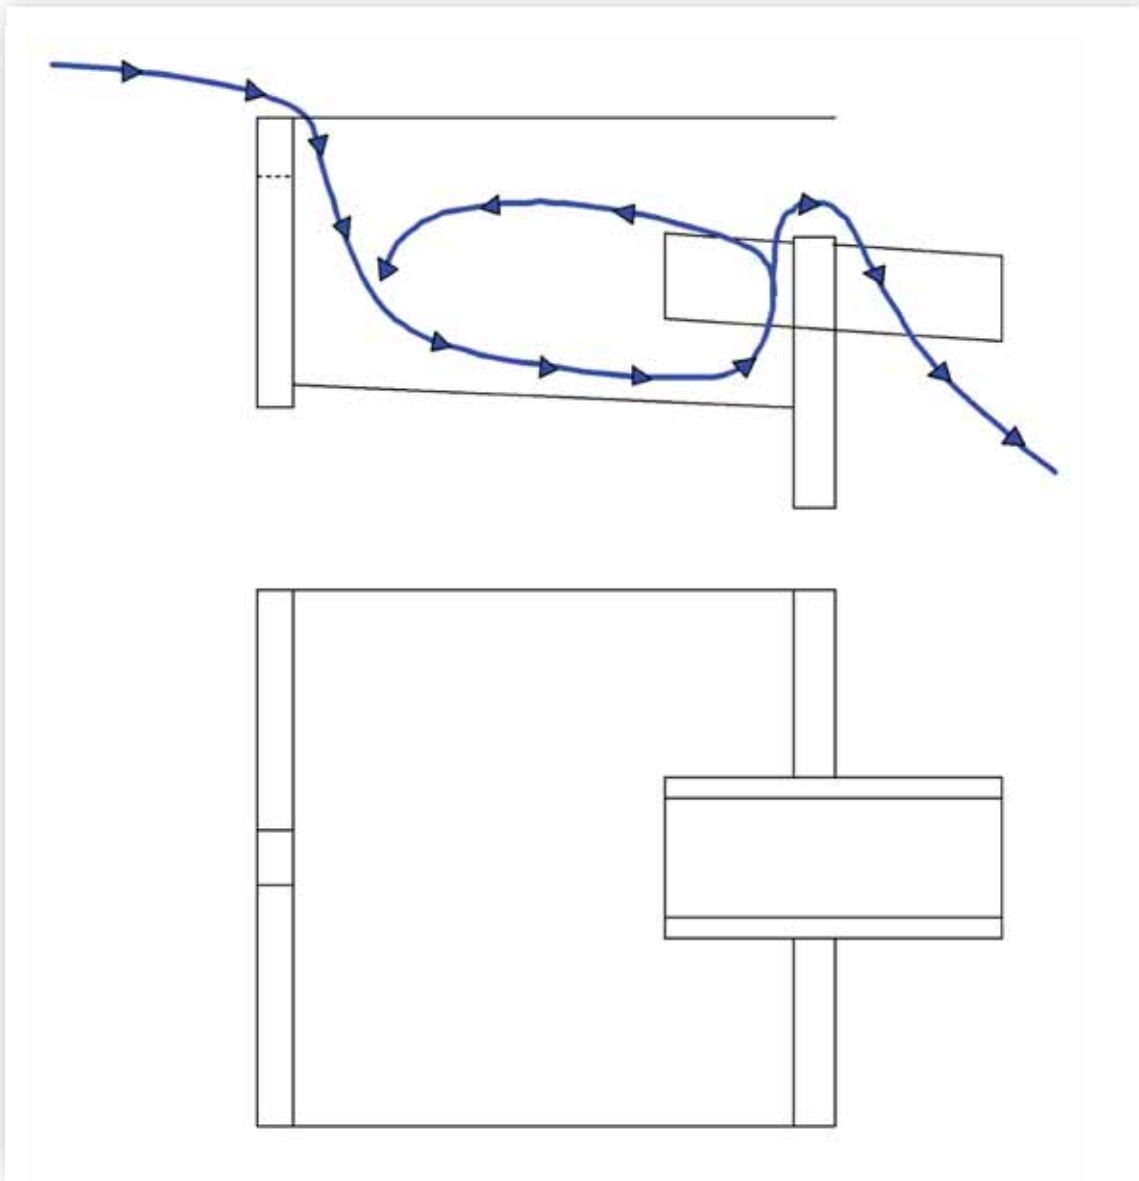
Appendix 8.3 Diagram of Weir.

- 6.2 The back flow at Portlaw Weir was longer than half a kayak length. As a general rule a kayaker can only pass obstacles that cause water back flow of less than half of their kayak length. Back flow is shown in a diagram in Appendix 8.3 as is the general flow of water through the weir. The design of this weir made it impassable regardless of the water flow over it.

- 6.7 There was no safety equipment/life saving appliances available at the weir.
- 6.8 The weir at Portlaw is, by design, next to impossible to escape from without the use of lifebuoys and or an access ladder.

The top part of this diagram shows the flow of water through the weir. Note that the flow splits in two at the top of the lower weir wall on the right side on the diagram. The flow that runs from right to left is the back flow. From the top photograph in 8.2 one gets some idea of the scale of the weir and the length of the back flow. This weir cannot be run.

- 7.4 The Local Authority should supply and install appropriate lifesaving equipment, including permanent exit ladders from the weir.
- 7.5 The Local Authority should prevent the use of the weir in its current design form.

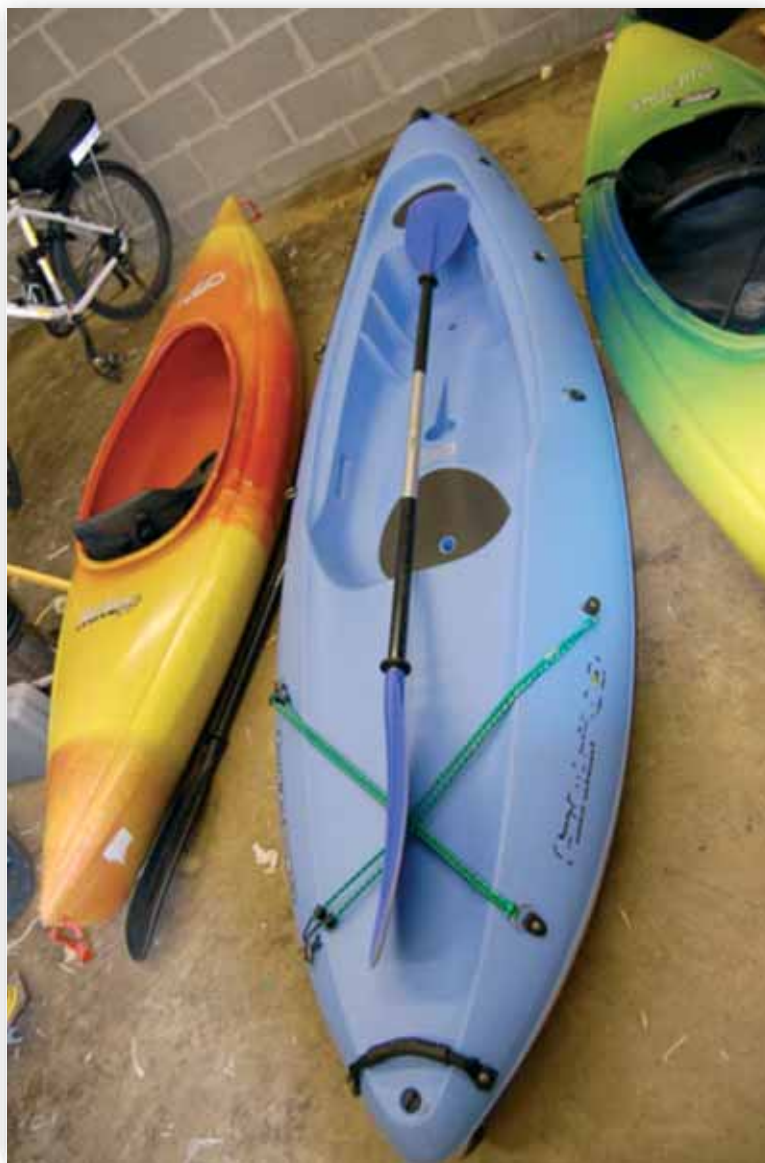
Appendix 8.4 Kayaks at time of inspection in Tramore Garda station.

- 6.4 No risk assessment of the proposed route had been undertaken.
- 6.5 None of the men had Swift Water Rescue Training.
- 6.6 The equipment that could be examined was found to be in good condition. However, it was not best suited for swift water/white water kayaking.

2 x Plastic Old town XT on left and right.  
Bic Sports Kayak blue in the centre.  
All are in near perfect condition.
