**REPORT OF THE  
INVESTIGATION INTO THE  
DEATH OF KAYAKER ON THE  
RIVER GADDAGH, CO. KERRY  
ON 28th DECEMBER 2007**

**REPORT No. MCIB/155**

Report MCIB/155 published by The Marine Casualty Investigation Board  
Published on 7th April 2009

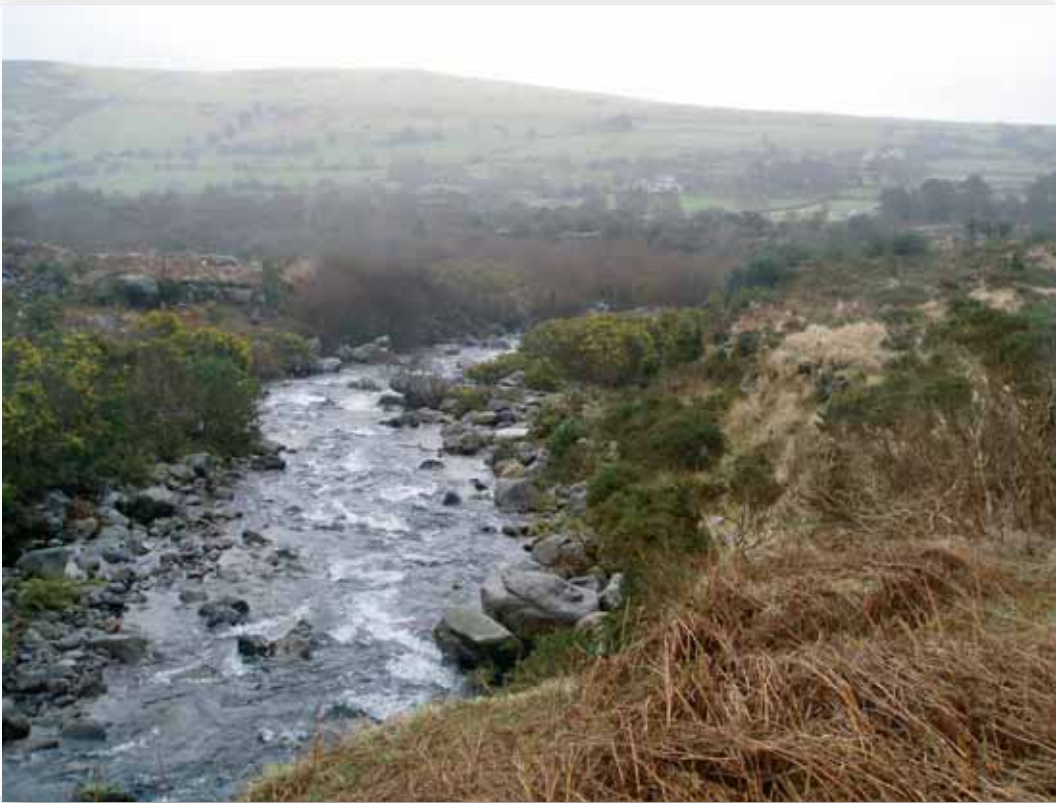
Fig. 1 - River at "get on point".

- 3.16 Shortly after midday, the first group entered the river, at the middle section, graded as level 4. (Appendix 8.2, Fig. 1) and proceeded downstream. The transit through this stage brought them through open gorse terrain before the river entered a heavily wooded section. (Appendix 8.2, Fig. 2). The second group entered the river five minutes later.

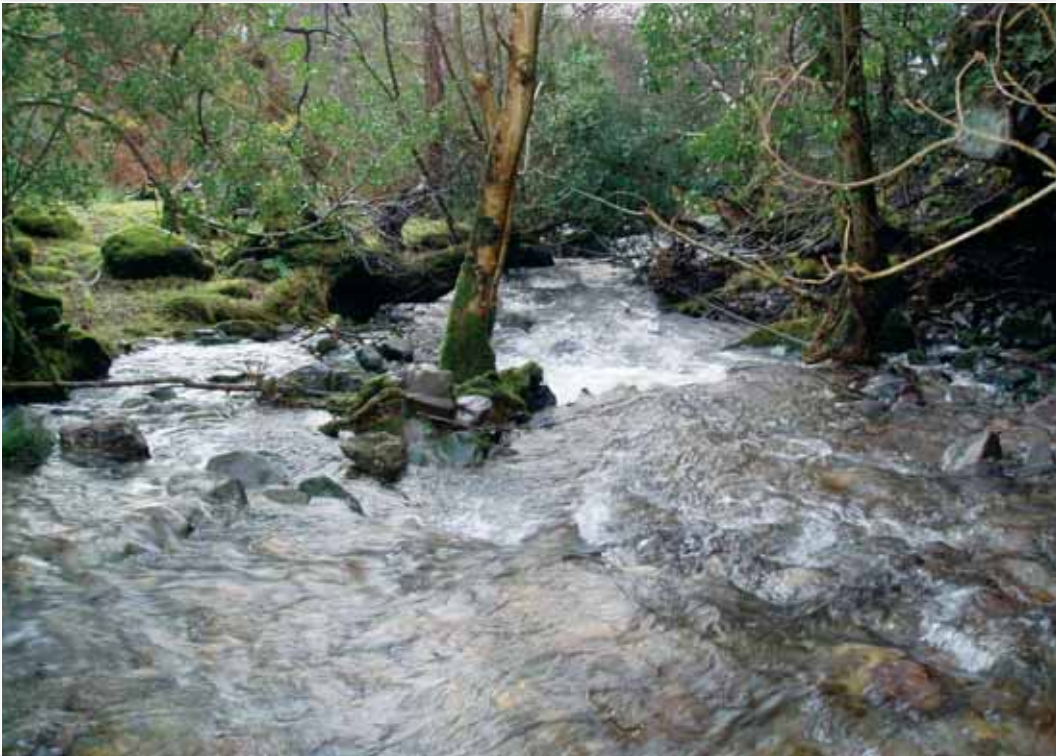
Fig. 2 - River conditions on first stage of transit.

- 3.17 During this stage, each group experienced difficulties and had various members capsize or encounter obstructions, in addition, it was noted that their canoes were encountering rocks and boulders carried along in the stream. Despite these difficulties, group members retained control of their situation and all remained in their boats.

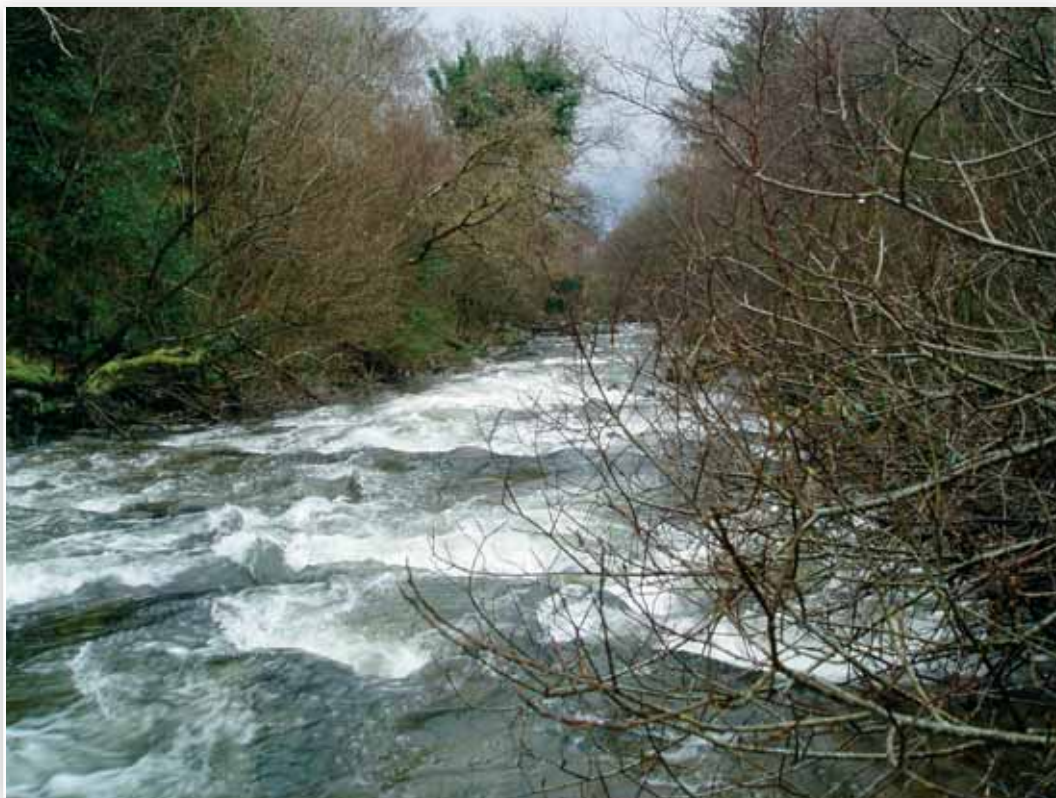
Fig. 3 - River on second stage of transit.

- 4.2 By this point, the river intensity had diminished to some extent, and the gradient had reduced.  
Beyond the eddy the group was resting in the river banks which were heavily lined with trees, however the river itself appeared to be clear of obstacles, other than one tree noted as blocking the right hand bank.  
A short distance beyond their stop point, the river assumed a right hand bend, beyond which it was not possible for the group to view its aspect.  
Having discussed their options, the group decided to proceed to complete the second stage of their intended course. (Appendix 8.2, Fig. 3).

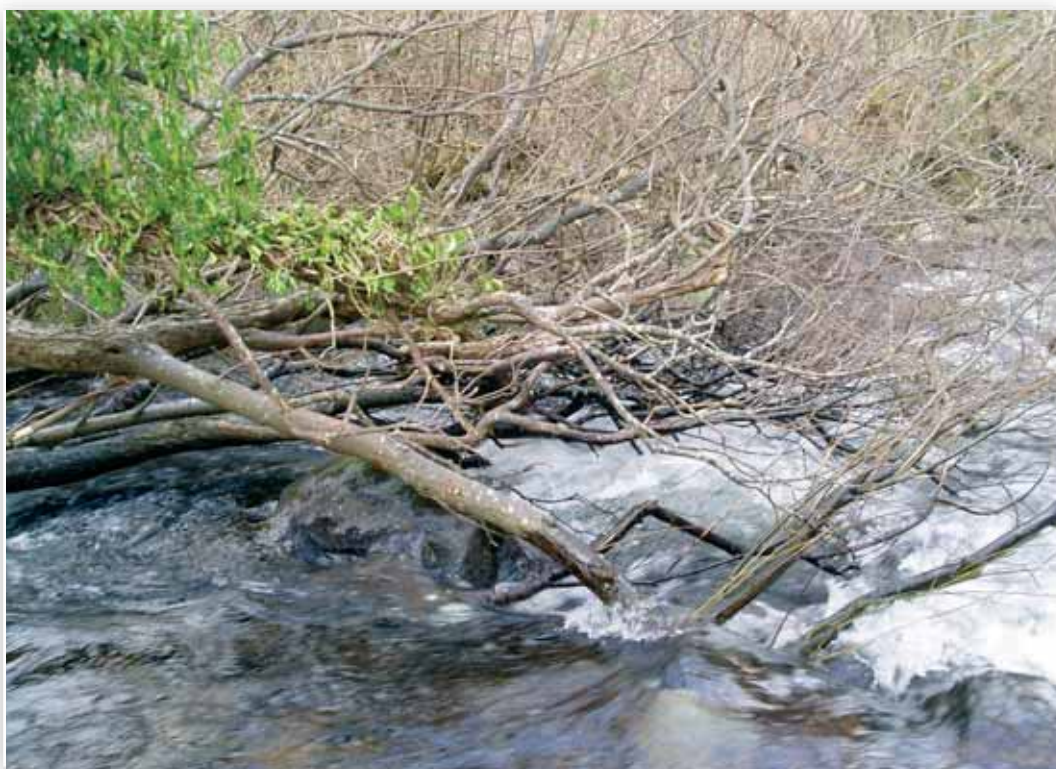
Fig. 4 - Fallen Trees obstructing river.

- 4.3 The group re-entered the river's main flow and headed downstream.
- 4.4 On rounding the bend, the conditions changed dramatically, the river now ran in a generally straight profile, but was obstructed over a 100 m section on both sides by approximately a dozen fallen trees. (Appendix 8.2, Figs. 4 & 5).  
Given the relatively short distance between riverbanks, the sequence of fallen trees formed a complete obstruction across the river in a number of places.

- 4.5 These obstructions coupled with the intensity of the river, produced immediate difficulties for the first group, causing it to split up as individual members were carried onto the fallen trees.

- 6.1 River conditions on that day were challenging and would have been physically demanding, however, the presence of the fallen trees on that river section, altered the balance of conditions from difficult to dangerous. Had that sequence of fallen obstructions not occurred, it is most likely the group would have exited safely at their intended get off point.

- 7.1 The Irish Canoe Union, should review this incident and produce guidelines for members intending to Kayak on extended sections of infrequently used rivers such as the Gaddagh.
- 7.2 Such Guidelines should cover the need for and means of, adequate preplanning and on site scouting on such rivers.
- 7.3 Kayaking groups are encouraged to develop local contacts in order to obtain details of current river conditions and dangers, particularly on infrequently used rivers. Such details may be incorporated and updated on the existing web based River Alert schemes.
- 7.4 The carriage of mobile phones in suitable watertight covers, by kayakers, for use to summon assistance in emergency situations should be considered.

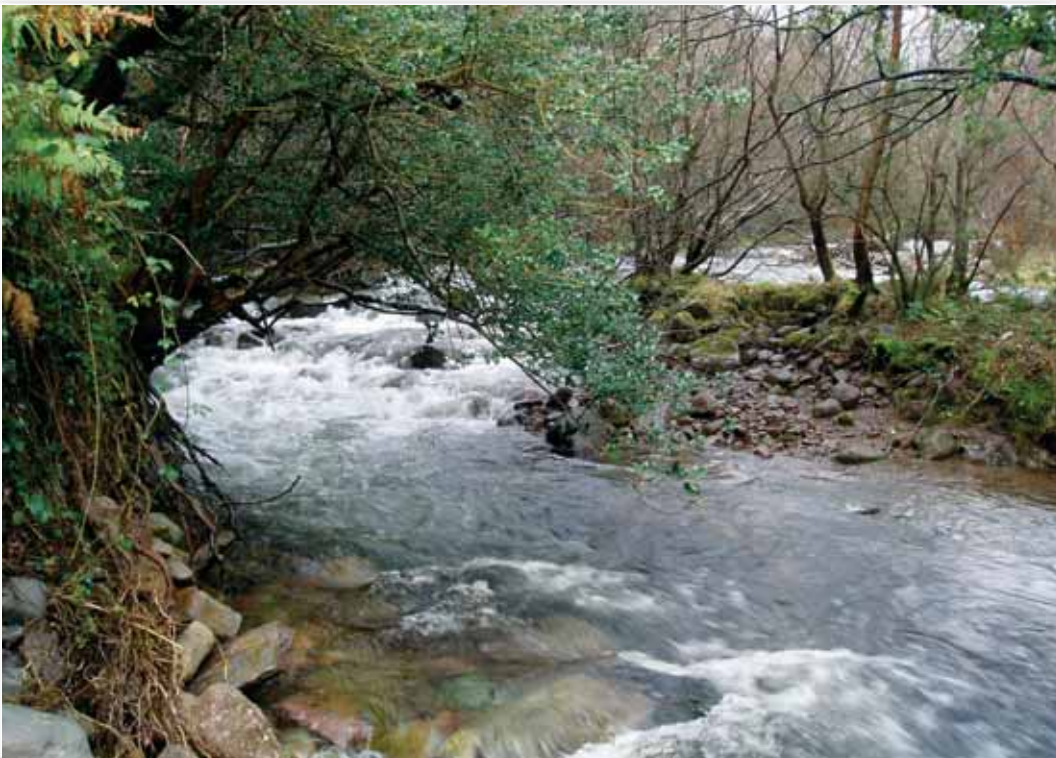
Fig. 6 - View up stream of Incident Site.

- 4.9 While the main flow of the river made a left hand turn, a tributary stream directed by one of the gravel islets, separated along the right river bank carried on in a straight line, through a heavily wooded section. This stream rejoined the main river some 150 m downstream. This tributary while narrow, produced a deep and fast flowing stream of water, consequently any floating item on the river right bank was directed into it. (Appendix 8.2, Fig. 6).

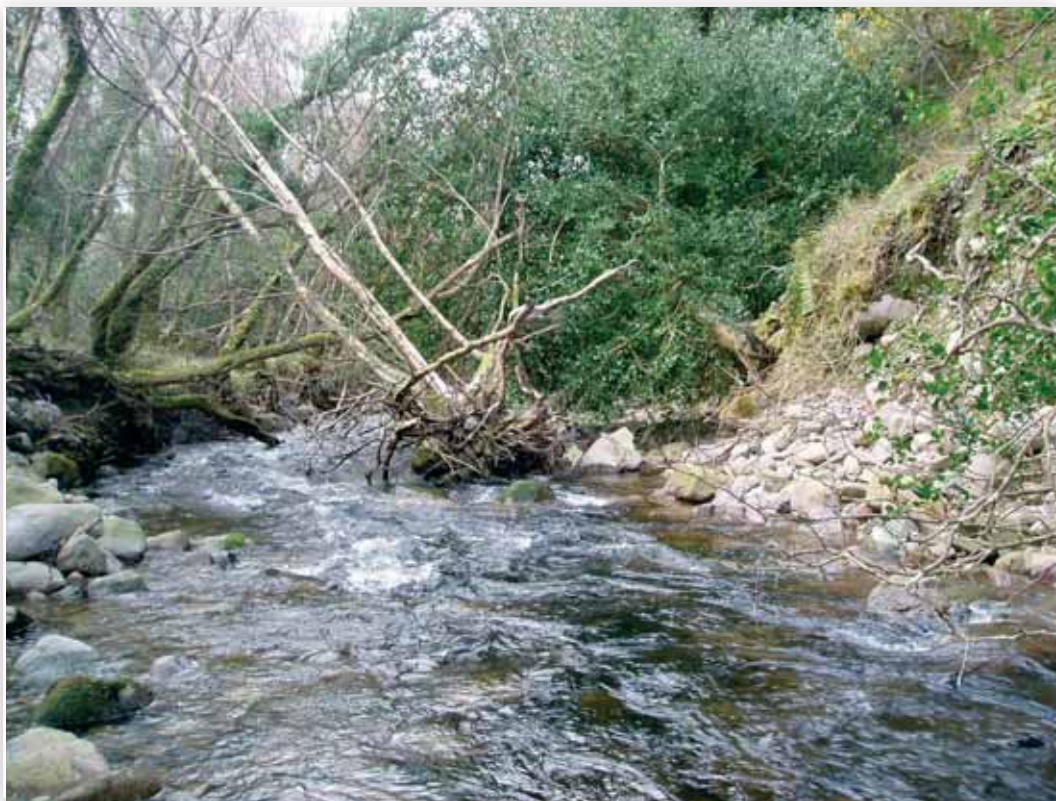
Fig. 7 - Incident Site.

- 4.11 From this point he noted an individual he identified as Ms. Conroy in the river right channel, pinned under what appeared to be the branches of a fallen tree, which had itself been swept into the right river channel. (Appendix 8.2, Fig. 7). Ms. Conroy did not appear to be moving, but at that point appeared to have her head above water level and was noted as having her helmet in position.
